***ROSETTA***

Consolidated Rosetta payload report for the MCRR

RO-EST-RP-3293

17 Nov 2004

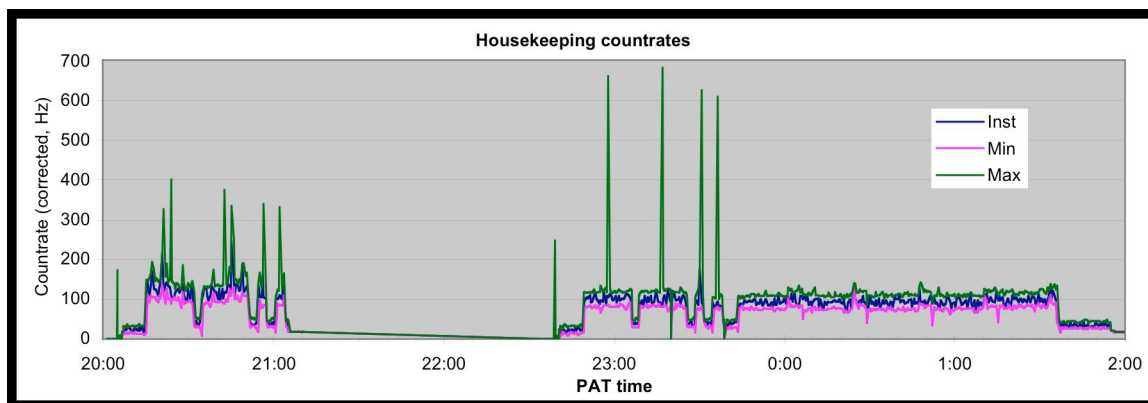
In the above graph the separate acquisitions can easily be distinguished as the aperture door was closed between all the scanning acquisitions. During the jailbar histogram acquisitions the aperture door remained open. Already in the housekeeping countrate values the peaks in the scan could be observed indicating that the stars were covered during the scans. The maximum countrate are about a factor of two smaller than the values suggested by the model. Also visible is that the scans of star 1 cover a field of view with other stars resulting in additional maxima in the countrate value.

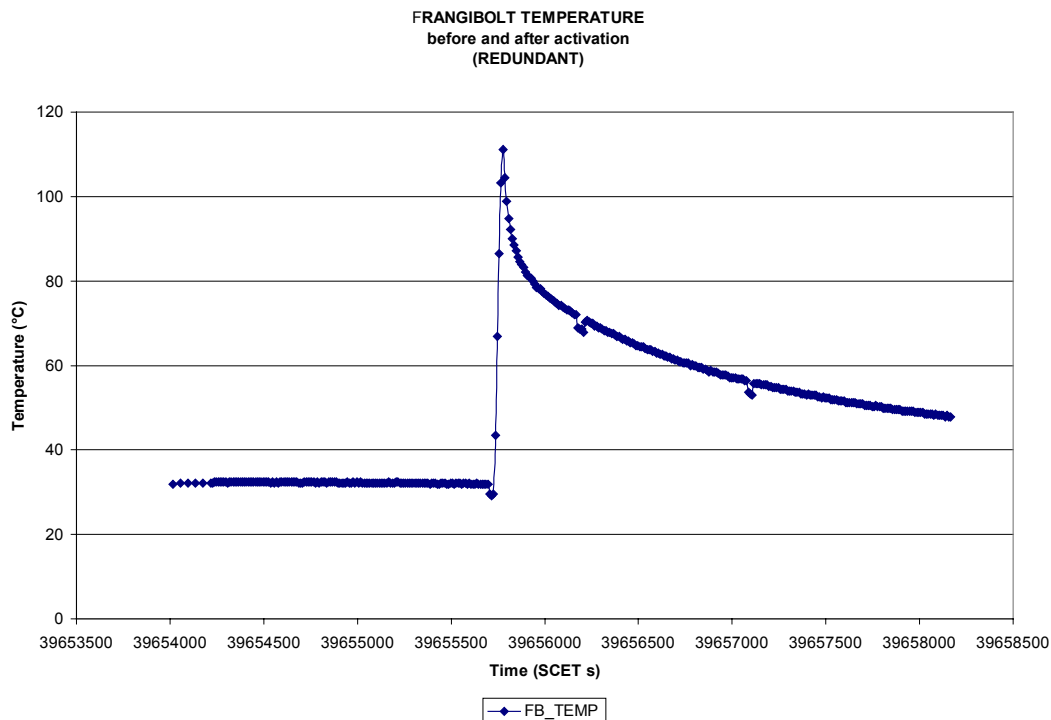
**Figure 1. Commissioning 1 - Frangibolt temperature during activation (REDUNDANT)**

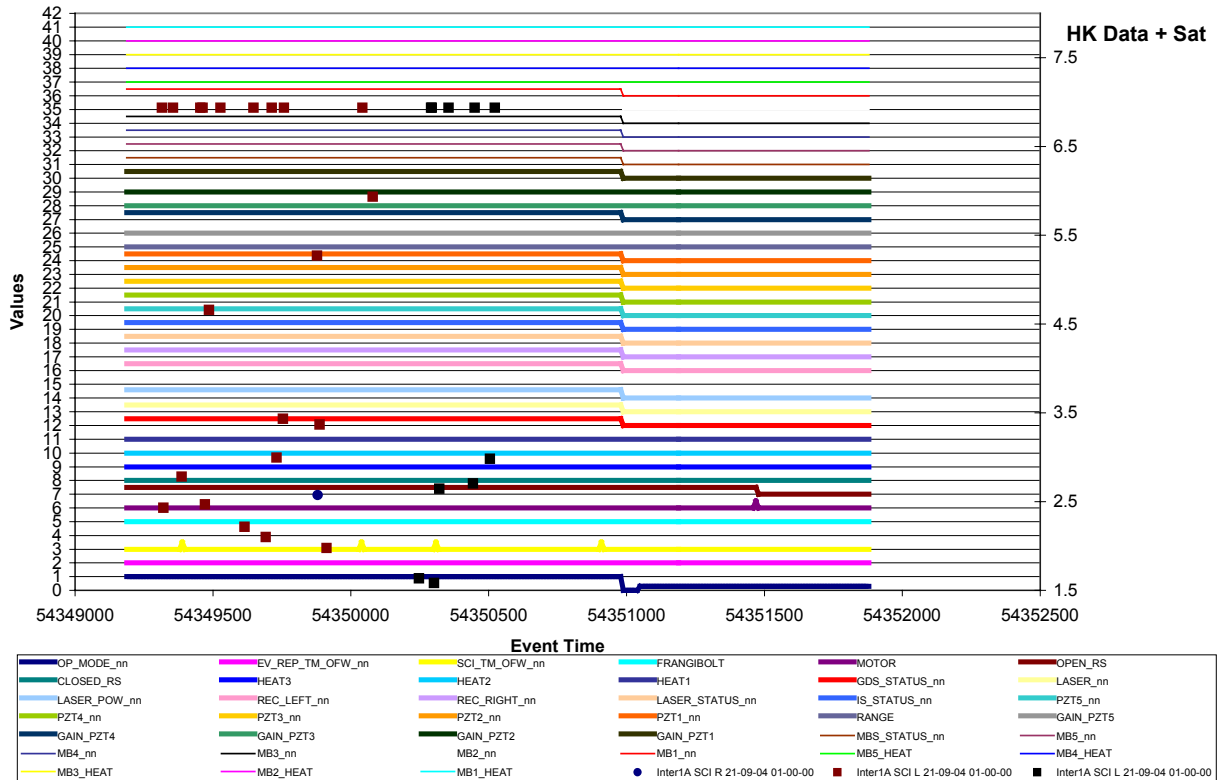
- Two types of **GDS stray-light "ghost detections"** are observed on the **Left channel**:
  - detections of amplitude of the order or little above the threshold (0.8 V); they are attributed to the high level of stray-light, now in combination with possible electronic noise (Figure 5).

Figure 6. Interference 1A - Ghost saturated events on GDS Left channel vs. GIADA status: no correlation with GIADA events is observed

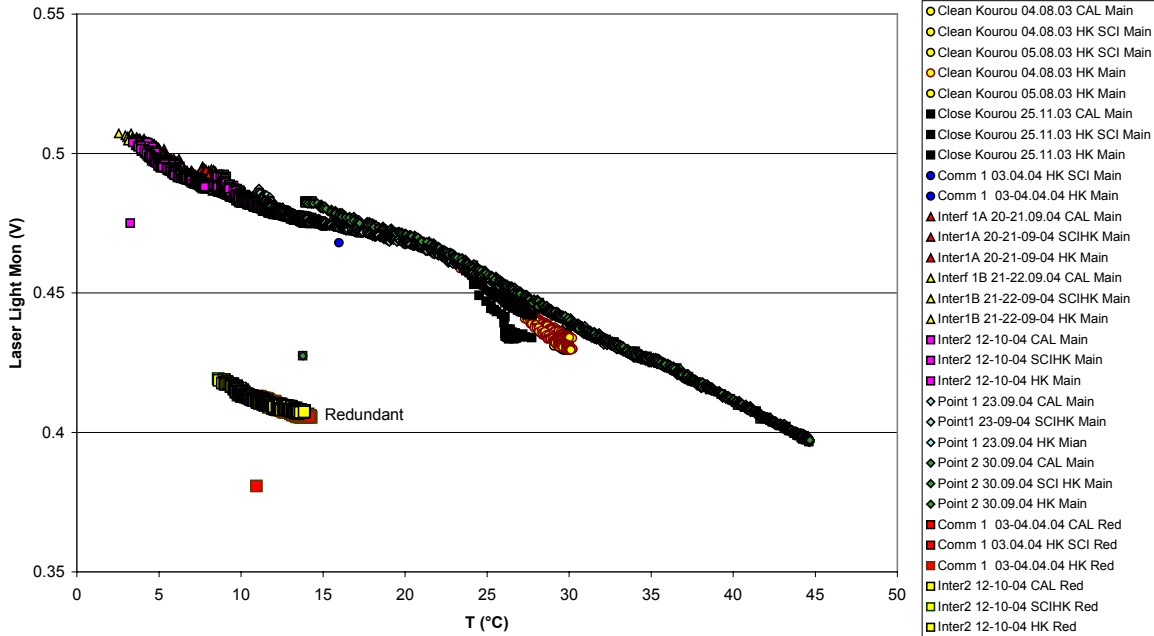
Figure 13. Comparison of different test results on Laser 1 light monitoring vs. temperature

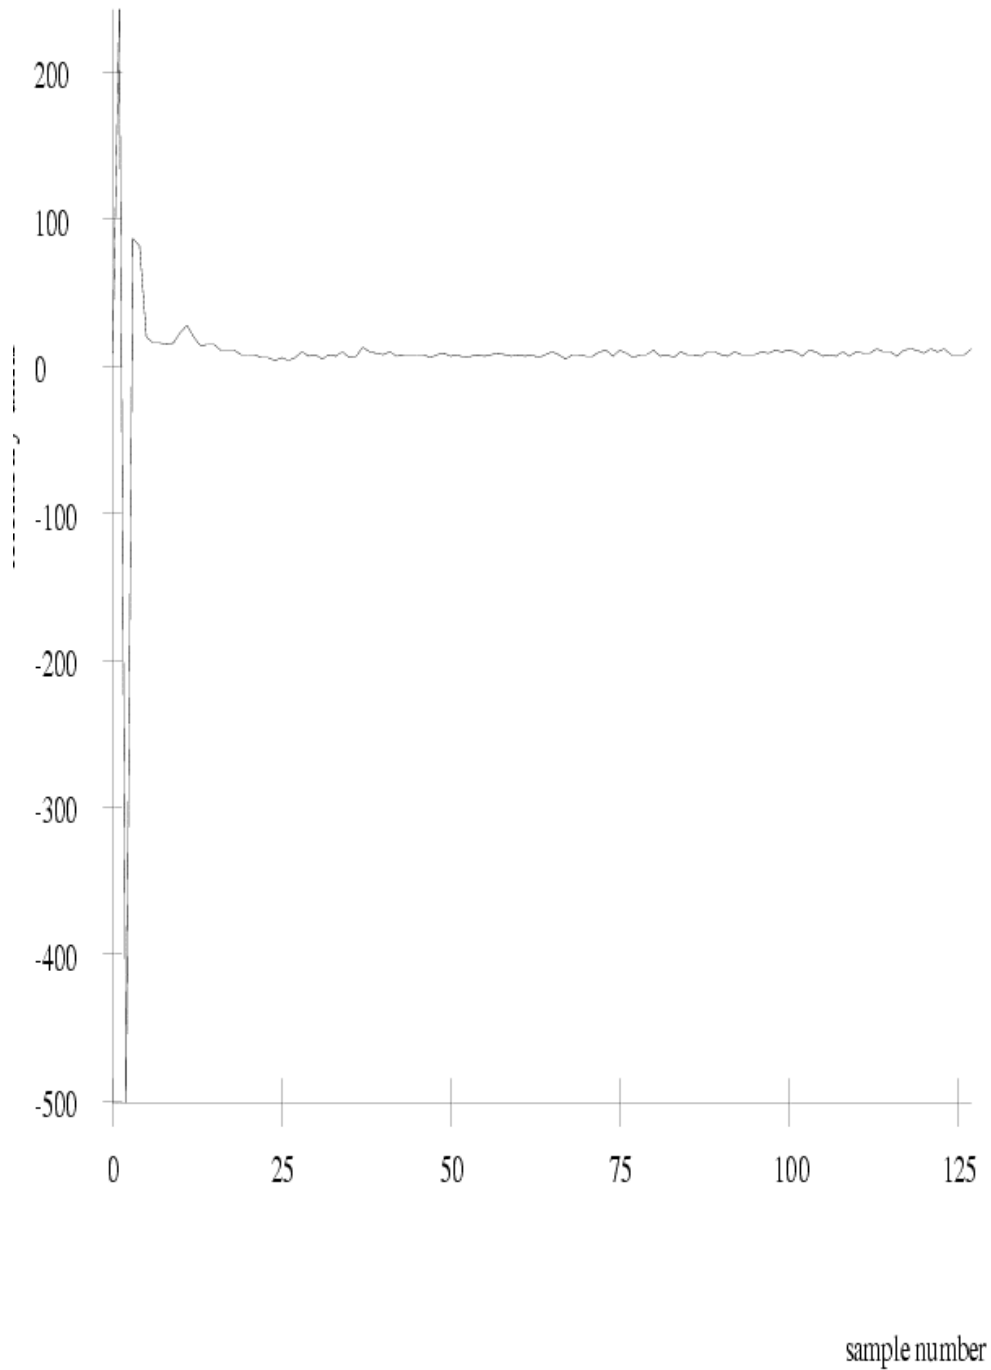
**Figure 5.** MIP signature in LAP data in LDL mode. Time series from probe 1 sampled at 18750 Hz.

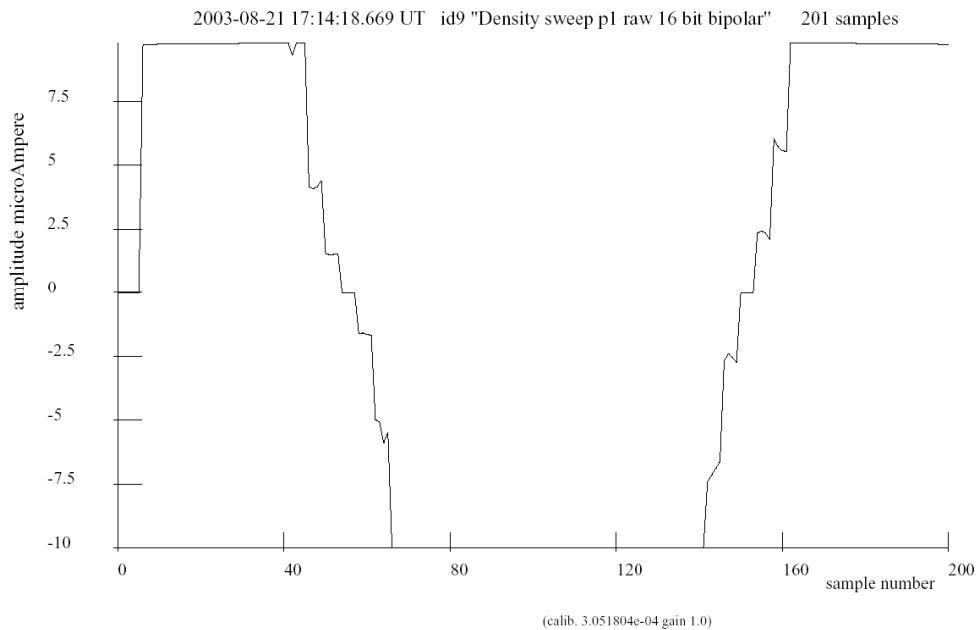
Figure 2. LAP probe bias sweep from 2003-08-21, when the MLI was observed to be in contact with the probe.

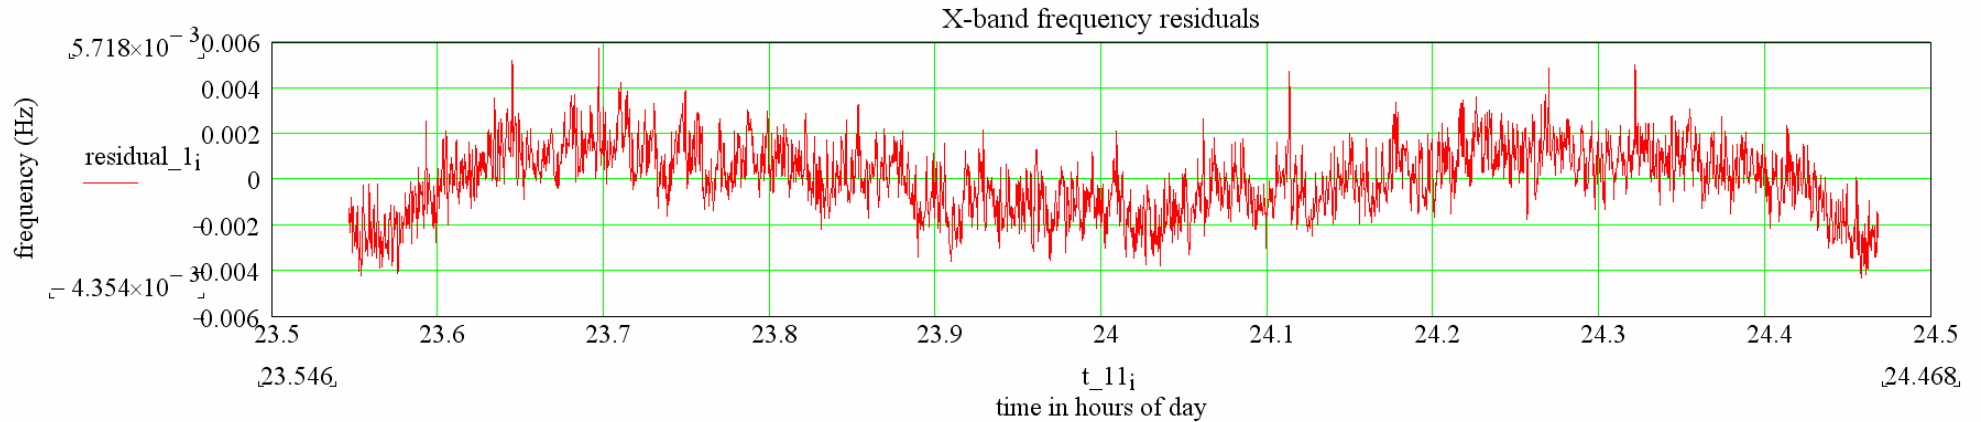
X-band frequency residuals one-way ONES driven by the USO with TM ON starting on 23:42 (23.7). 1-sigma frequency noise is 46µm/s mainly caused by the long-period variation. There are spikes every three minutes in the data.
