***ROSETTA***

Consolidated Rosetta payload report for the MCRR

RO-EST-RP-3293

17 Nov 2004

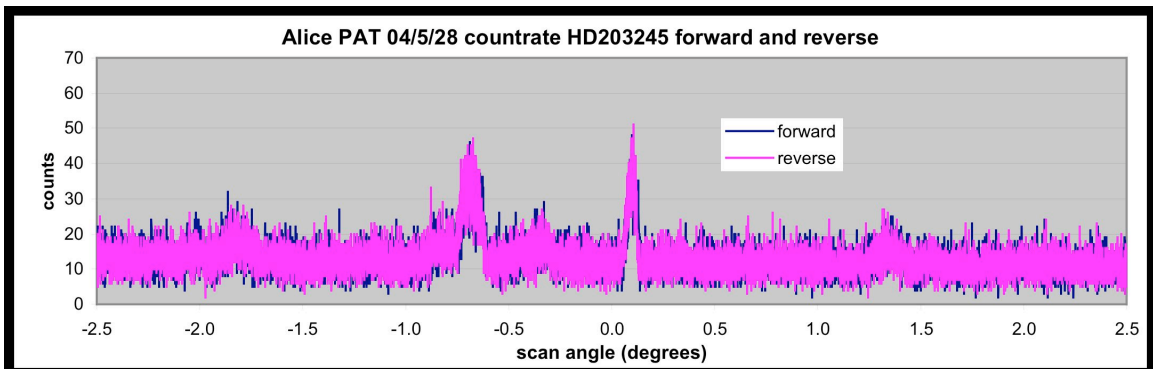
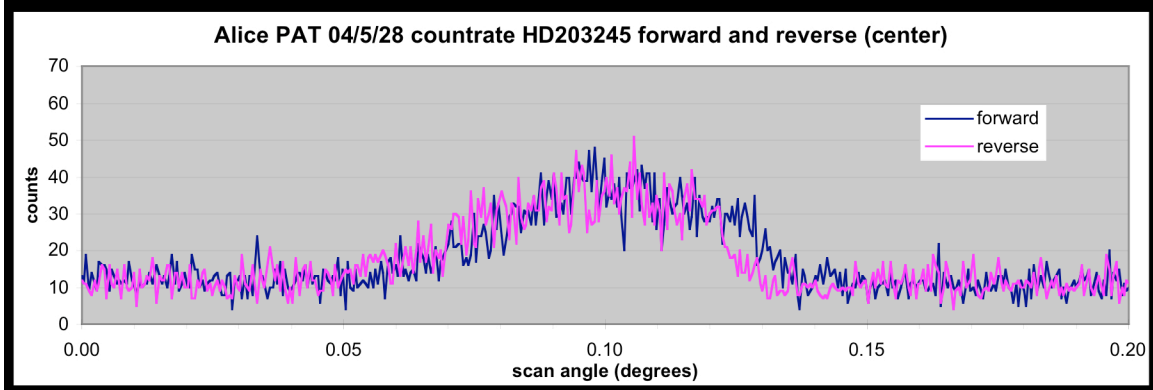
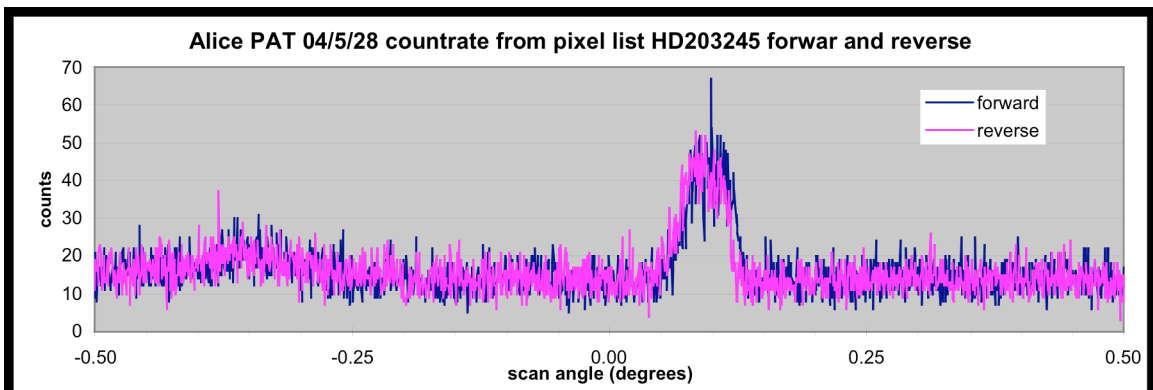
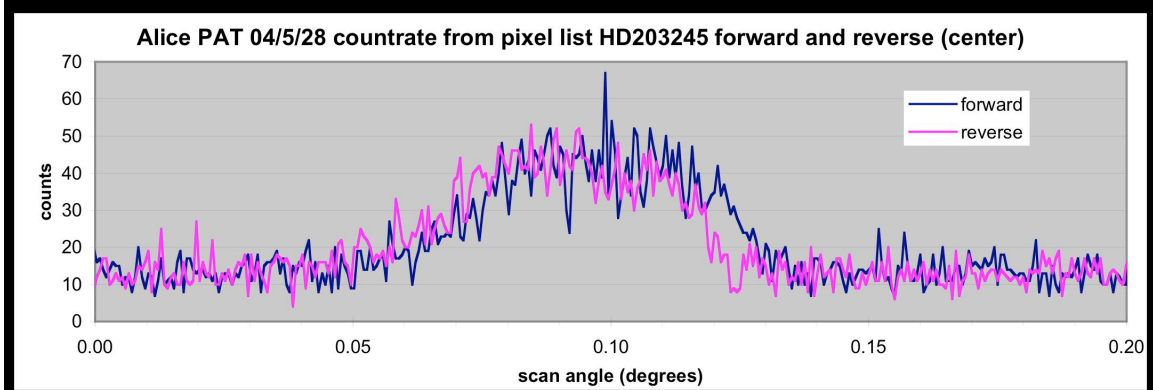
The first graph shows both the measured countrate of the forward and reverse scans, at this scale both scans match. The next (second) graph shows the center section of this graph, were it can be seen that the bore sight offset is about 0.1 degrees. The last two graphs show the same information extracted from the pixellist acquisition scans on the same star. This shows the same bore sight alignment value as the countrate observations.

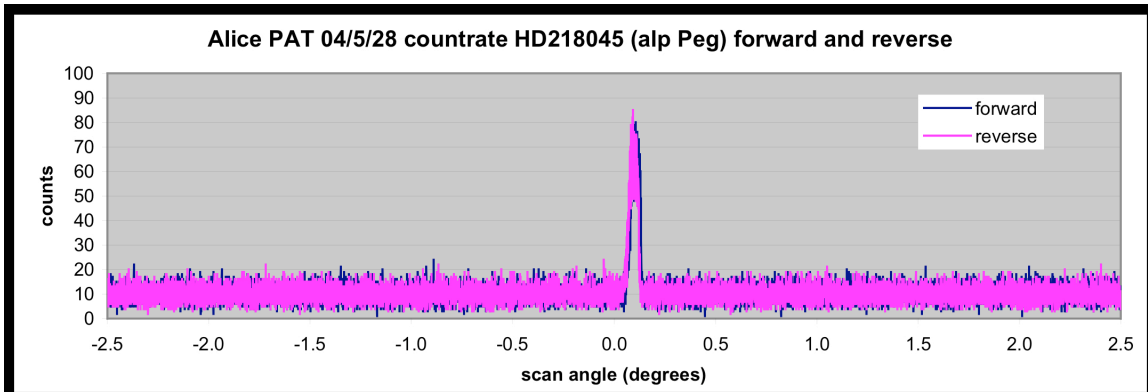
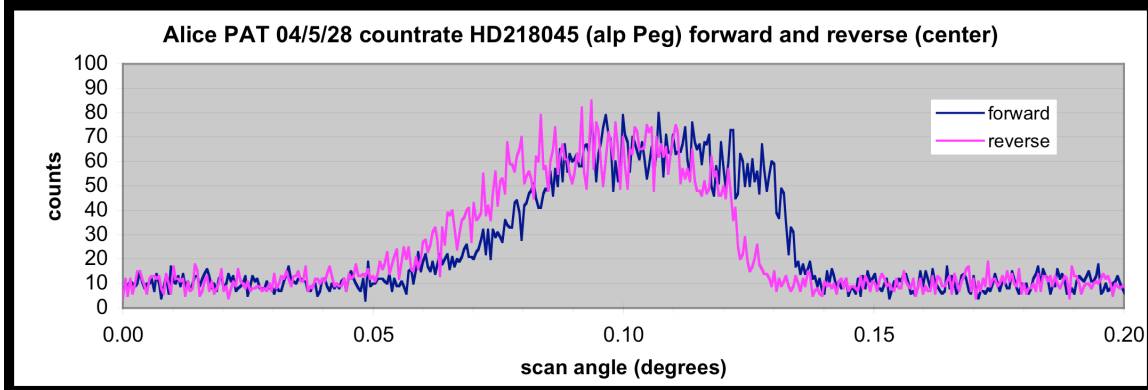
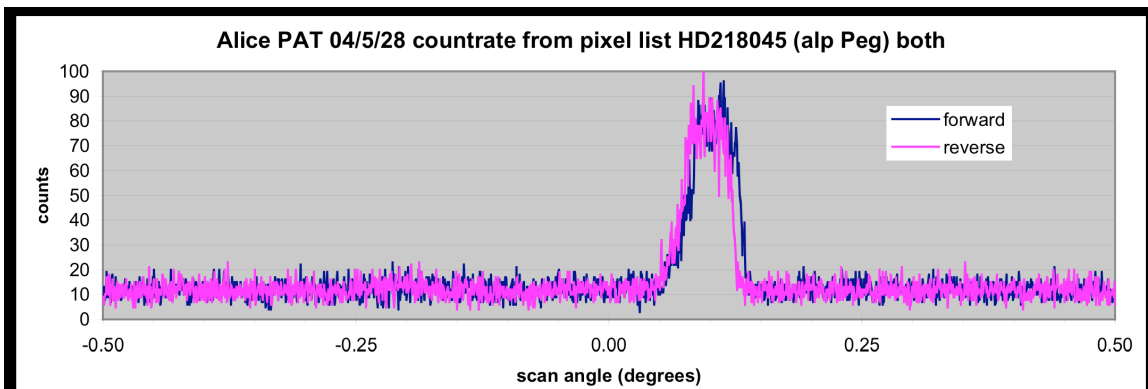
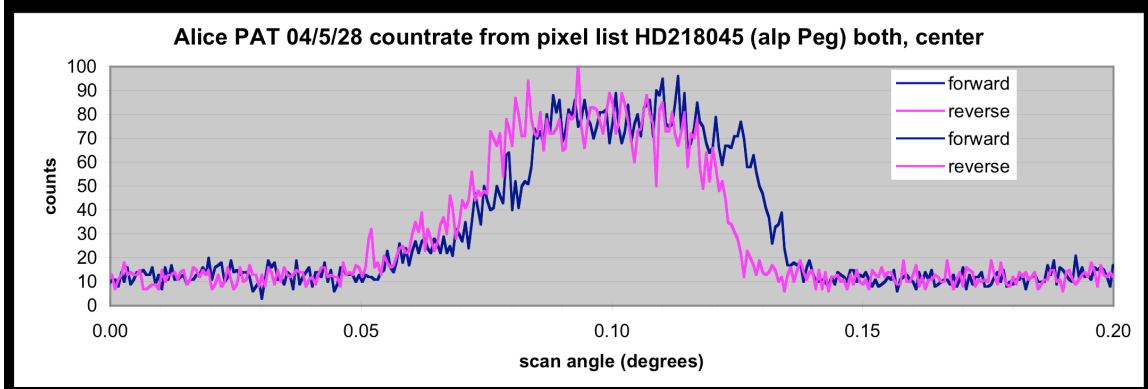
For the second star the same scans were performed, these scans show a quieter background and a much better signal to noise ratio. For the results see the four corresponding graphs:

. The same alignment value is again visible in all four graphs, more clearly visible in these graphs, but also already visible in the scan results of the first star is that there is a reproducible difference between the forward and back ward scan. This difference is larger than the acquisition resolution for the scans so it doesn't seem to be related to the acquisition operation, unless there is an overall inherent time shift in the acquisition operation of the Alice instrument. This difference in forward and backward scan is about 0.01 degree, but further analysis of the figures is needed.

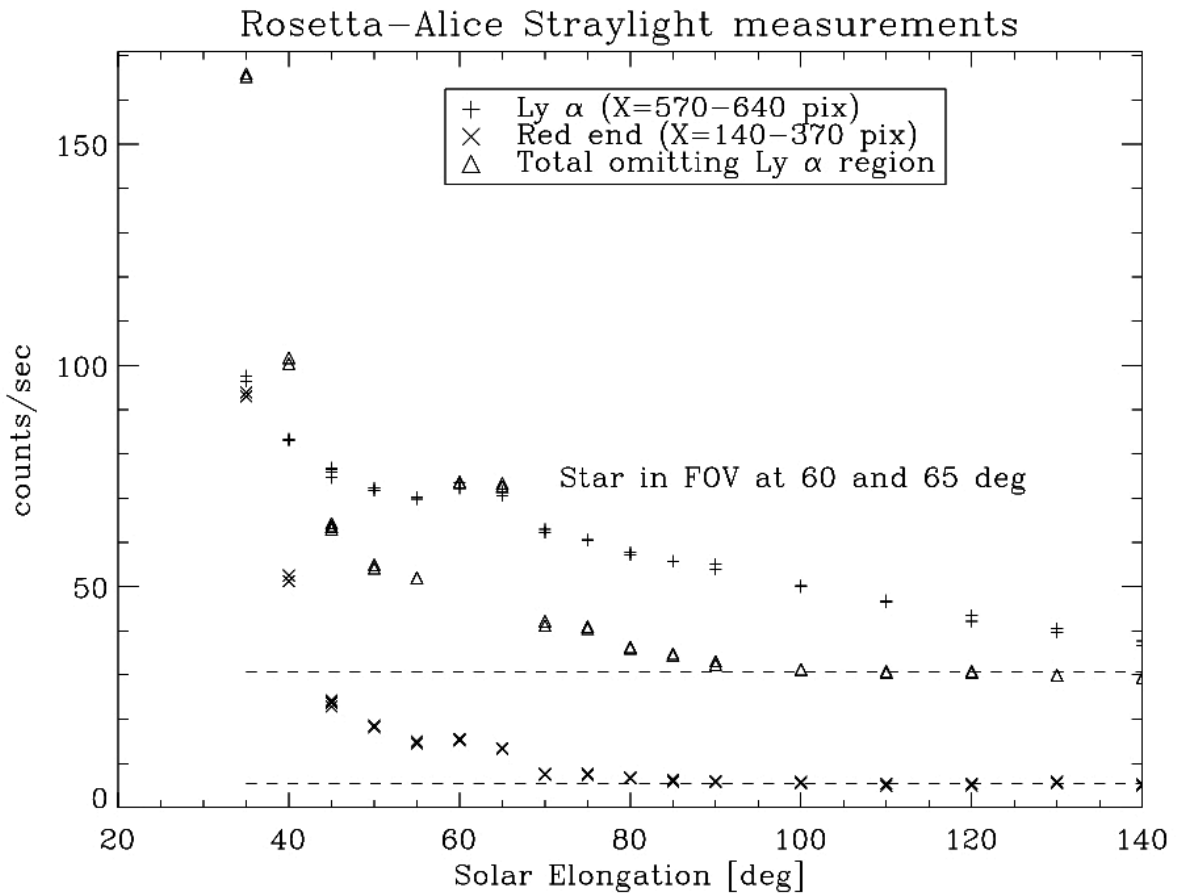
**Figure 2:** A plot of the count rate as a function of solar elongation.

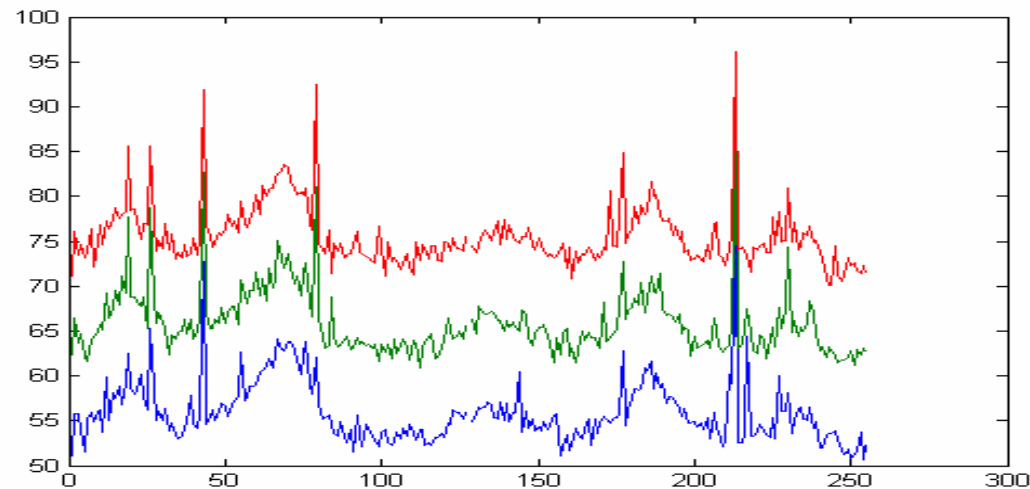
- Mean spectrum (RMS) for each slot in dB from 85 to 95 MHz 10 dB Shift between each graph.
- The following signal shows a signal shape with oscillation larger than the orbiter ones (10 dB versus 2 dB).
- The measured noise level is a few dB larger on the Lander than on the Orbiter.
- The Lander antenna is folded and this can be the reason of these larger oscillations.

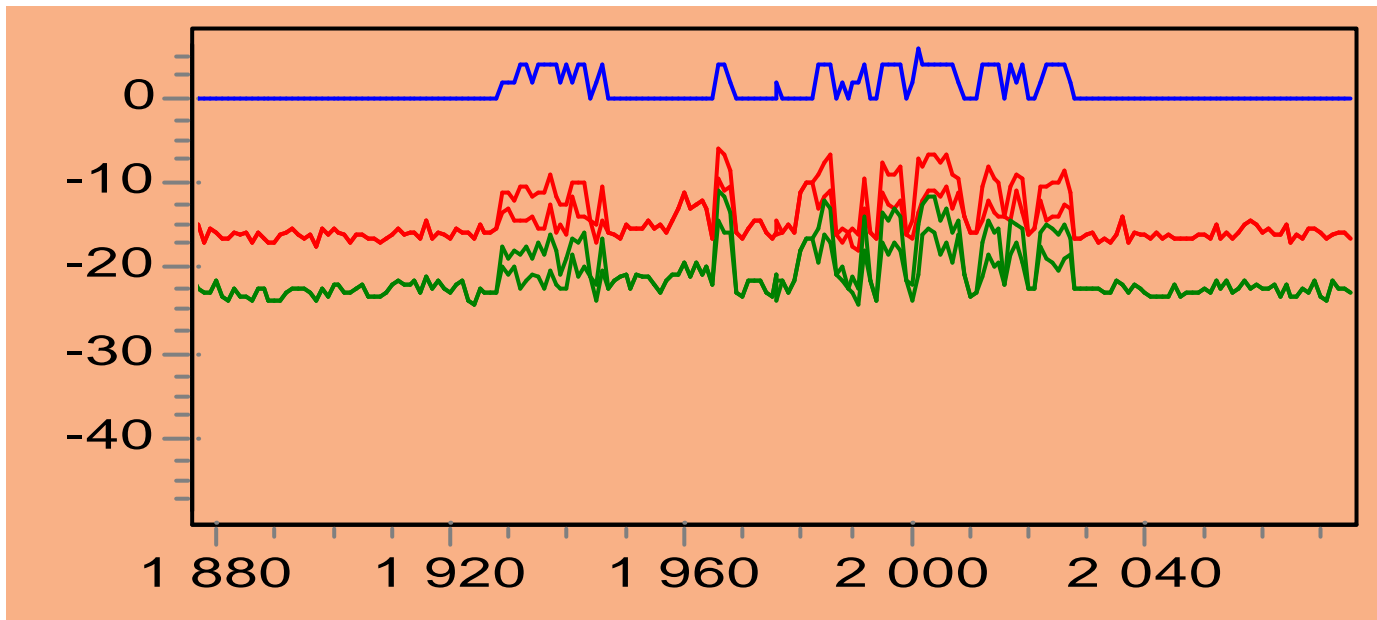
- Sesame disturbing the Consert measurements.

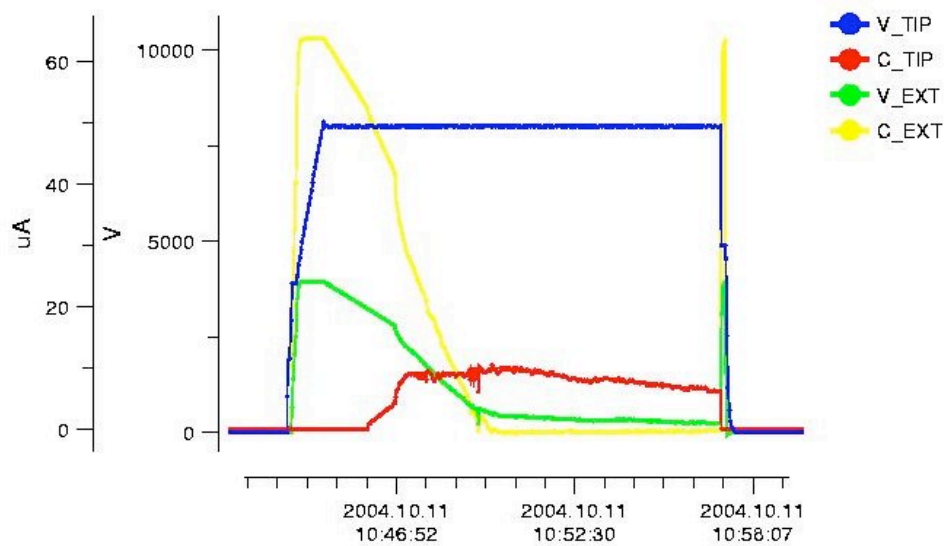
At the end of the commissioning the emitter 'C', which previously was hard to turn ON worked flawlessly, while the emitter 'A' which previously worked excellently caused problems. This problem will need special attention in the future maintenance operations, which are planned roughly every 9 months into the mission.

**Figure 8.** Tip and extractor currents and voltages during unstable behavior of Emitter A.

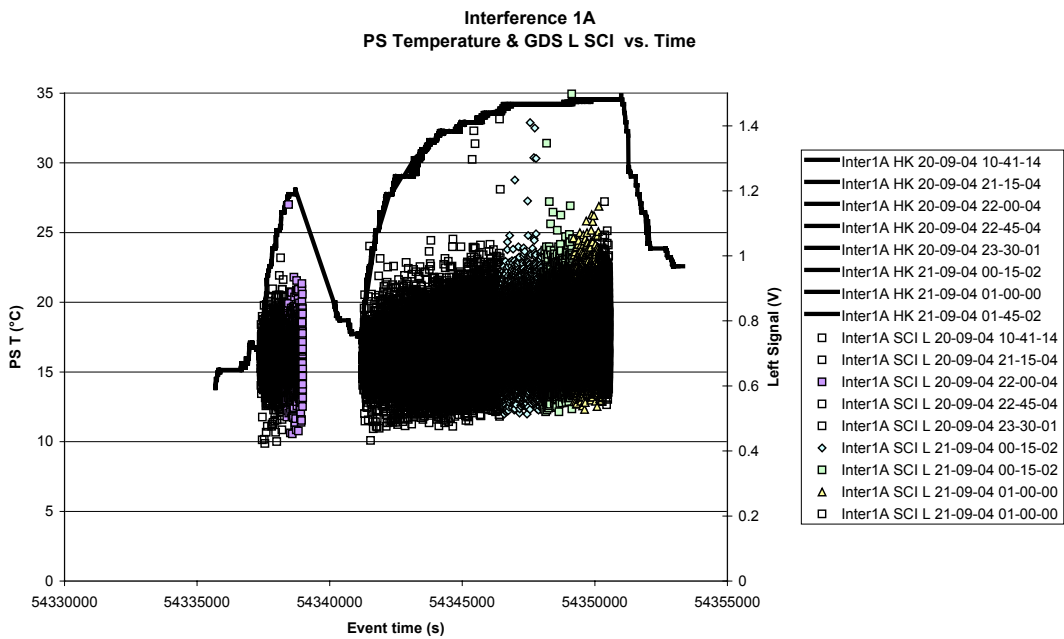
- Two types of **GDS stray-light "ghost detections"** are observed on the **Left channel**:
  - detections of amplitude of the order or little above the threshold (0.8 V); they are attributed to the high level of stray-light, now in combination with possible electronic noise (Figure 5).

This effect could be due to interference with other P/L (see Section 8) or to internal GIADA effects, as - for example - temperature effects (see behaviour in Figure 5).

**Figure 5. Interference 1A - GDS Left "ghost events" and Main Electronics temperature vs. time**

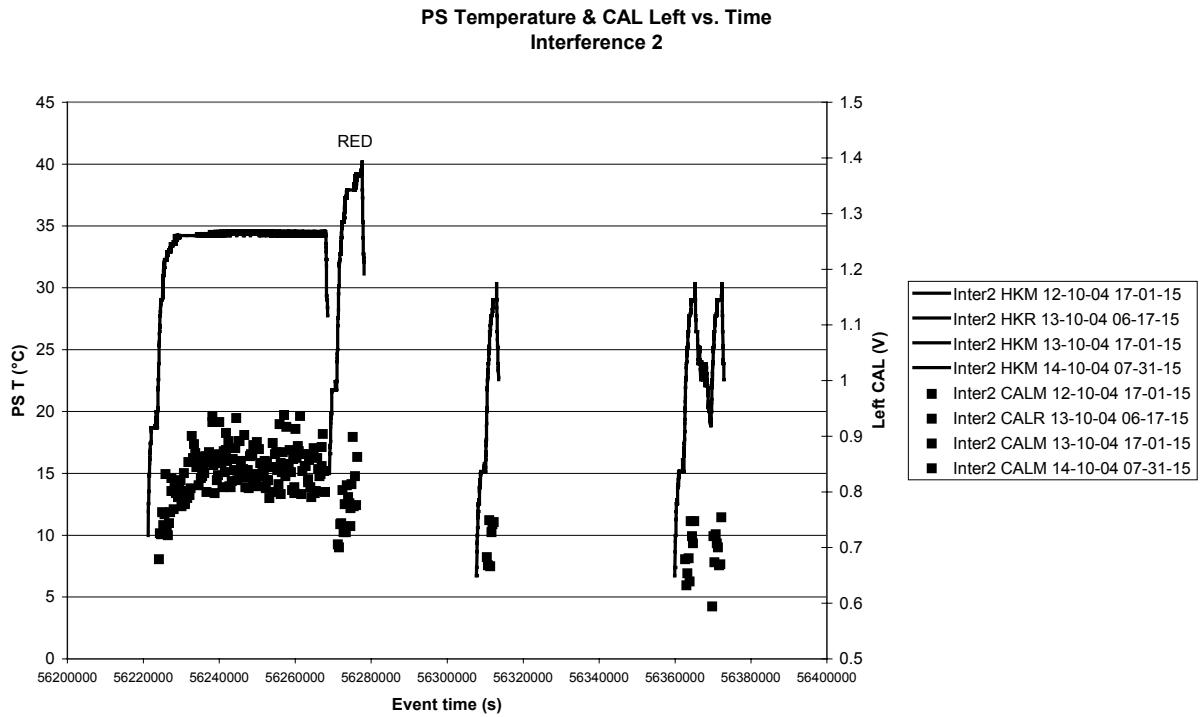
**Figure 7. Interference 2 - GDS Left Calibration data (mean values) and Main Electronics temperature vs. time and used interface (RED = Redundant)**

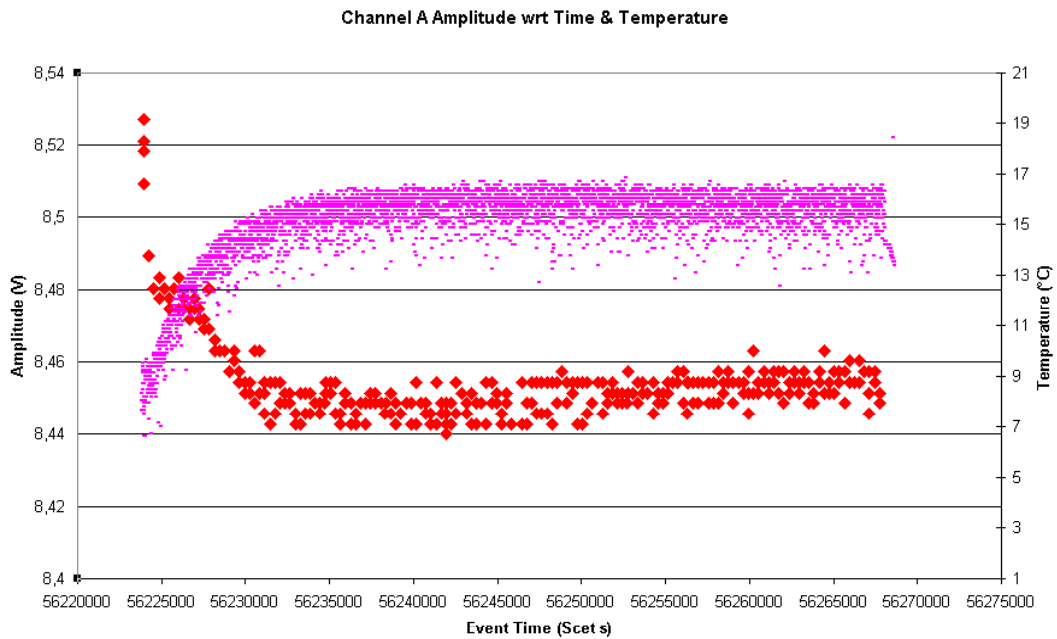
- The **IS calibration** presents the following behaviour
  - Channel-A response (amplitude and delay time) is quite stable. A slight dependence of amplitude on temperature is observed (Figure 8)
  - Channel-B response (amplitude and delay time) is quite stable. A slight dependence of amplitude on temperature is observed
  - Channel-C voltage and delay time are confirmed not stable in time  
**It is suggested to increase channel C detection threshold (e.g., 100 - 150 mV)** to keep the channel detection less susceptible to noise
  - Channel-D response (amplitude and delay time) is quite stable. A slight dependence of amplitude on temperature is observed
  - Channel-E response (amplitude and delay time) is quite stable. The measured amplitude decreases rapidly and reaches a minimum and then increases and becomes almost stable

**Figure 8. Interference 2 - IS Channel A calibration behaviour and IS temperature**

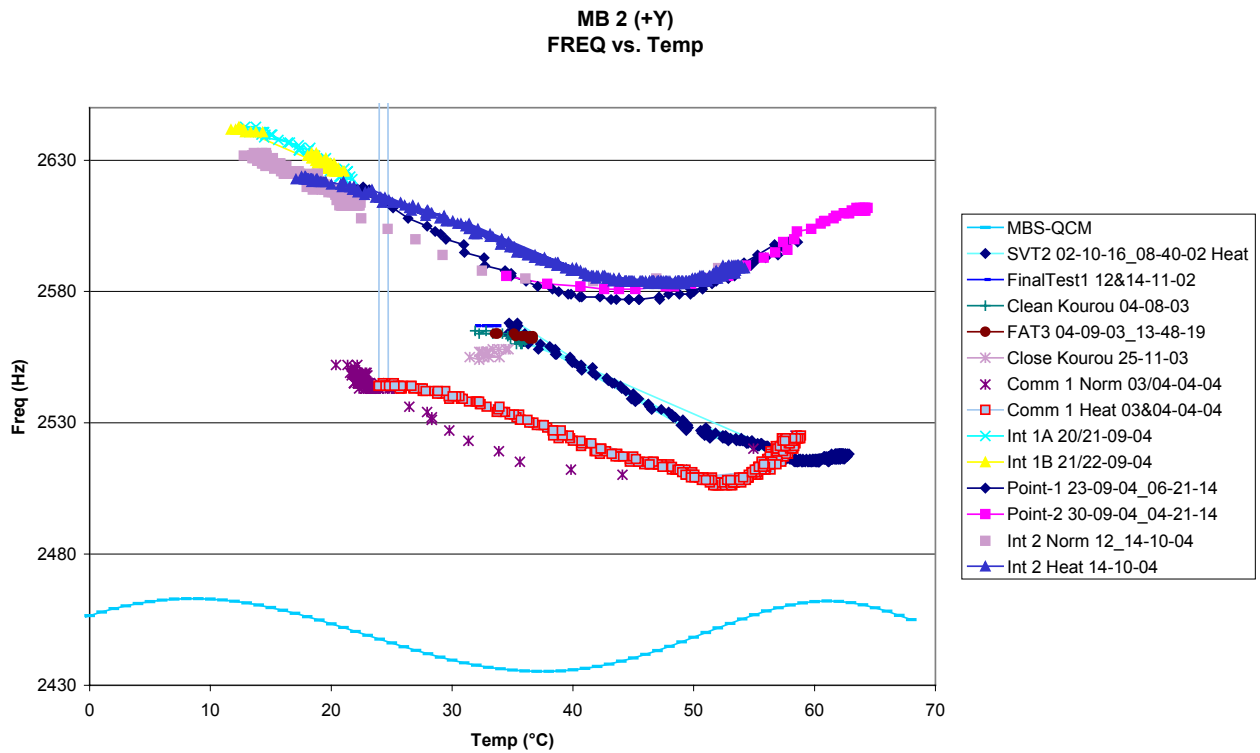
- The **MBS** have been heated to check if the frequency change, observed already during Interference 1A-B, was due to contamination of volatile material. Unfortunately, the contamination is not changed with heating (Figure 9). Actually, this result was expected as during Pointing tests (see Section 9) MBS were already exposed to high temperature and no frequency change (beside the normal temperature dependence) was observed.

This effect seems to have happened **between 1<sup>st</sup> commissioning and Interference tests and has remained stable afterwards. The deposited material seems not volatile, as heating has not produced its release. The confirmation of MBS contamination requires investigation in conjunction with other Rosetta P/L to check for similar behaviours.**

**Figure 9. Comparison of the frequency behaviour for MBS-2 during different tests**

- A **partial contamination of 3 micro-balances is definitely observed**. The contamination seems to have occurred between 1<sup>st</sup> Commissioning (3-4 April 2004) and Interference (20-21 September 2004). The contamination seems **NOT** to be **increased afterwards**. **This behaviour should be compared with results obtained by other P/L**. It looks the contaminants **are not volatile**, as MBS heating up to about 60 °C and exposure to Sun (during Pointing tests) have not produced significant release of material (frequency decrease). For the rest, the MBSs behaviour is nominal.

**These effect must be checked in following tests and may indicate some contamination of MBS exposed sensor crystal. An MBS heating is recommended at next opportunity to check if accumulated material can be removed, if sufficiently volatile.**

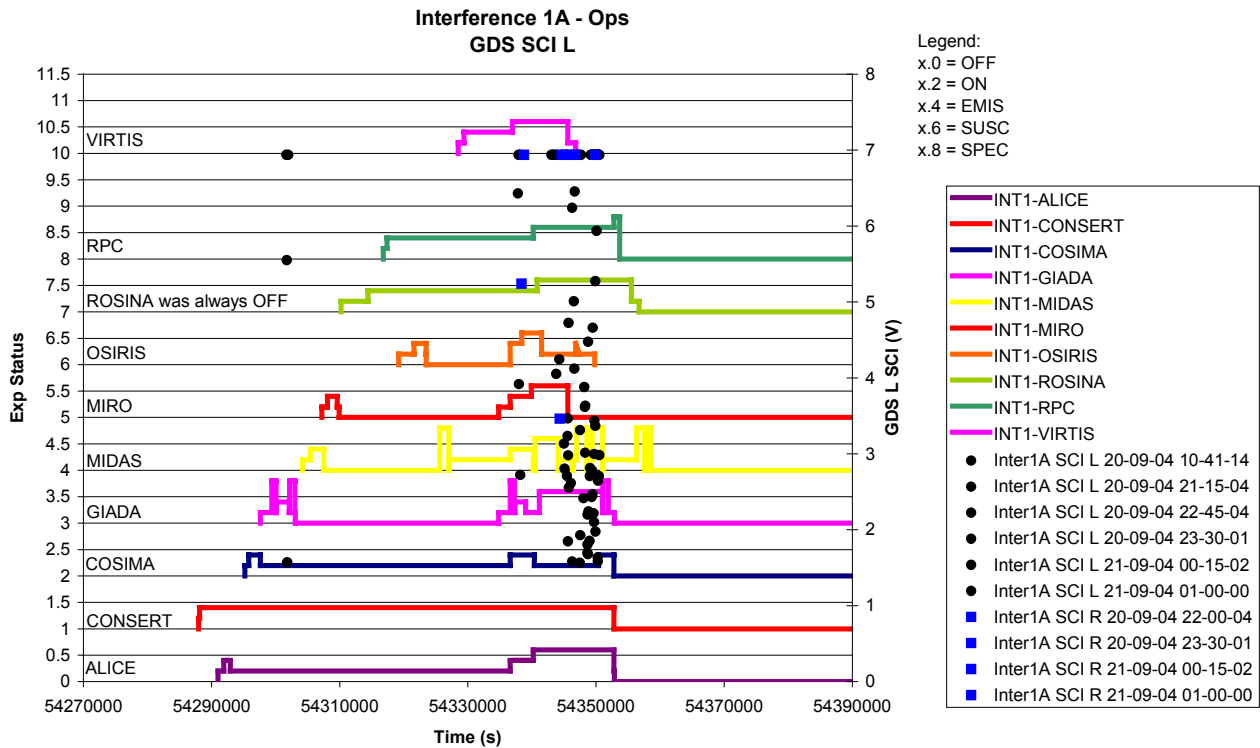
Figure 10. GDS Left "ghost events" generation vs. Rosetta P/L status during Interference 1A

**No clear relation between GIADA noise (GDS Left "ghost events") generation and Rosetta P/L status can be identified at the present time.** In fact, Consert and Midas are the only experiments that are not switched ON/OFF during periods in which GIADA presented GDS Left "Ghost events". However, these experiments were ON during Interference 2C phase, when GIADA was quiet. **It must be checked if Consert and Midas performed the same operation during Interference 1 and Interference 2C phases. If this is the case it might be concluded that GIADA is susceptible to some Rosetta status when all P/L is ON.** On this matter, also the comparison when GIADA Main or Redundant interface are used must be considered carefully.

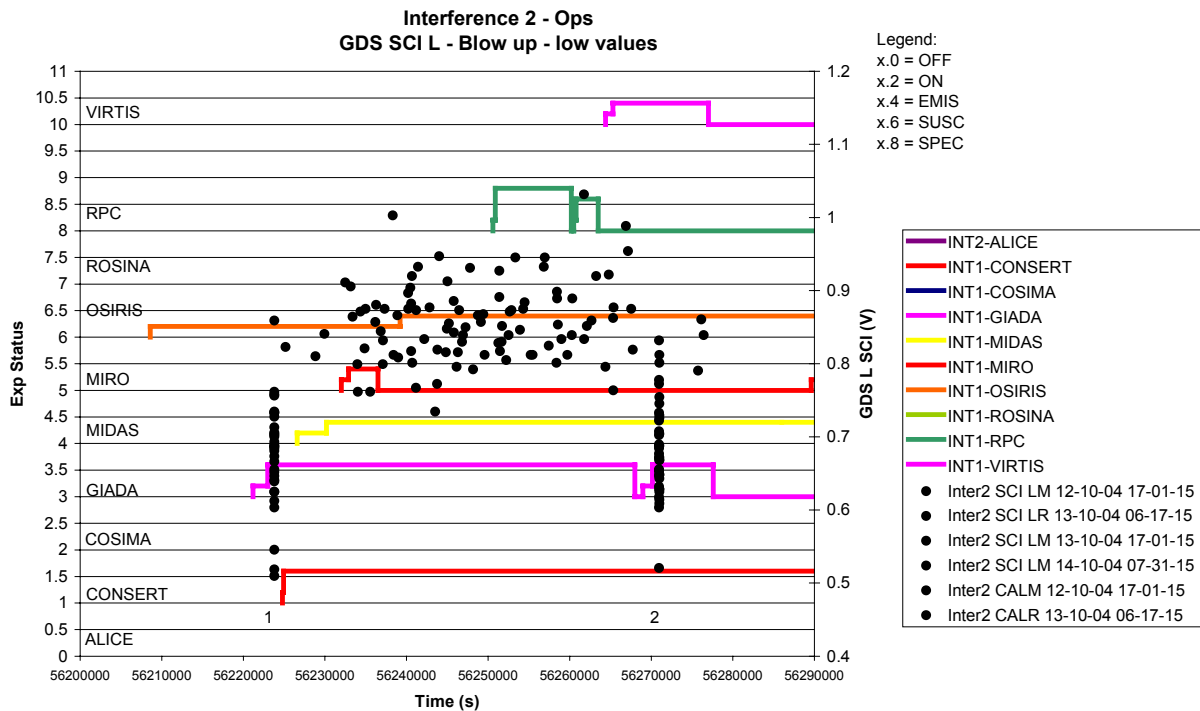
Figure 11. GDS Left "ghost events" generation vs. Rosetta P/L status during Interference 2

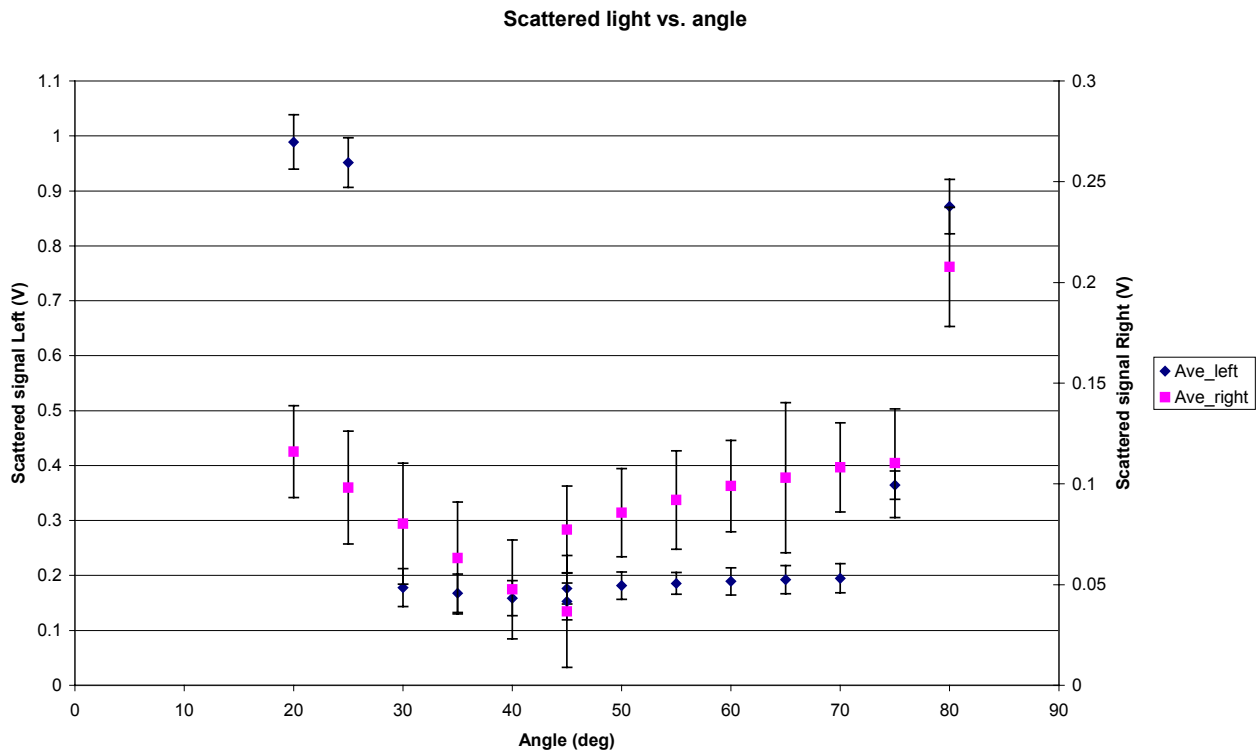
- The GIADA GDS Left and Right outputs are reported in Figure 12, vs. Sun angle position wrt. S/C Z axis  
 We notice that the signal drops to very low values, indicating an external stray-light saturation due to Sun light entering (directly or reflected on the external parts of GIADA) the cavity where the GDS is positioned. The GDS output behaviour is also synthesised in Table 4.  
 We notice that the **Left channel is saturated between 30 and 75 deg**, probably because in this range of angles the Sun light is reflected towards the detectors, so saturating the detector acquisition chain, while below 20 deg, the direct light does not strikes the Left detectors  
 We notice that the **Right channel is saturated up to 75 deg**, probably because in this range the Sun light is either reflected or directly strikes the Right detectors  
 This interpretation is compatible with the internal geometry of GIADA and the light Sun incoming direction.

**Figure 12. Pointing Test - GDS output vs. Sun angle wrt. S/C Z axis in the XZ plane**

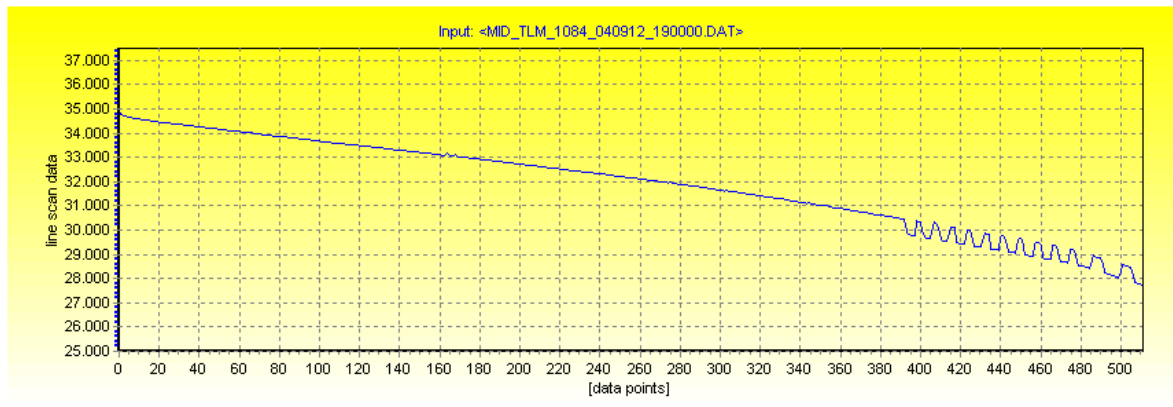
Three long linescans (112  $\mu\text{m}$ ) were performed on the calibration facet 1 in commissioning slot 3. The X-scanner range was set between 30000 and 60660 units. The goal was to find the grid structure, which was indeed finally found in the last part of the X-range (see Fig. 8).

Fig. 8. Line scan of calibration surface TGZ02 (raw data); parameters: open loop mode, wheel position 32, origin coordinates (30000,30000), 512 points, step size 60, tip 6, dynamic mode.

This result proves that the scanner performs as expected. The reason for the initial failure to find the grid was obviously due to a small misalignment of the wheel position relative to the scanner unit, probably introduced during the refurbishment activities in summer 2001, when the launch-locks of several mechanisms did not allow an end-to-end verification measurement of the alignment.

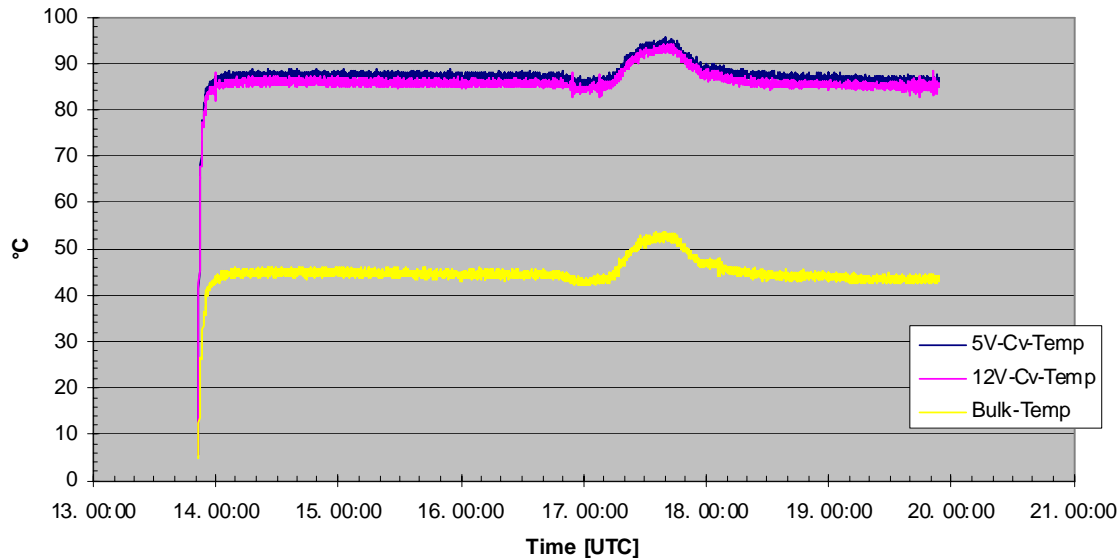
Fig. 4: ESS (main) converter temperature during some days of Block 3. Nowhere the limit of 103 °C was exceeded. The bulge at 17. May is related to the manoeuvres due to the Comet observation.

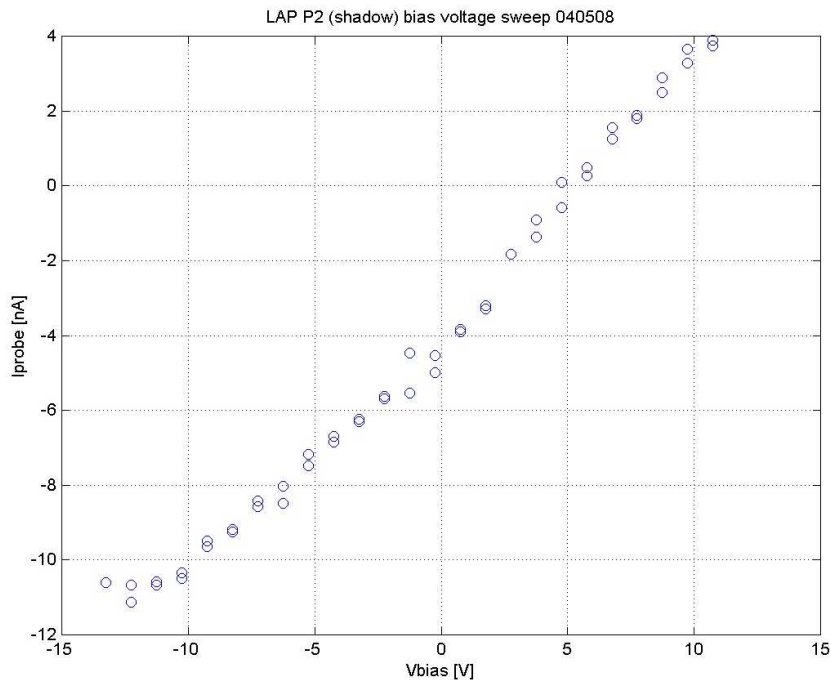
**Figure 6.** A LAP P2 (shadow) probe bias voltage sweep obtained during the out-of-pass EN test (step 0050 in the first out of pass). The linear behaviour through  $I = 0$  indicates that the offsets determined from the calibration in the first pass, which have been corrected for in this plot, do not apply or are imperfectly handled.

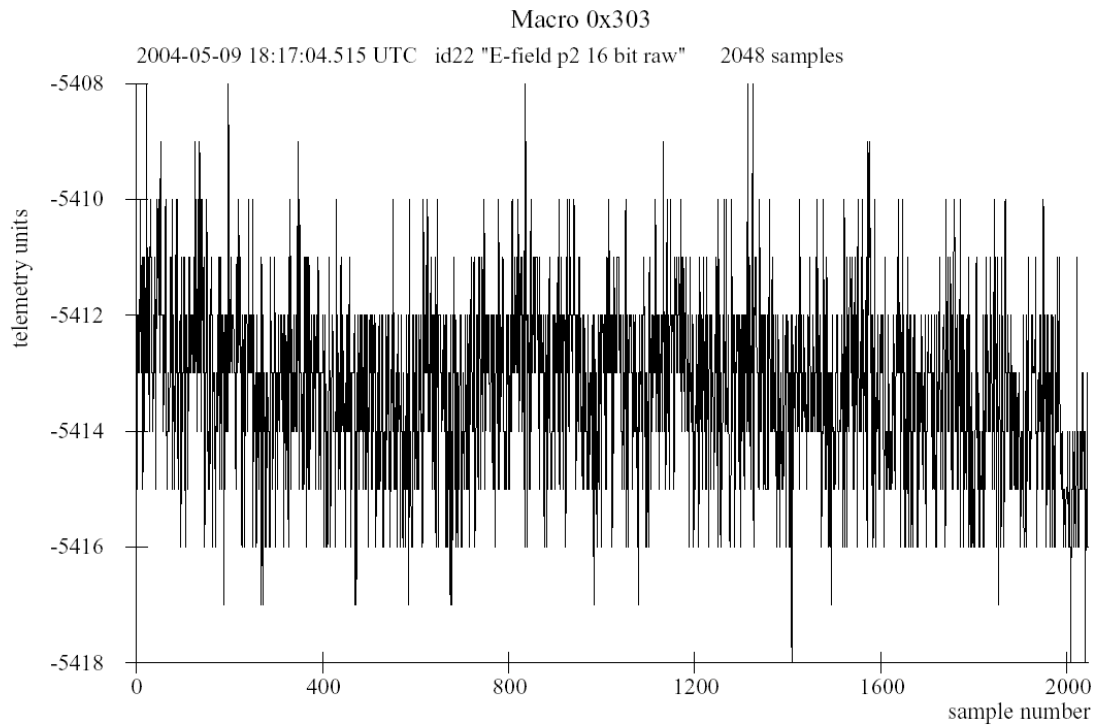
**Figure 7a.** The noise level in the voltage measured on probe 1. Only bit level noise is seen. Calibration factor is 1.22 mV/TM unit. A weak low-frequency signal can be seen. Sampling frequency is 18750 Hz, low-pass filtered at 8 kHz. CHECK!

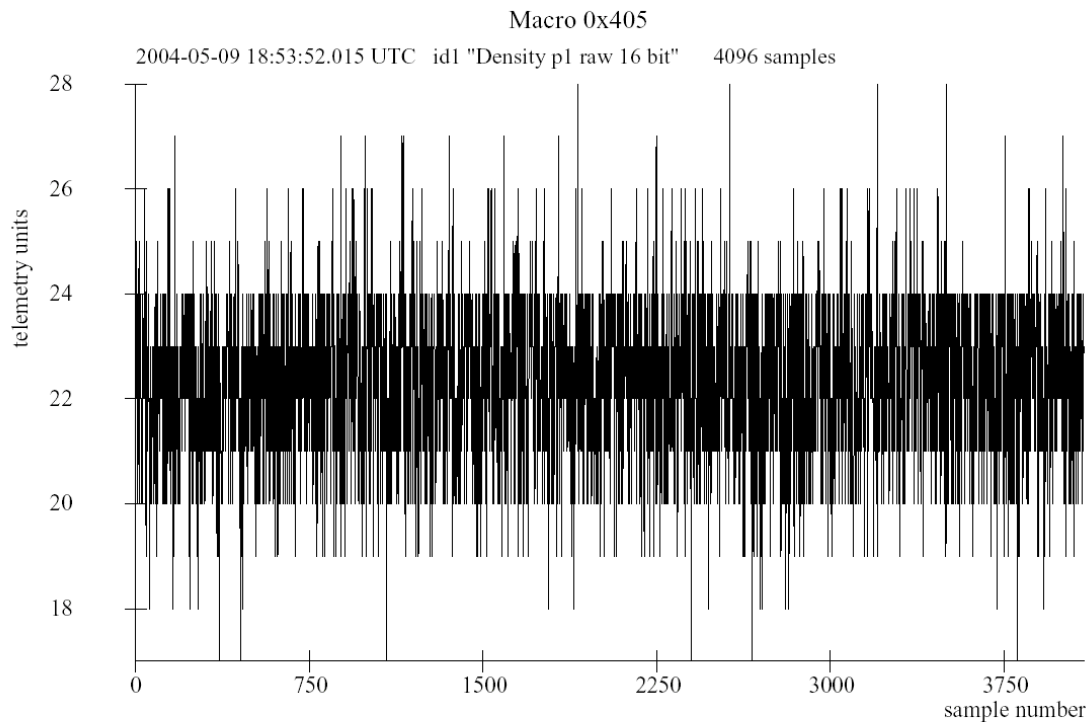
**Figure 7b.** The noise level in the current measured on probe 1. Only bit level noise is seen. Calibration factor is 0.305 nA/TM unit. Sampling frequency is 18750 Hz, low-pass filtered at 8 kHz. CHECK!

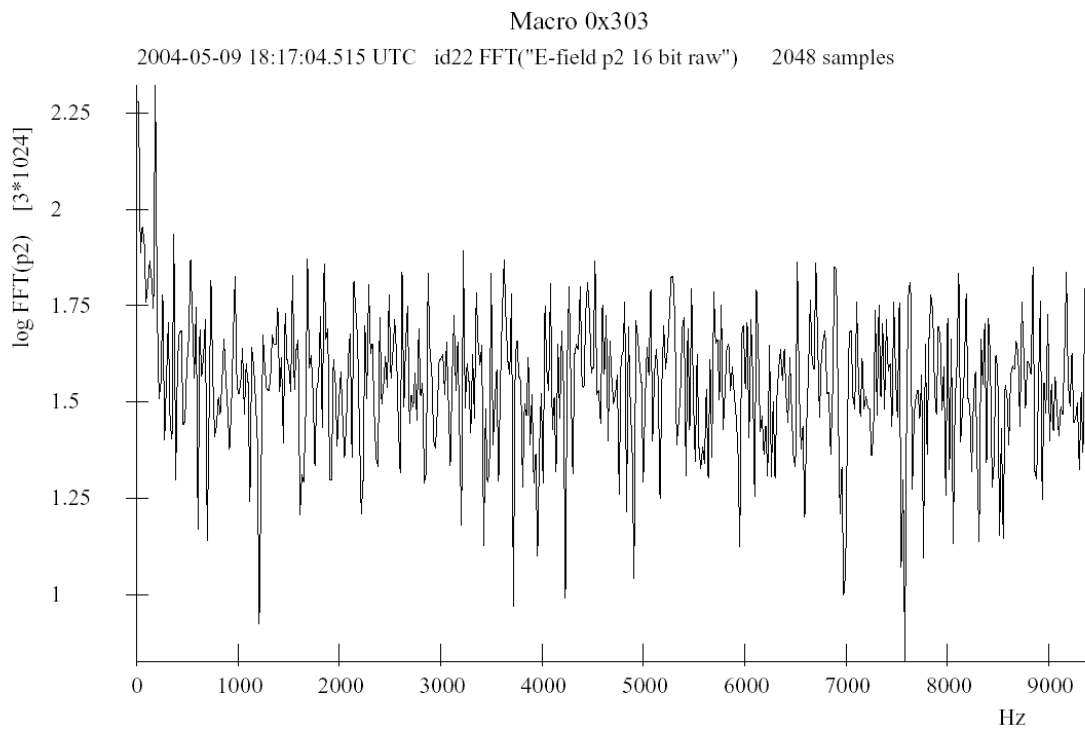
**Figure 7c.** Spectrum of the signal in Figure 7a. The peak at 180 Hz is the only persistent feature rising above the white noise.

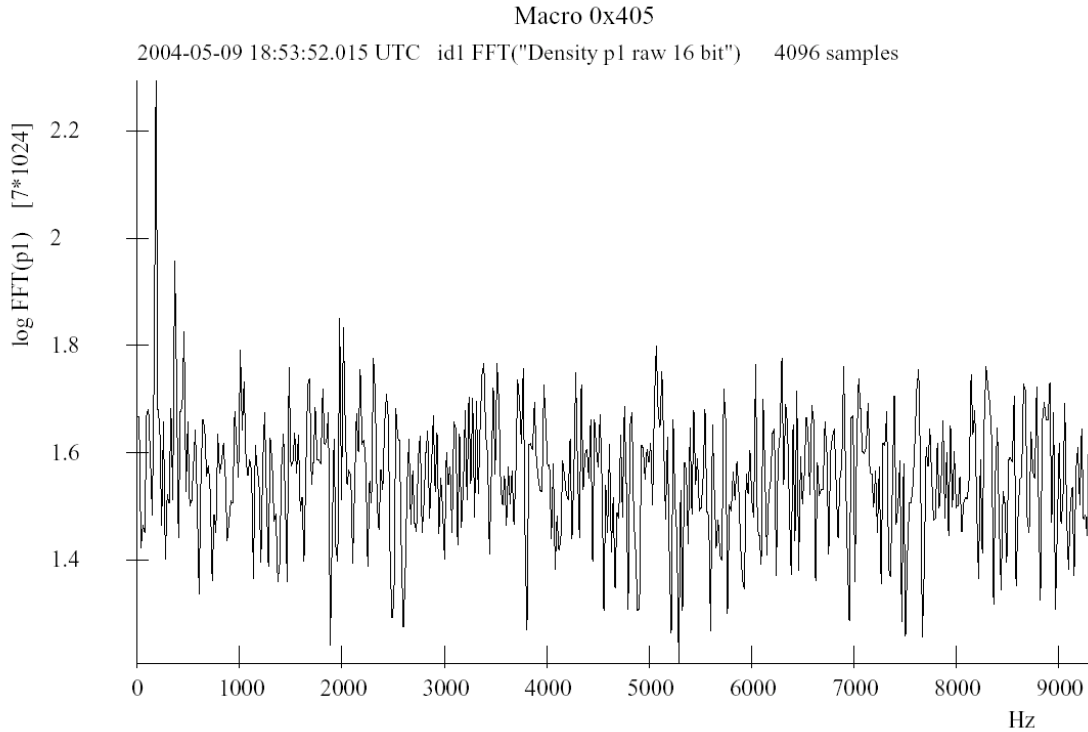
**Figure 7d.** Spectrum of the signal in Figure 7b. The peak at 180 Hz is the only persistent feature rising above the white noise.

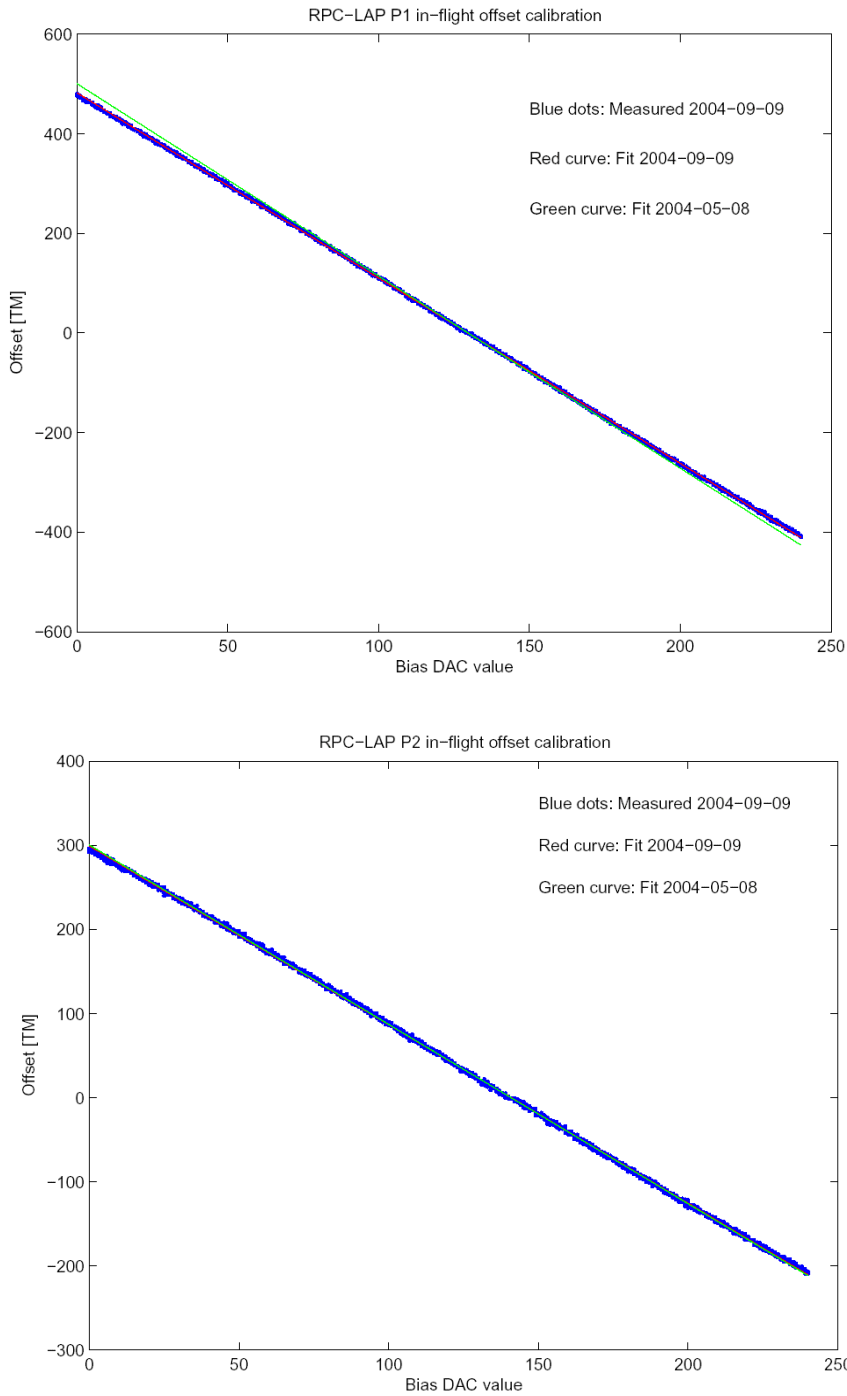
The difference between the P1 offset curves determined in May and September is mainly due to a change of slope of the curve. This can be a temperature effect, though we are more inclined to believe that we here see the real drift we had anticipated, and for which we have included the possibility of onboard calibrations. The difference in the slopes determined in May and September is small, only corresponding to 0.17 nA/V.

**Figure 4.** Offset determinations on September 9, 2004, for P1 (top) and P2 (bottom). Blue dots are data, red line a linear fit. The green line is a linear fit to offset determination from May 8, 2004. Each bias DAC step is 0.25 V, and each TM unit on the vertical axis corresponds to a current of 0.305 nA. A drift in the slope of the P1 offset curve from May to September is clearly seen. The possibility to do onboard calibration was implemented precisely because of such long-term drifts are expected.

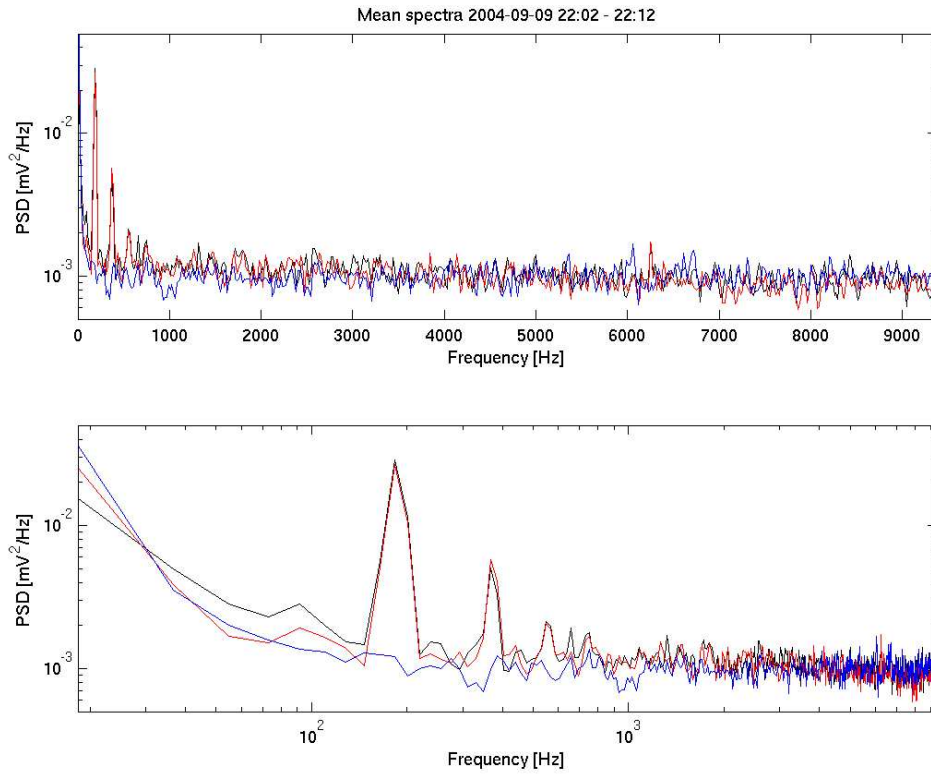
Figure 3, showing averages of power spectra, reveals that the noise has two components. First, there is some signal at around 190 Hz and its first few harmonics. Note that this signal essentially disappears in the differential signal, and hence is a common mode interference. Apart from this, the noise is approximately white with a level of  $0.001 \text{ mV}^2/\text{Hz}$ , corresponding to an RMS value of around 3 mV or 2-3 TM units over the full frequency range, consistent with the time series data in Figure 2.

**Figure 3.** Mean of spectra calculated from 16 snapshots similar to those in Figure 2, with 32 second delay between each. Colour codes as in Figure X. Based on 1024 point FFTs and Hann window. Normalization is such that the RMS value of the time series is the square root of the integrated power spectrum.

Figure 3 shows typical spectra of LAP data obtained at full sampling frequency (18750 Hz, filtered at 8 kHz). The only persistent features are the lines around 190 Hz and its first few harmonics, as discussed in Section 3.1 above. The origin of these lines is not known. However, it should be noted that the blue curve in Figure 3, based on the differential signal between the two probes, these lines are absent. It is thus a common mode signal which will not influence wave measurements.
