***ROSETTA***

Consolidated Rosetta payload report for the MCRR

RO-EST-RP-3293

17 Nov 2004

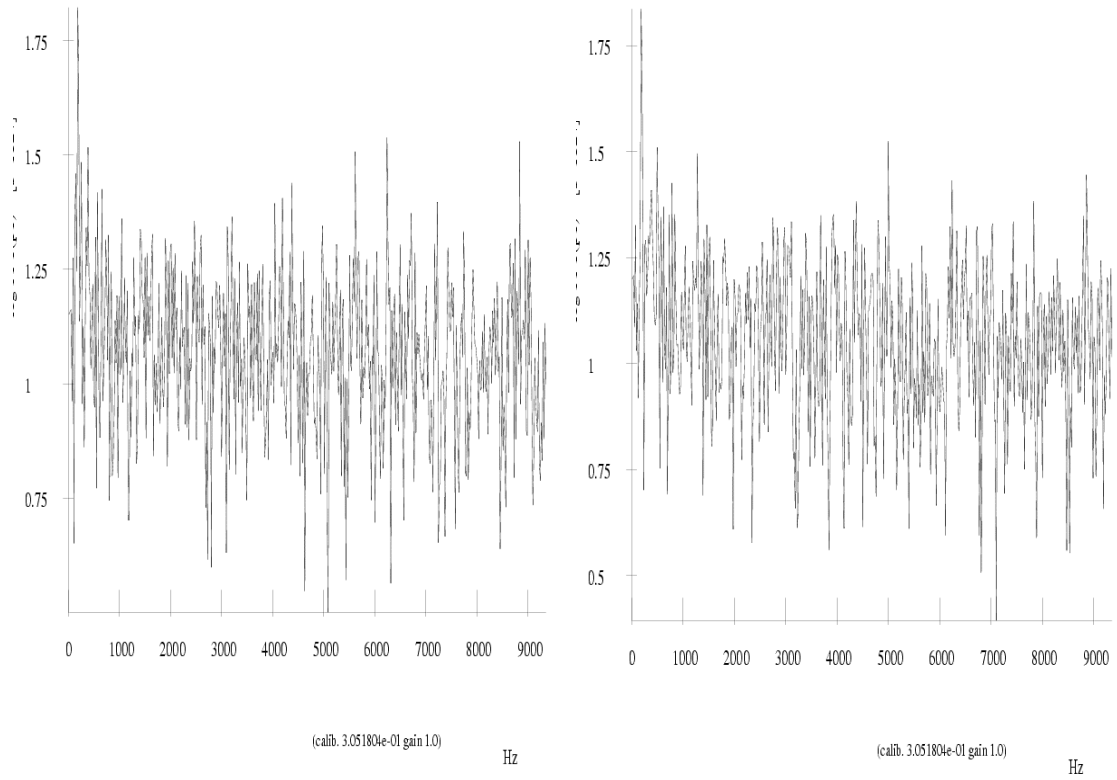
**Figure 4.** Example plot from the LAP interference scenario report, showing LAP P1 spectra before and after GIADA going into active mode. No obvious signature can be detected.

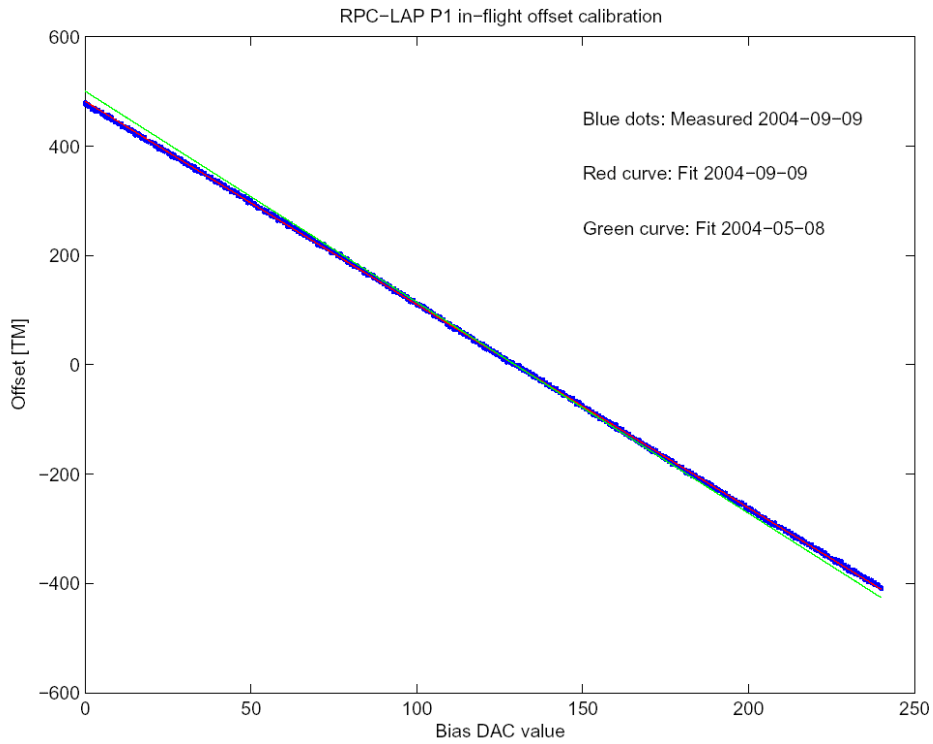
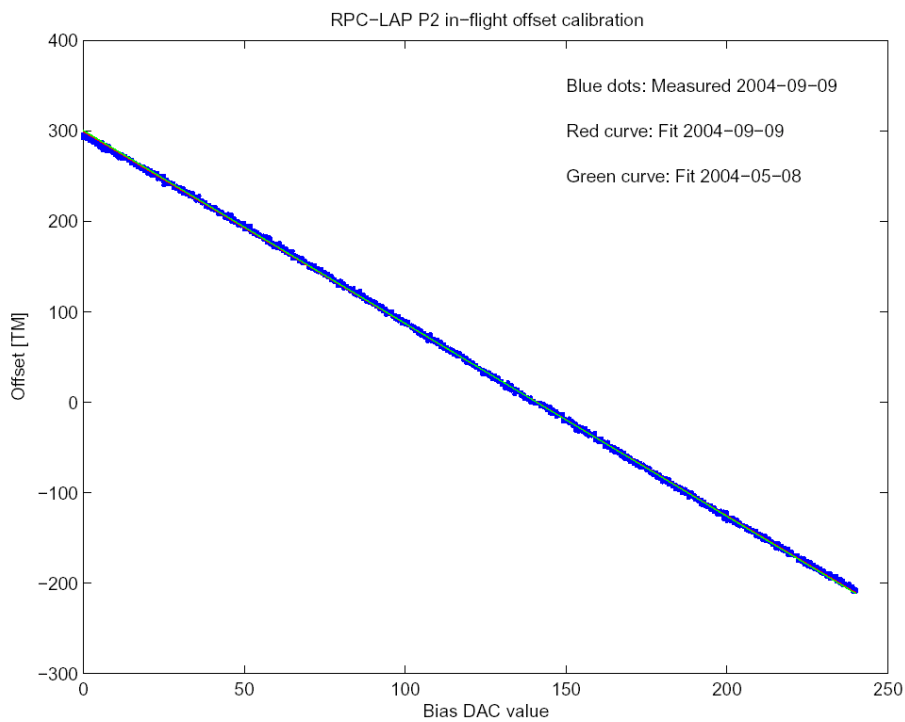
The difference between the P1 offset curves determined in May and September is mainly due to a change of slope of the curve. This can be a temperature effect, though we are more inclined to believe that we here see the real drift in instrument electronics that we had anticipated, and for which we have included the possibility of onboard calibrations. The difference in the slopes determined in May and September correspond to 0.17 nA/V, which we for the moment can use as a worst-case uncertainty measure for slope determinations. Even this is an excellent value, corresponding to little more than 10 nA over the full LAP bias range, and we should note that this certainly is an upper value with a good margin.

**Figure 5.** Offset determinations on September 9, 2004, for P1 (top) and P2 (bottom). Blue dots are data, red line a linear fit. The green line is a linear fit to offset determination from May 8, 2004. Each bias DAC step is 0.25 V, and each TM unit on the vertical axis corresponds to a current of 0.305 nA.

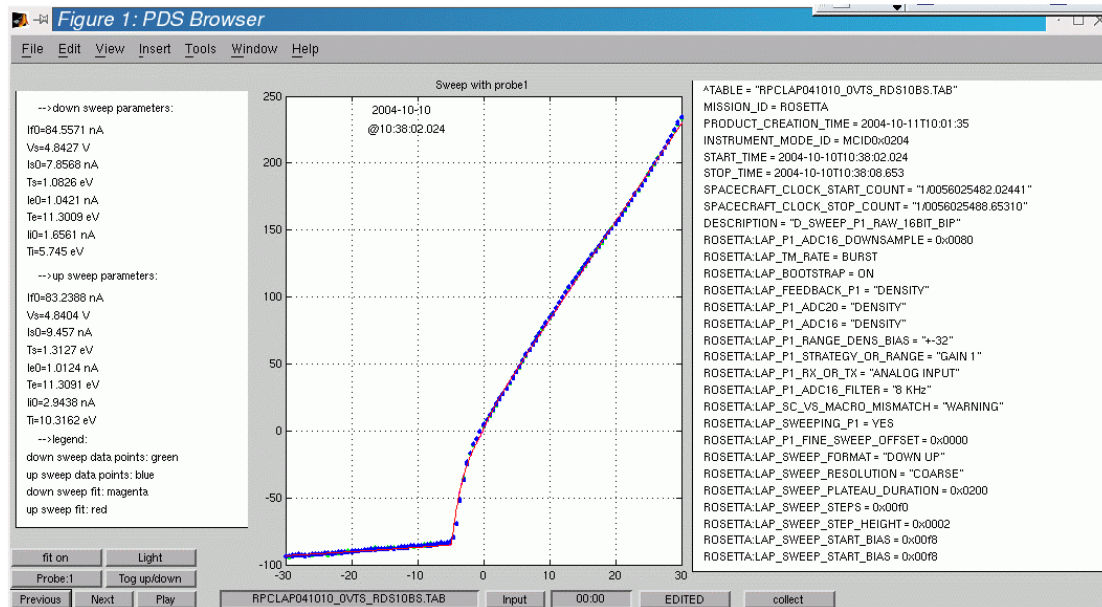
A notable and stable feature of the LAP bias sweeps in the solar wind is the slope of the curve on the negative side, amounting to around 0.5 nA/V in Figure 6. The worst-case uncertainty on the slope of 0.17 nA/V discussed in Section 3.3 is not sufficient to explain the observed slope, which can be seen in both probes. While some unknown instrumental effect may be hypothesized, we are more inclined to suspect either a leakage current over the insulator between probe and stub, or a real plasma population. The solar wind plasma is not expected to include ions below some 1 keV, but it could be due to for example photoelectrons emitted by a very negative area on the spacecraft (below -30 V) or possibly ions from still ongoing outgassing from the spacecraft.

**Figure 6.** A Langmuir probe bias sweep obtained by LAP during the pointing scenario ("LAP dance"). In the tenuous solar wind plasma, the sweeps are dominated by emission and collection of photoelectrons. Though one can make a good fit to the measured data, most of the derived parameters cannot be considered reliable here.

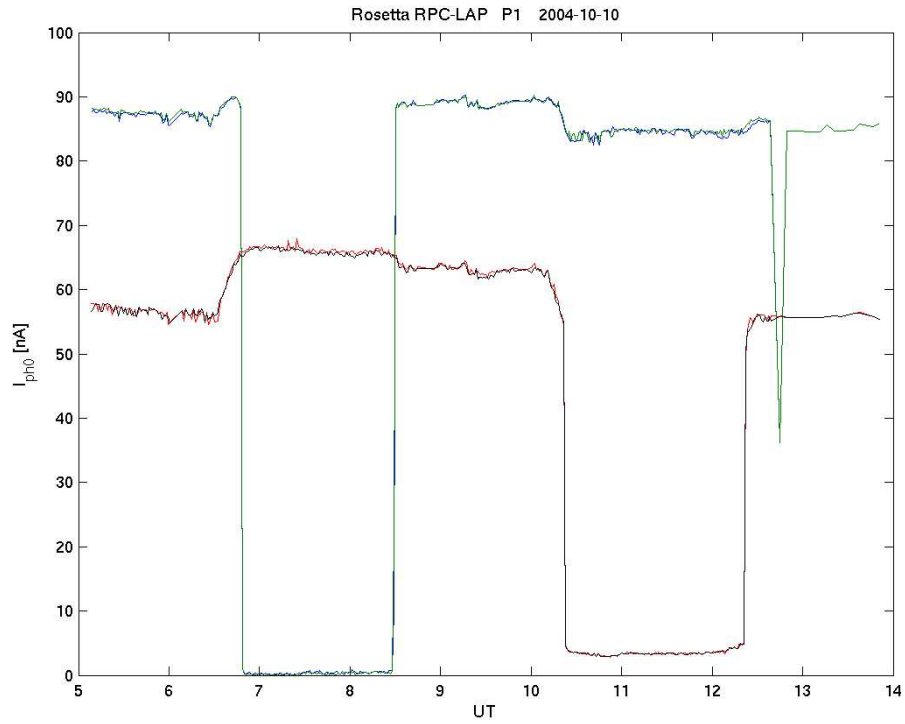
Figure 7 shows the photoemission current estimated for the two LAP probes as a function of time during the LAP dance. Some basic features are readily observed. First, we can clearly see when probe 1 (blue-green curve) and probe 2 (red-black curve) goes into eclipse as a sudden drop in photoemission current. The different residual values of electron emission or ion collection for the two probes when in shadow could possibly be due to calibration issues. The strength of the increase in photoemission from P2 when and just before P1 goes into shadow at 6:50 is to some extent an artifact of the analysis routine and of changing ion current, and the dip seen in the P1 curve just before UT 13:00 is clearly spurious. However, that P2 is lower in photosaturation current than P1 is obvious directly from the sweeps. This could possibly be due to negative charging of spacecraft or lander structures in the vicinity of P2, but more likely also be due to contamination on the probe, perhaps from thruster firings. One should note that P2 has spent much less time in sunlight than has P1. It will be very interesting to see if this difference persists. It has little or no impact on the scientific performance of the instrument.

**Figure 7.** Photoemission saturation current derived from probe bias sweeps (Figure 6 is an example) during the LAP dance. Some features in the curve are spurious, but the drastic drops in current when the probe goes into eclipse are clear, and also that P2 (red-black) has less photoemission than P1 (blue-green).

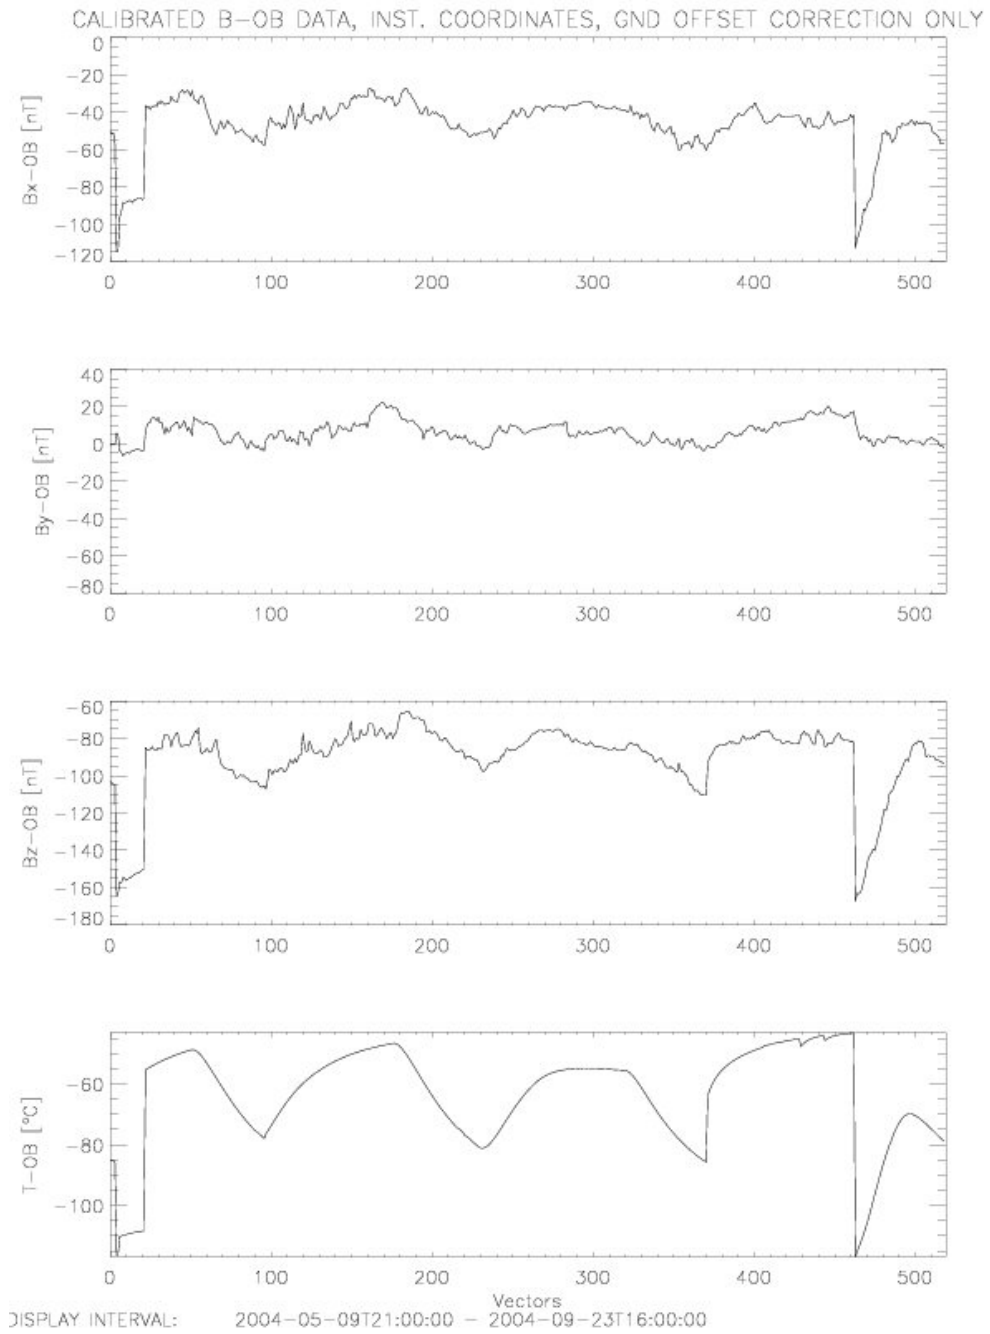
Figure 3: 600s average OB Magnetometer readings, calibrated with ground calibration results, versus sensor temperature.

It is obvious that a strong correlation between the sensor temperature and the MAG sensor readings occurs. Therefore, a better temperature model has to be developed.

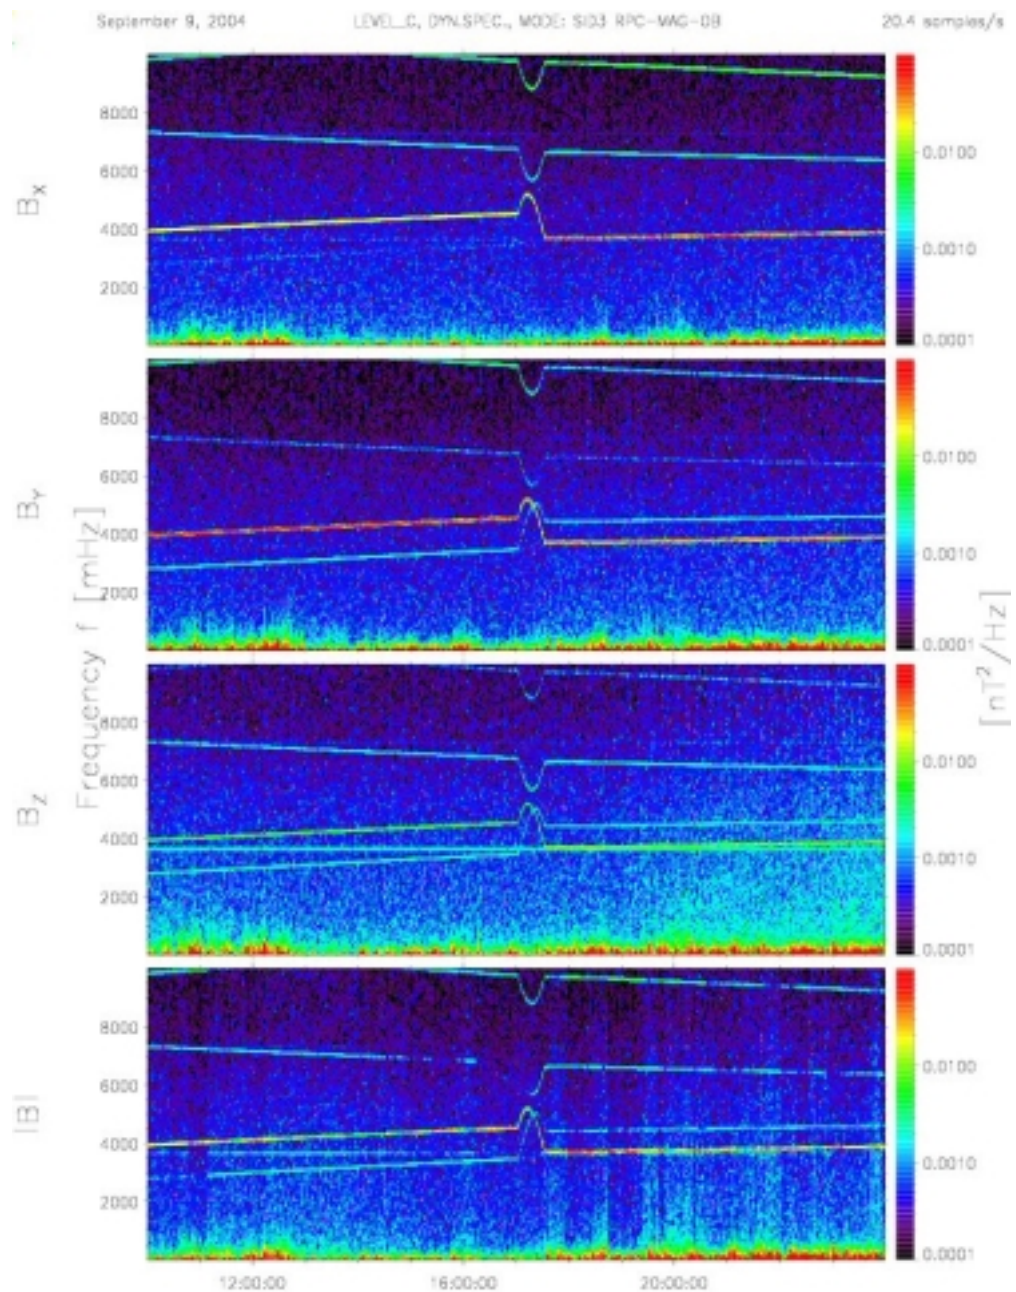
Figure 8: Typical Dynamic spectra. Data of the OB sensor in Burst mode (20 Hz sampling) in s/c coordinates is plotted.

The dynamic spectra show various spectral lines beside the “real magnetic field data”. These line vary slowly with the time and show specific structures. The shape of these disturbance lines is specific to the sampling frequency of the MAG sensors. All these criteria lead to the guess, that the disturbance might be an Aliasing effect and might be dependent of ROSETTAs four reaction wheels.

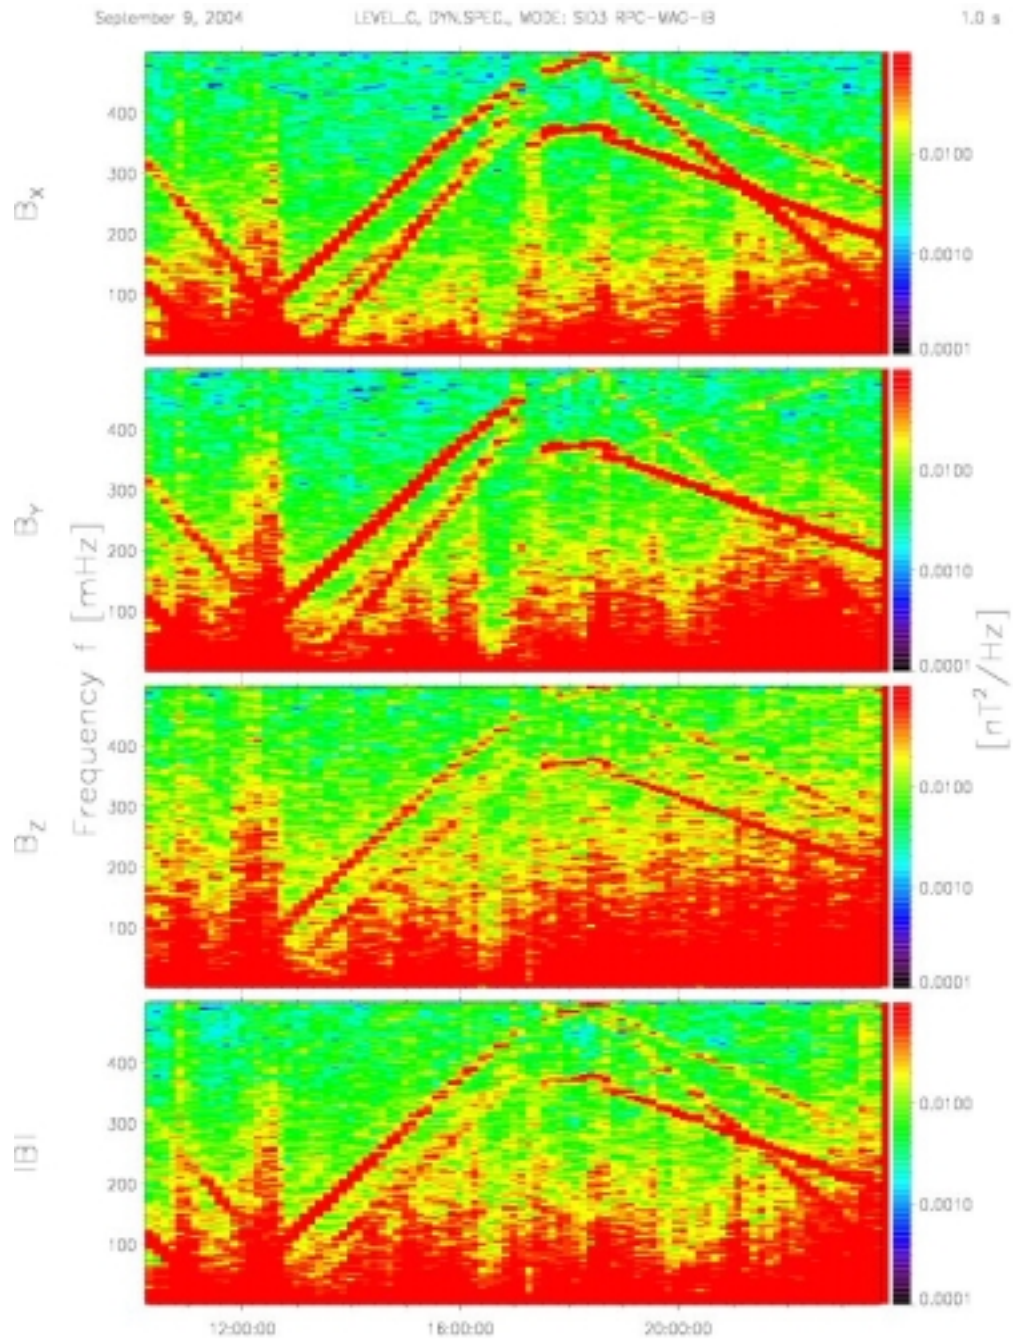
Figure 9: Typical Dynamic spectra. Data of the IB sensor in Burst mode (1Hz sampling) in s/c coordinates is plotted.

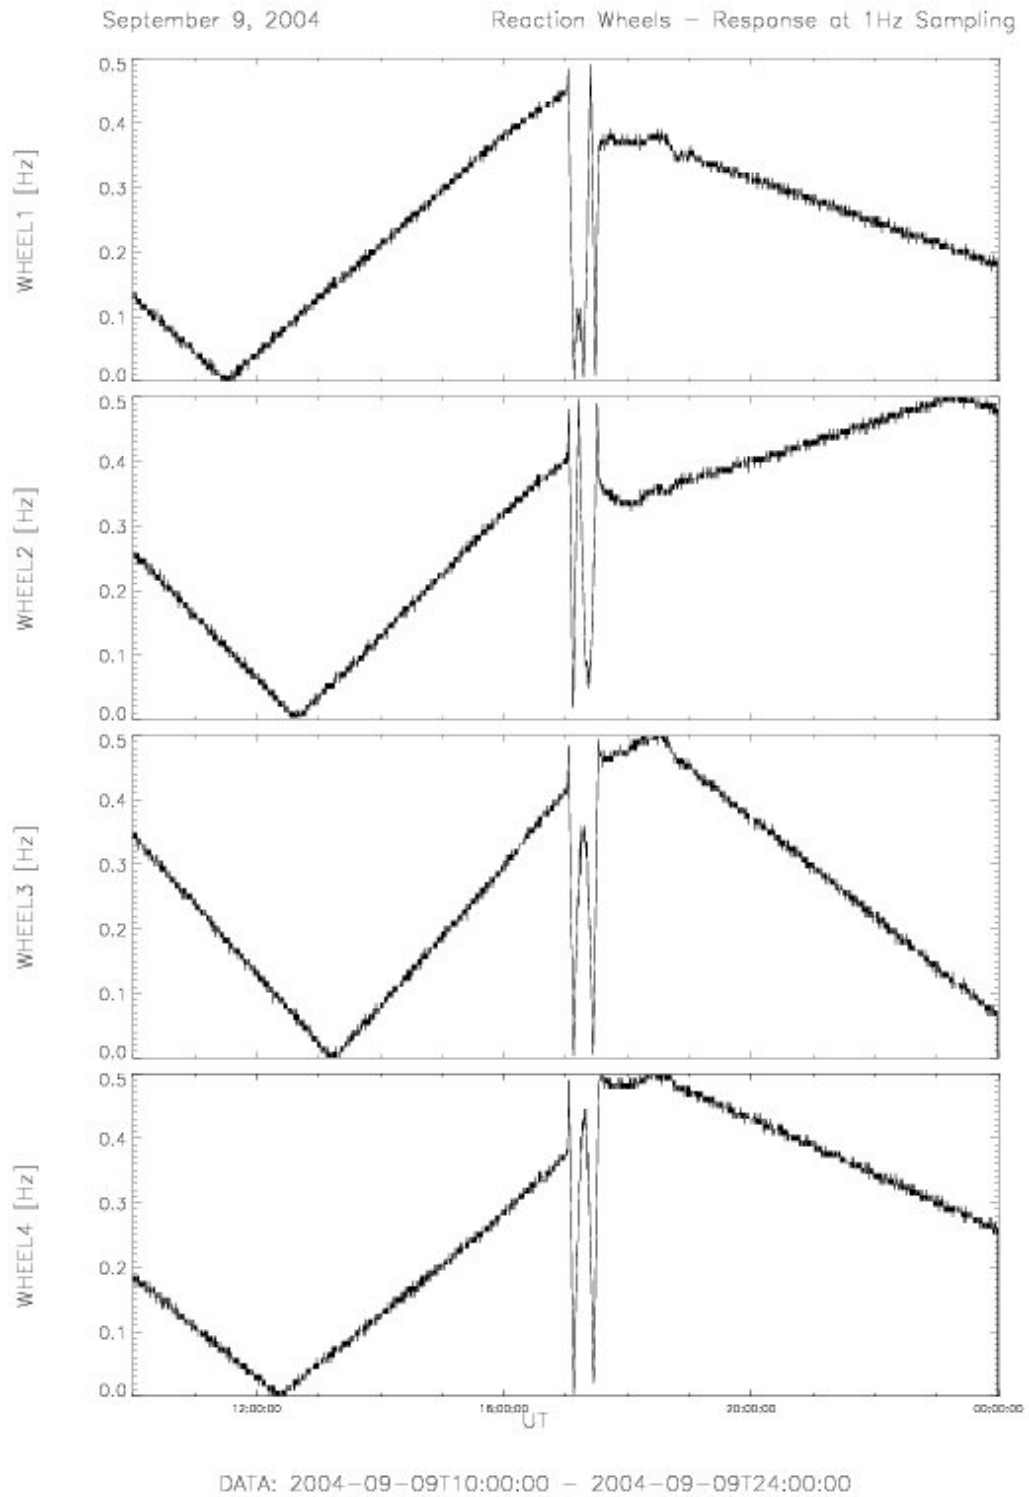
Figure 13: Magnetic signature of the 4 Reaction wheels seen by a sensor which is sampled with 1 Hertz.

To get an idea how the “high frequent” reation wheel speeds would appear on sensor which is only sampled with 20 Hz or 1Hz the wheel data have been shifted and folded down to the Nyquist frequency interval according the sampling theorem. The result can be seen in Figures 13 and 14.

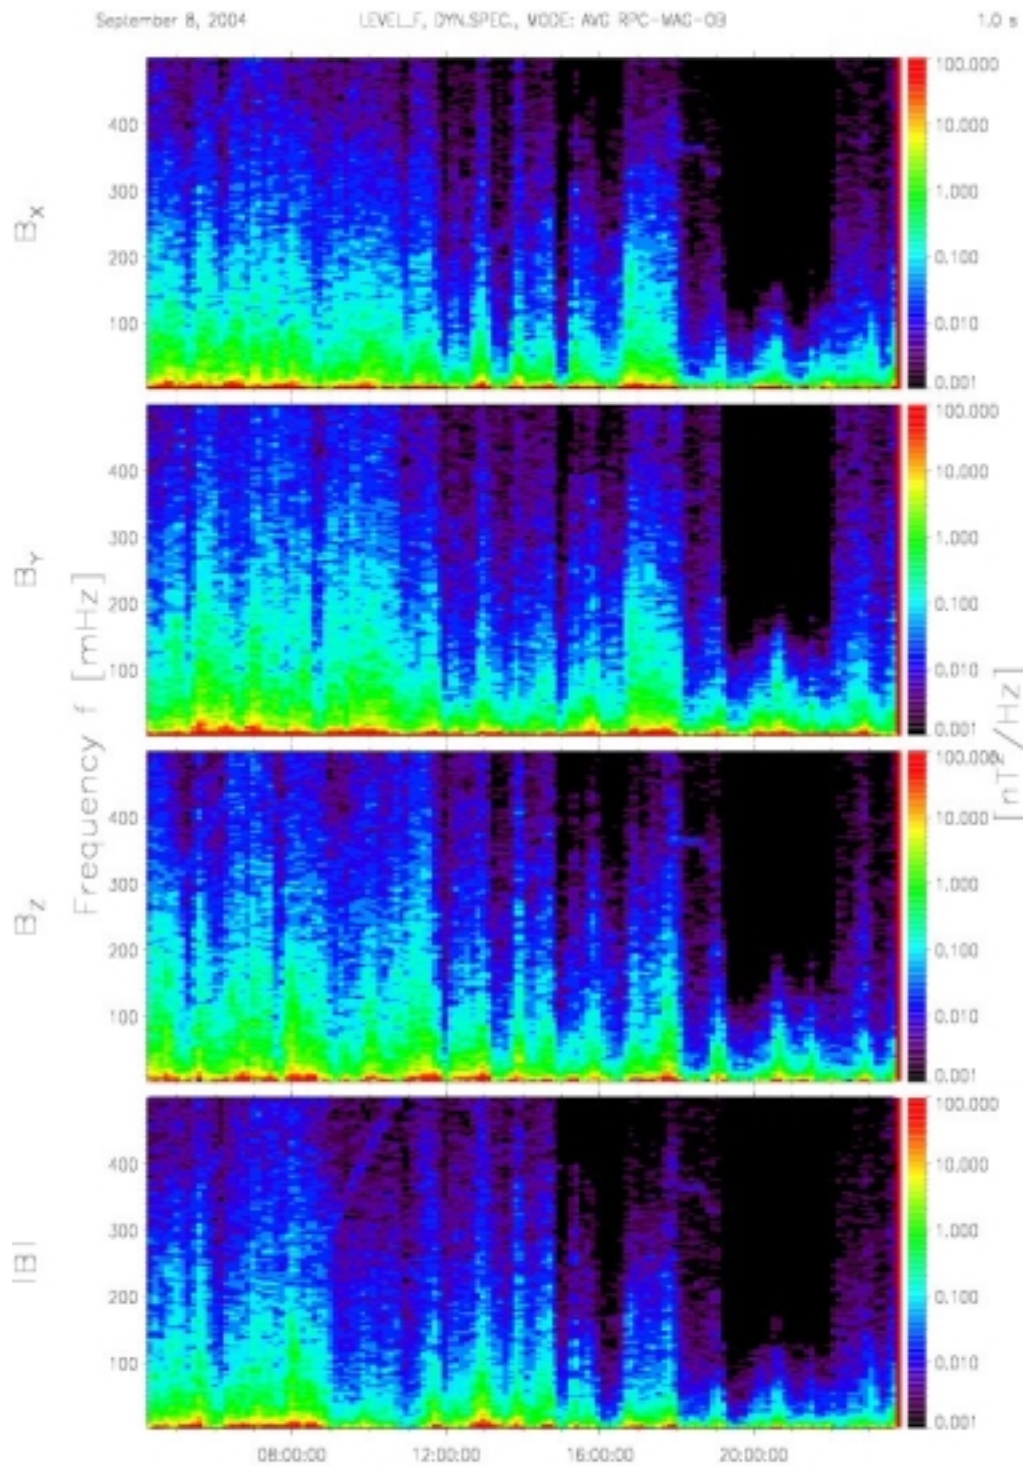
As a last point of the investigation also the dynamic spectra for RPCMAG and ROMAP are shown in Figures 18 – 20. All there sensor sho the impact of the reaction wheels. The slightly different pictures are caused by different sampling modes.

- RPCMAG OB was sampled with 20 Hz. The data were averaged later to 1s mean values.
- RPCMAG IB was sampled with 1Hz. No additional averaging was done. The “low activity” areas in the spectrum are caused by a mode switching to a low smapling mode on the IB sensor.
- ROMAP was sampled with 1Hz. No additional averaging was done.

Figure 17: Dynamic Spectra of the RPC-MAG OB sensor. 1 s average data in s/c coordinates.

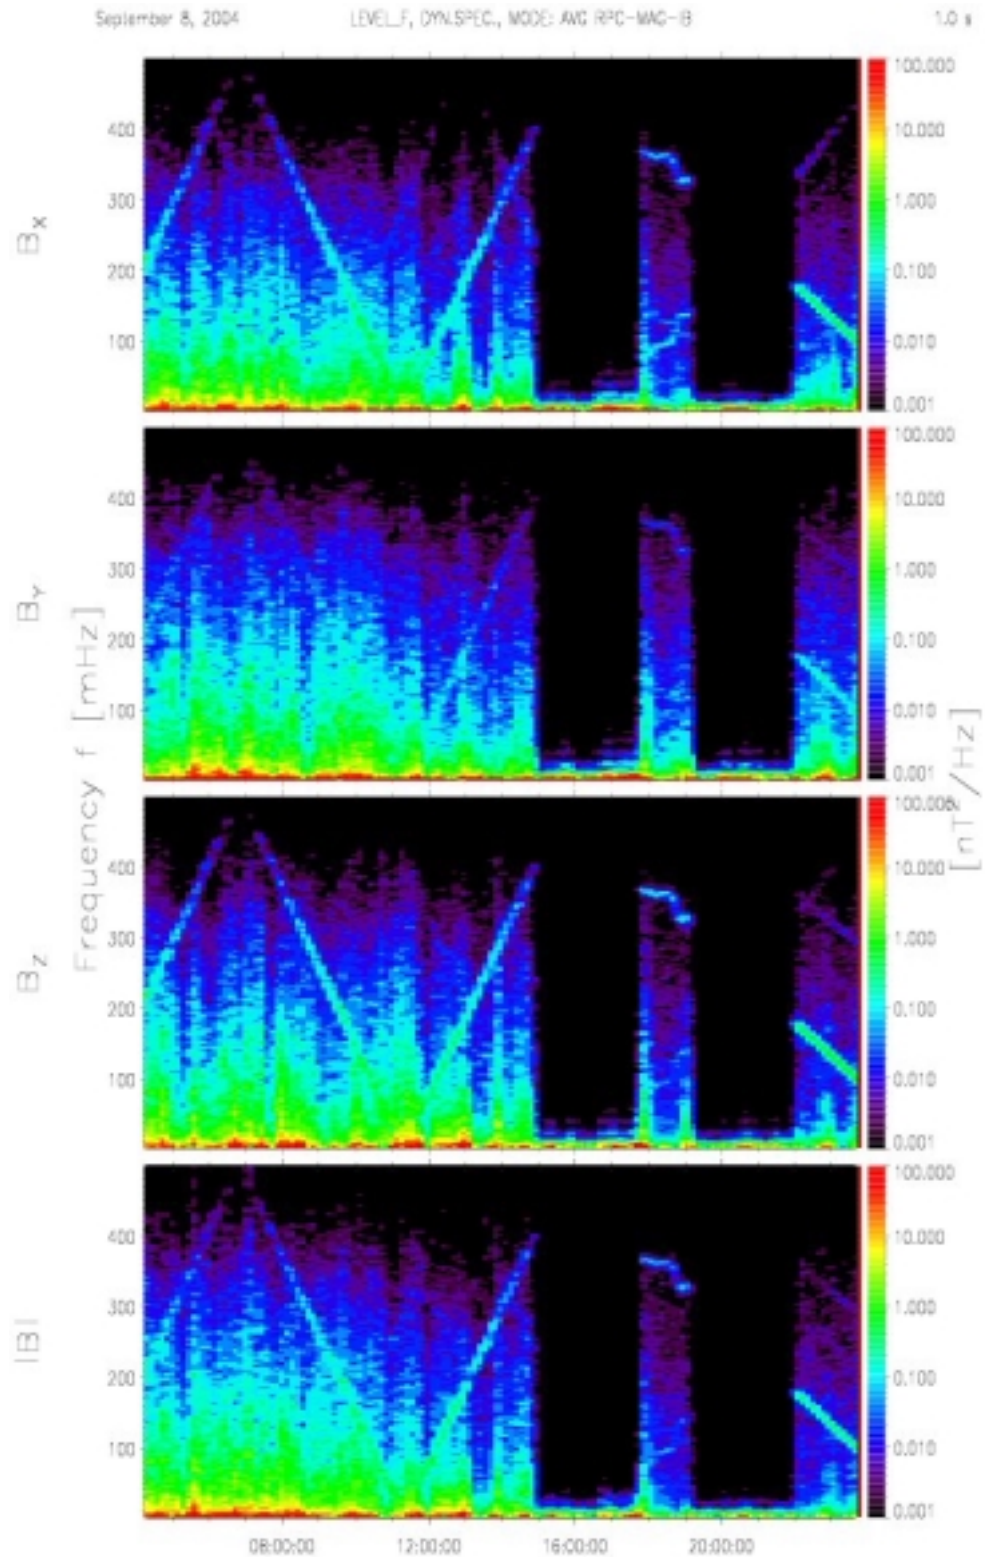
Figure 18: Dynamic Spectra of the RPC-MAG IB sensor. 1 s average data in s/c coordinates.

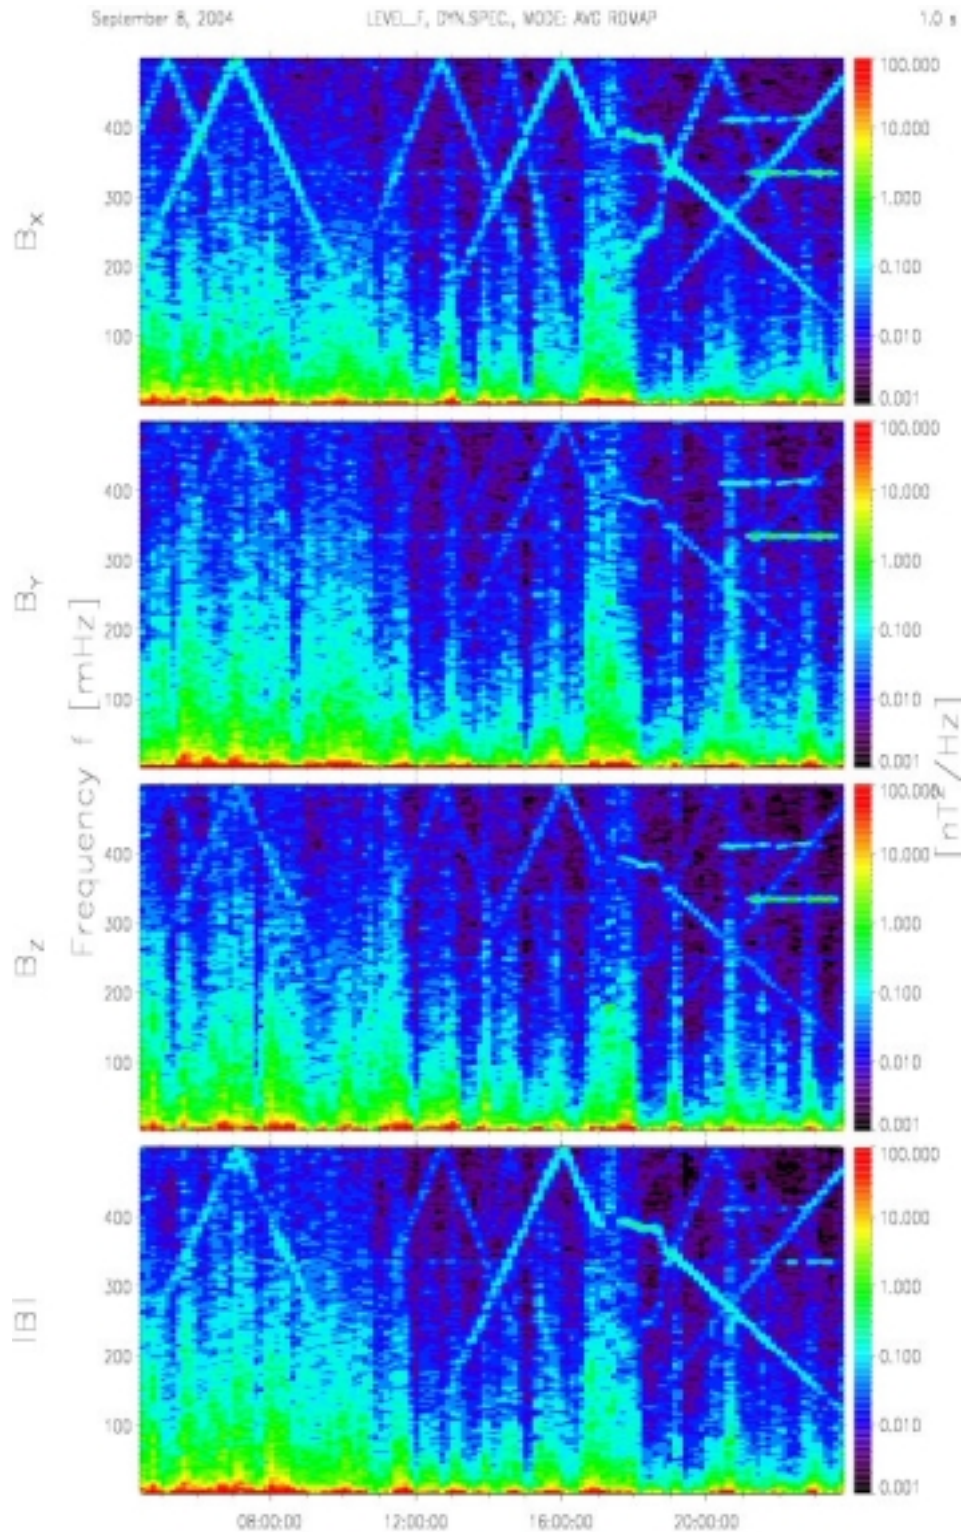
Figure 19: Dynamic Spectra of the ROMAP sensor. 1 s average data in s/c coordinates.

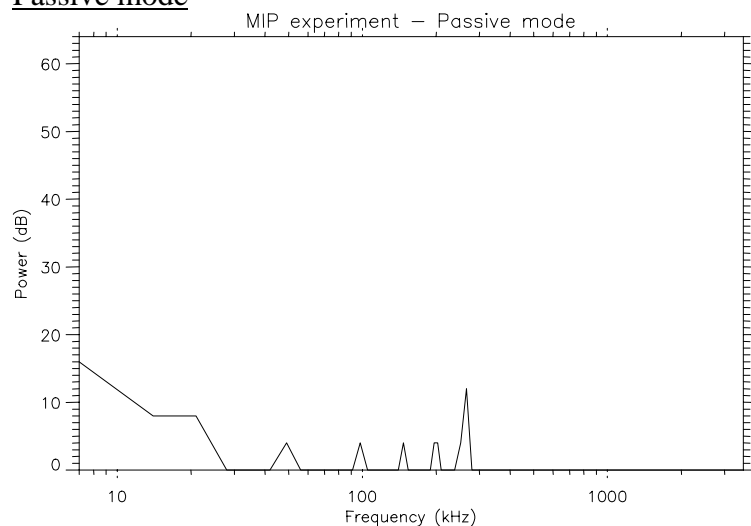
were already observed during Commissioning Part 2. Every one, except 266 kHz, could be considered as harmonics of 49 kHz. They are probably generated by RPC.

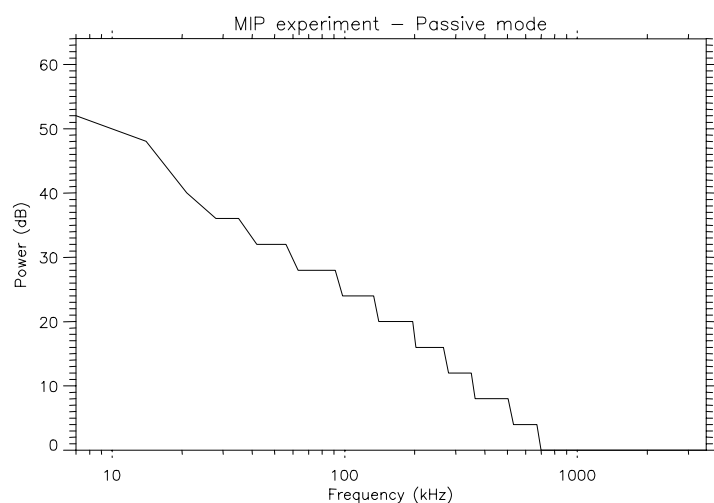
It appears that during this time LAP1 is transmitting square wave frequencies between 1 and 6.7 kHz, but MIP sees strong harmonics up to 700 kHz.  
 22:04:34 to 22:29:06            Gap of data (no Science, no HK).

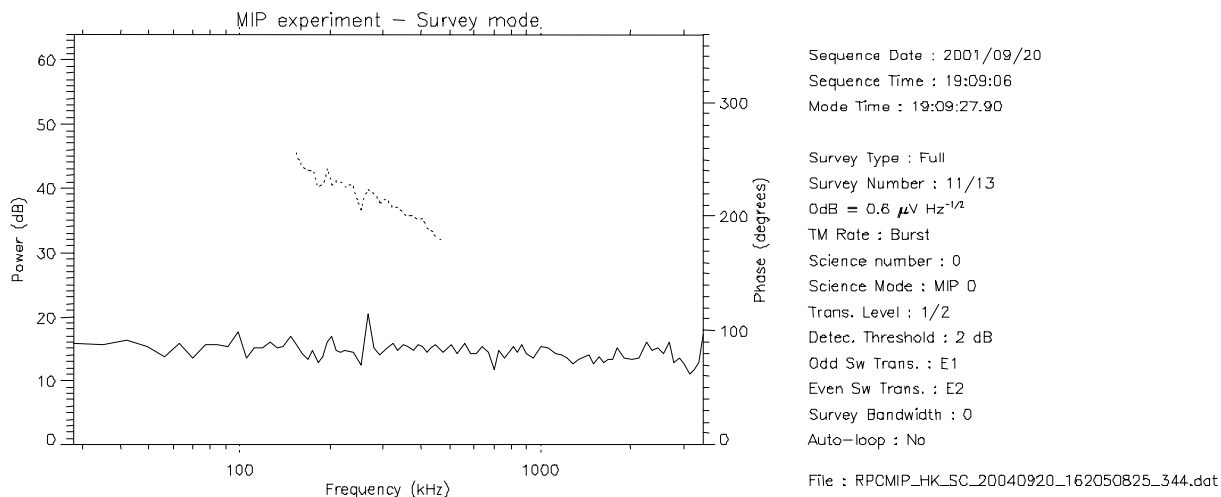
We observe the same results as compared to HV Commissioning, except for 266 kHz peak which is 2 dB higher.

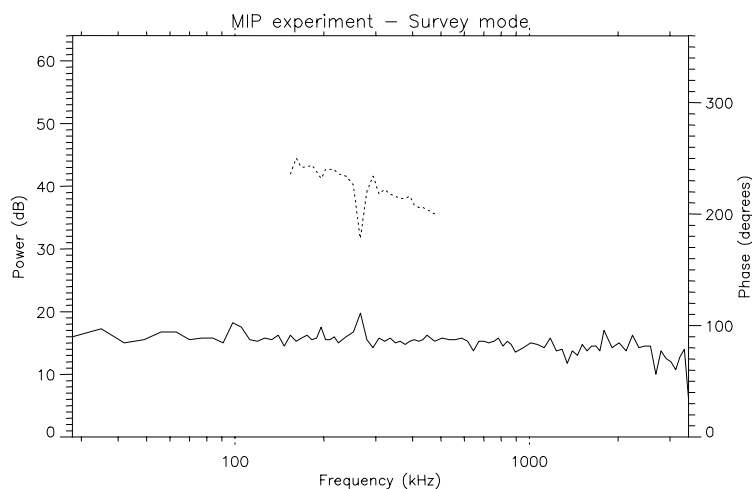
We observe the same results as compared to HV Commissioning, except for 266 kHz peak which is 2 dB higher.

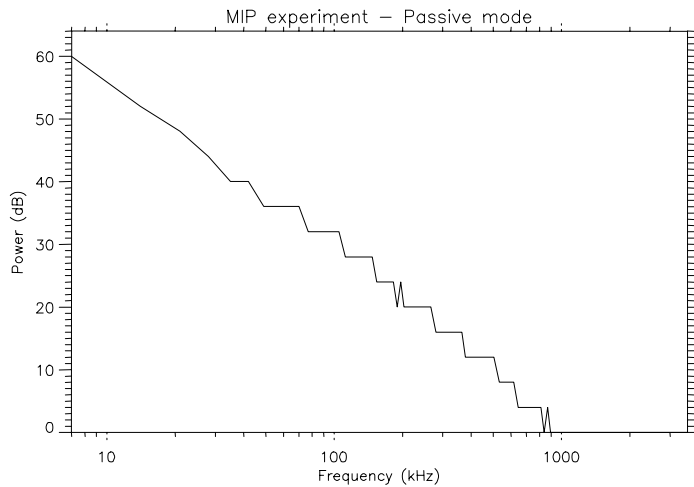
Same results as obtained at 17:32:26, except during LAP active interferences between  
 - 21:04:42 and 21:07:54 (20 dB at 150 kHz),

- 21:07:54 and 21:08:26 (20 dB at 63 kHz),
- 21:13:14 and 21:14:50 (20 dB at 200 kHz).

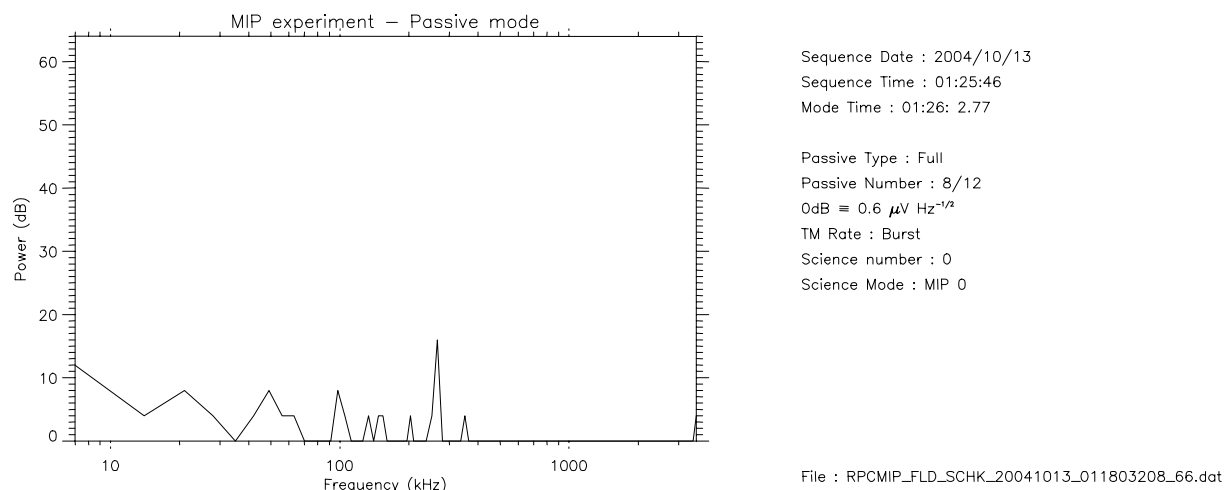
Compared to the Interference Scenario Part 1 we observe the same frequency peaks :

- 49 kHz (8 dB)
- 98 kHz (8 dB)
- 147-154 kHz (4 dB)
- 203 kHz (4 dB)
- 266 kHz (16 dB)

The electrical environment seems a little bit noisier.

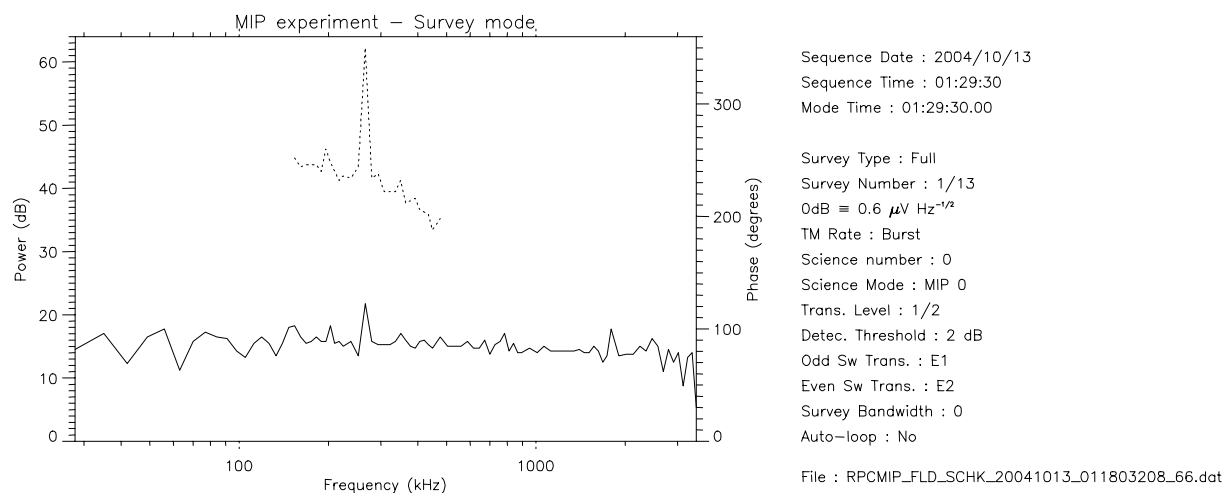
Same results as Interference Scenario Part 1. The medium level is at 15 dB.

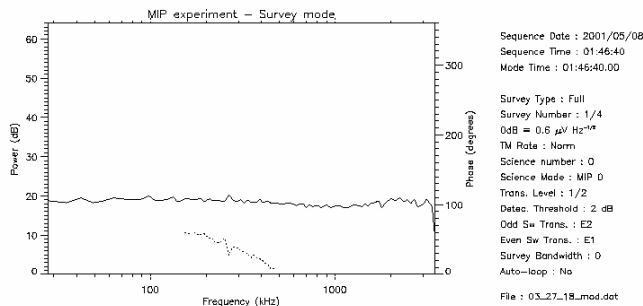
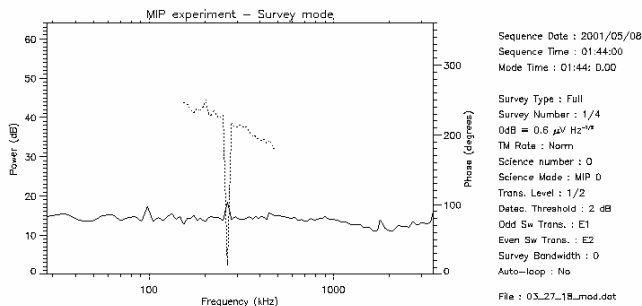
With E2 the signal is 3 to 4 dB higher than with E1. Presently we have no explanation for this dissymmetry.

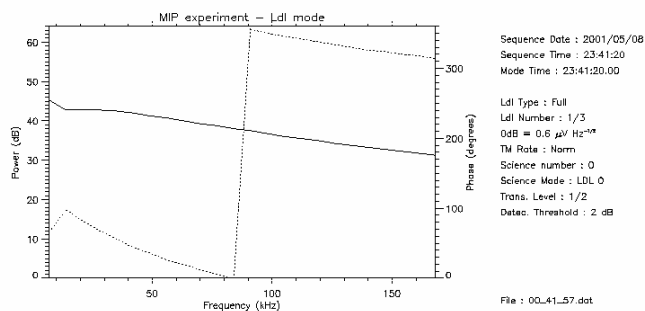
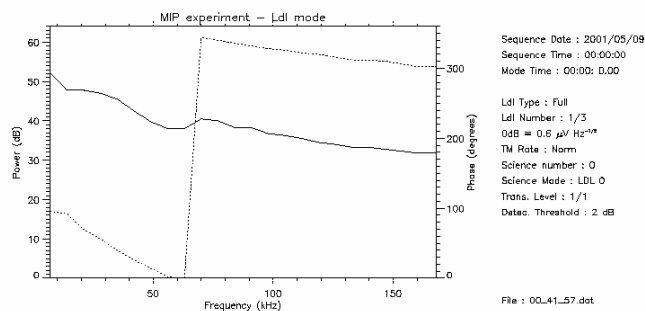
File : 00\_41\_57.dat

2 transmitting levels are checked : levels 1/2, 1. We can notice a strong distortion with the full level transmission.

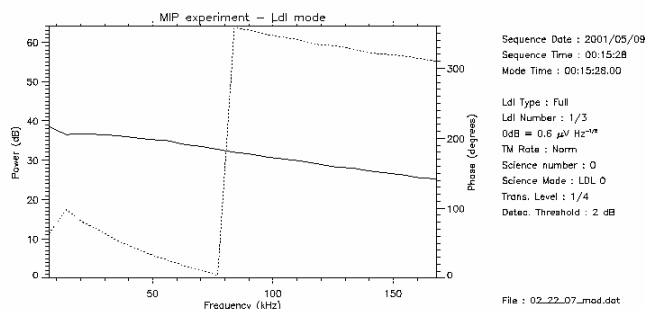
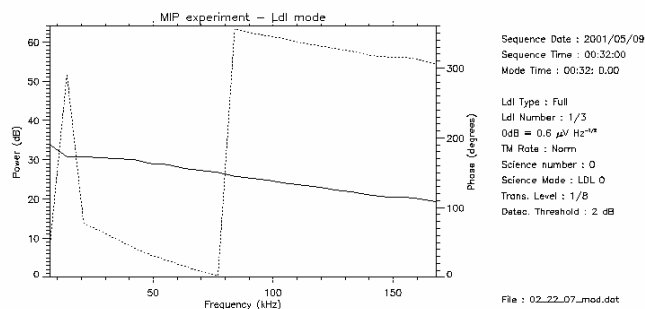
File : 02\_22\_07.dat

2 other transmitting levels are checked : levels 1/4, 1/8  
The end of this file was corrupted due to a wrong command (?)

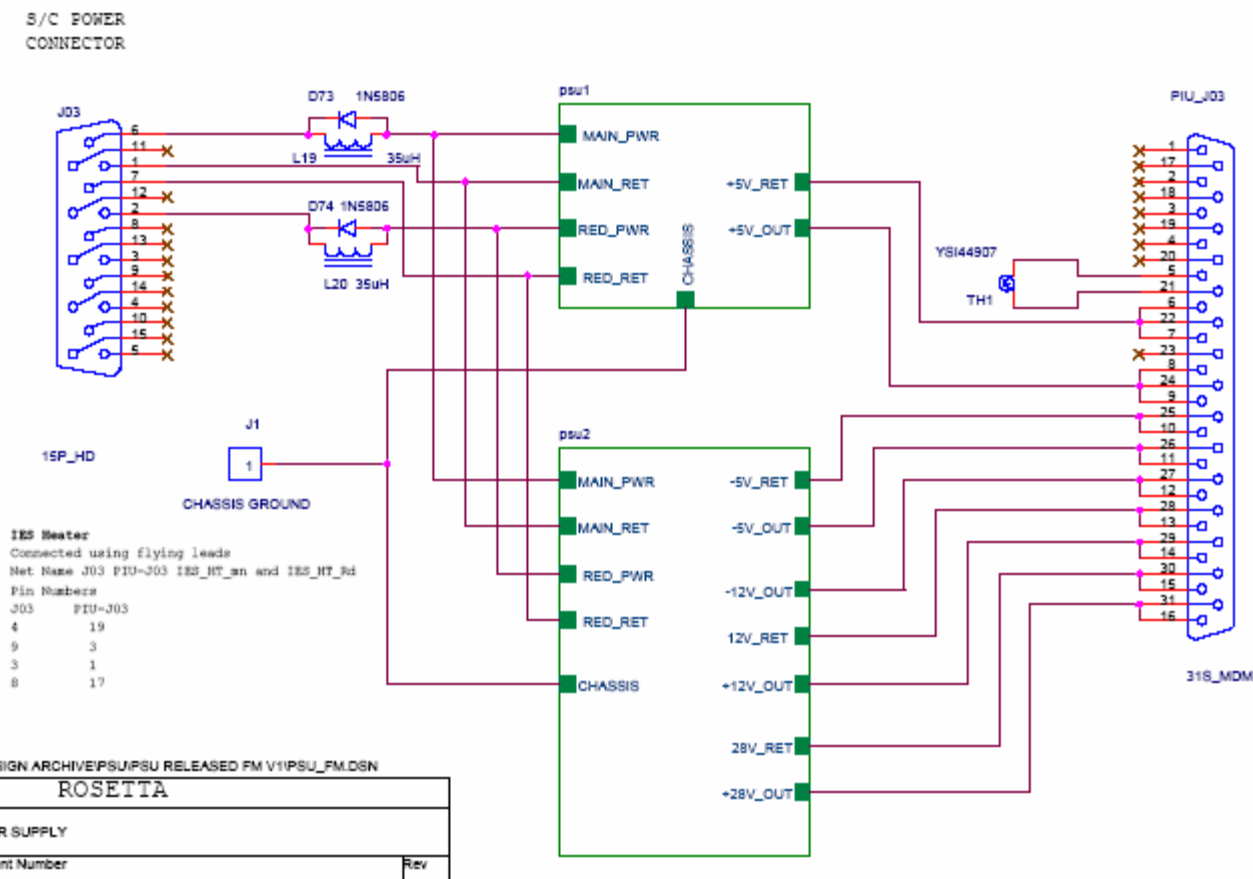
- +12V, -12V & +28V secondary (un-regulated)
- The observed failure mode is consistent with a short circuit of the PSU1 +5V secondary to ground
  - Confirmed by bench test on breadboard model of the power supply

- The observed failure mode is constant current of 240mA
    - When the lab model +5V supply is shorted to ground, then 240mA is drawn
    - This is a combination of the limiting short-circuit current drawn by PSU1 plus the normal (quiescent) current drawn by PSU2

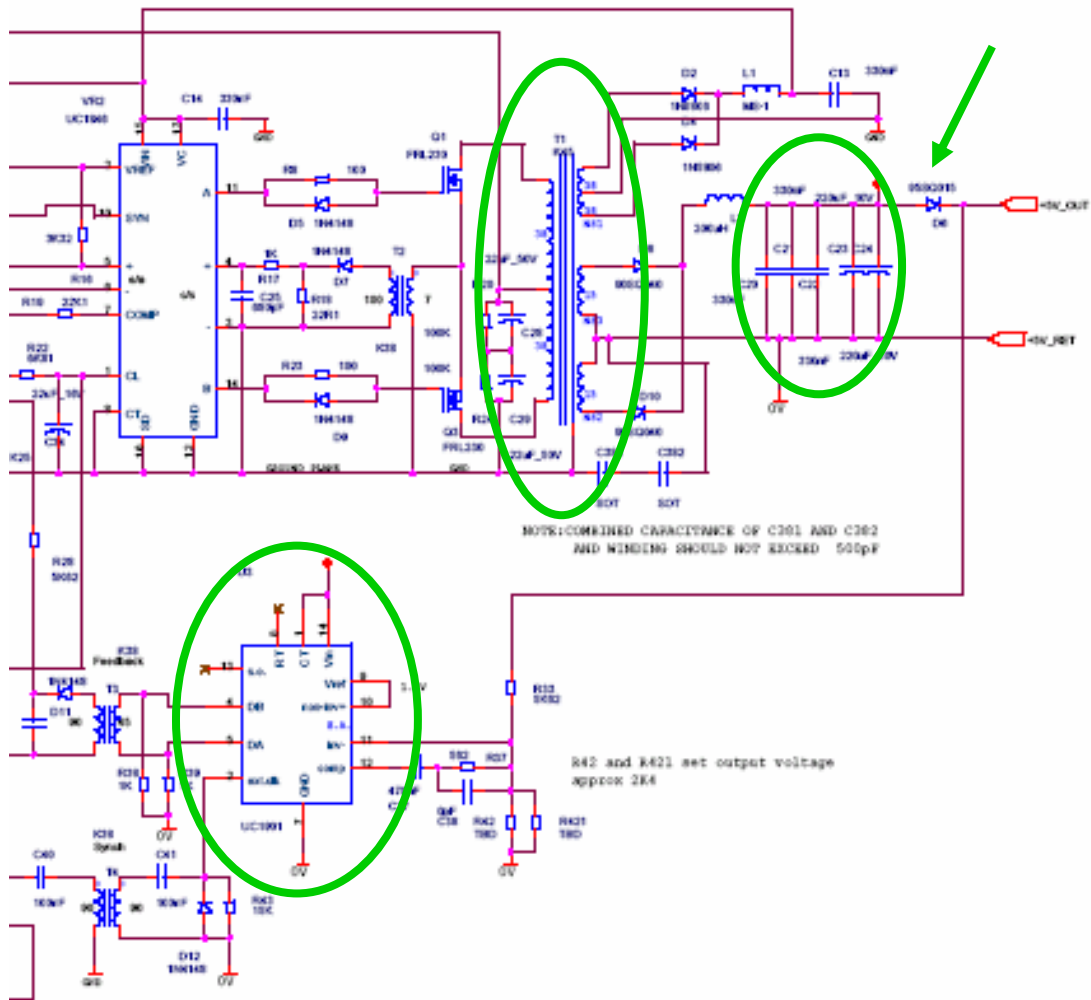
- Refer to the schematic of the secondary side of PSU1 on the following slide
- Four failure mechanisms are considered:
  - Short circuit of transformer (circled)
  - Failure-to-short of Feedback generator Integrated Circuit (circled)
  - Short circuit of Capacitor (circled)
  - Other unspecified short-to-ground such as
    - PCB failure
    - Short due to debris inside box
    - Loose or broken component or mechanical part
- Note that the short circuit is prevented from propagating outside the PSU1 unit by the use of an isolating diode on the output (arrowed)

- Short circuit of Capacitor
  - Two types, both Hi-rel ESA SCC Level C
    - Ceramic type CKRO6 330nF
    - Wet Tantalum type CLR79 220uF
  - Capacitors are known to fail short circuit

- 5 parts versus 1 each of the above
- Other unspecified short
  - No known indications for this
- On balance of probability, we consider that capacitor short-circuit is the likely failure mechanism

- A capacitor short-circuit is considered to be the most likely failure mechanism
  - Some QA concerns exist for the ceramic CKR06 type
    - High manufacturer lot-test failure rate
