***ROSETTA***

Consolidated Rosetta payload report for the MCRR

RO-EST-RP-3293

17 Nov 2004

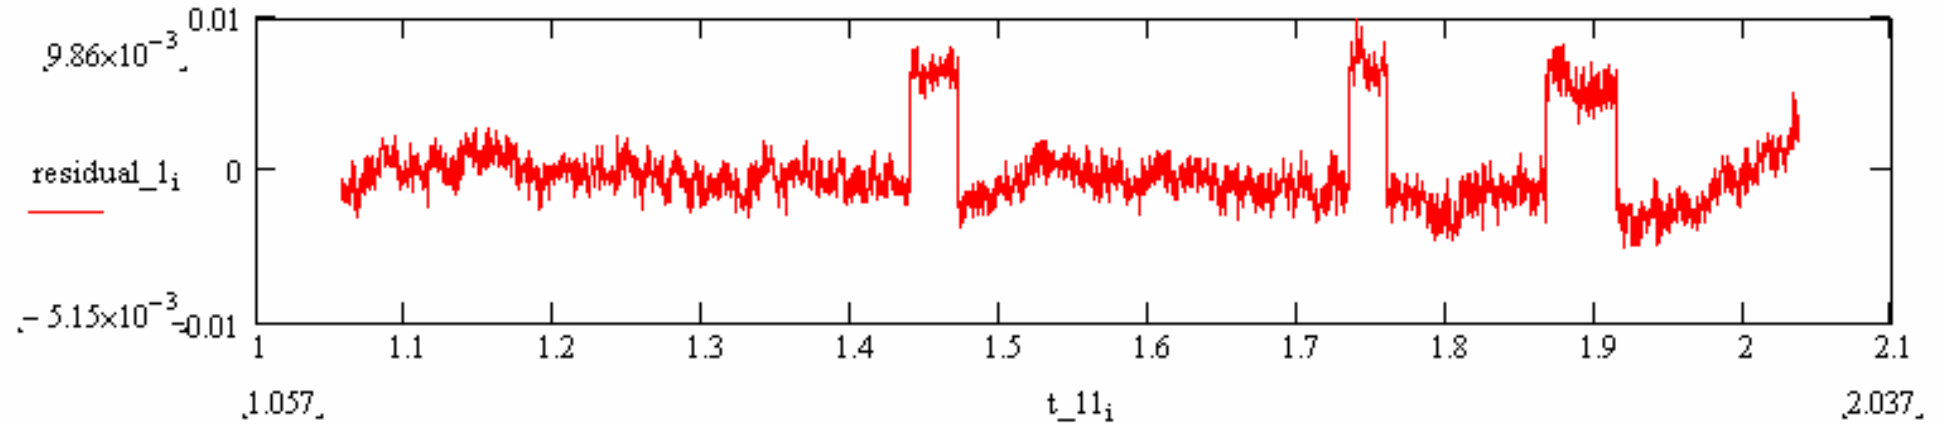
X-band residuals between 089.01:01 and 089.02:01 UT after subtracting a polynominal fit. Note the 10 mHz jumps which last several minutes.

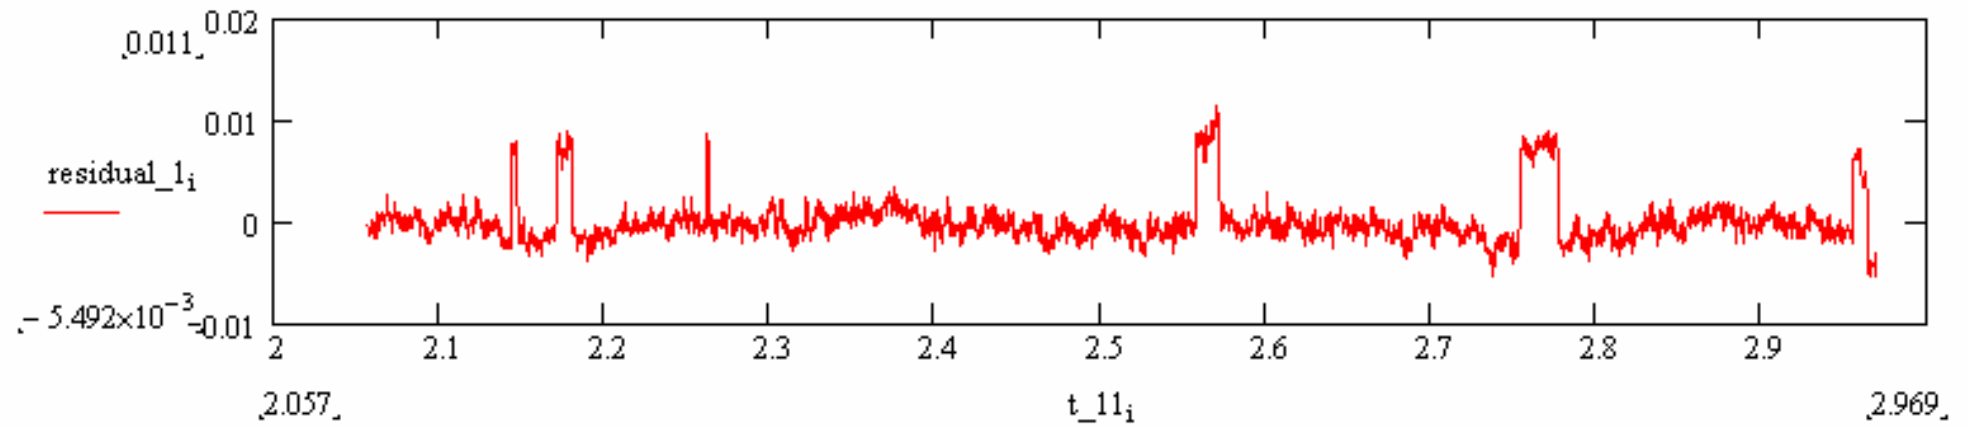
X-band residuals between 089.02:01 and 089.03:01 UT after subtracting a polynomial fit. Note the 10 MHz jumps which last several minutes.

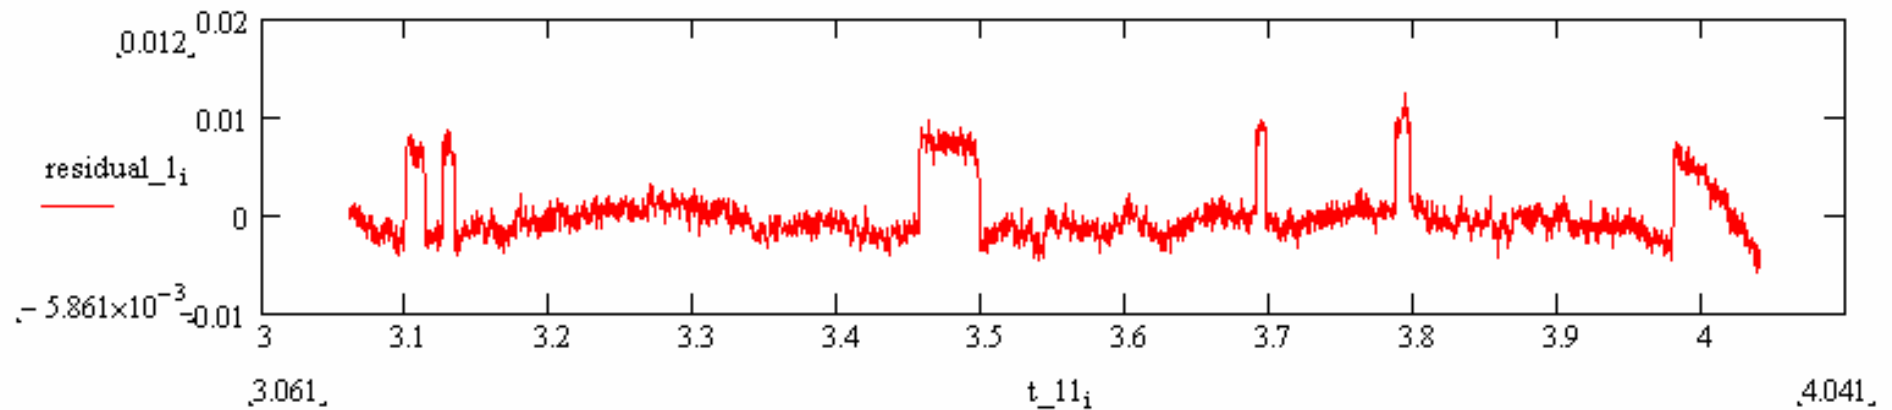
X-band residuals between 089.03:01 and 089.04:01 UT after subtracting a polynomial fit. Note the 10 MHz jumps which last several minutes.

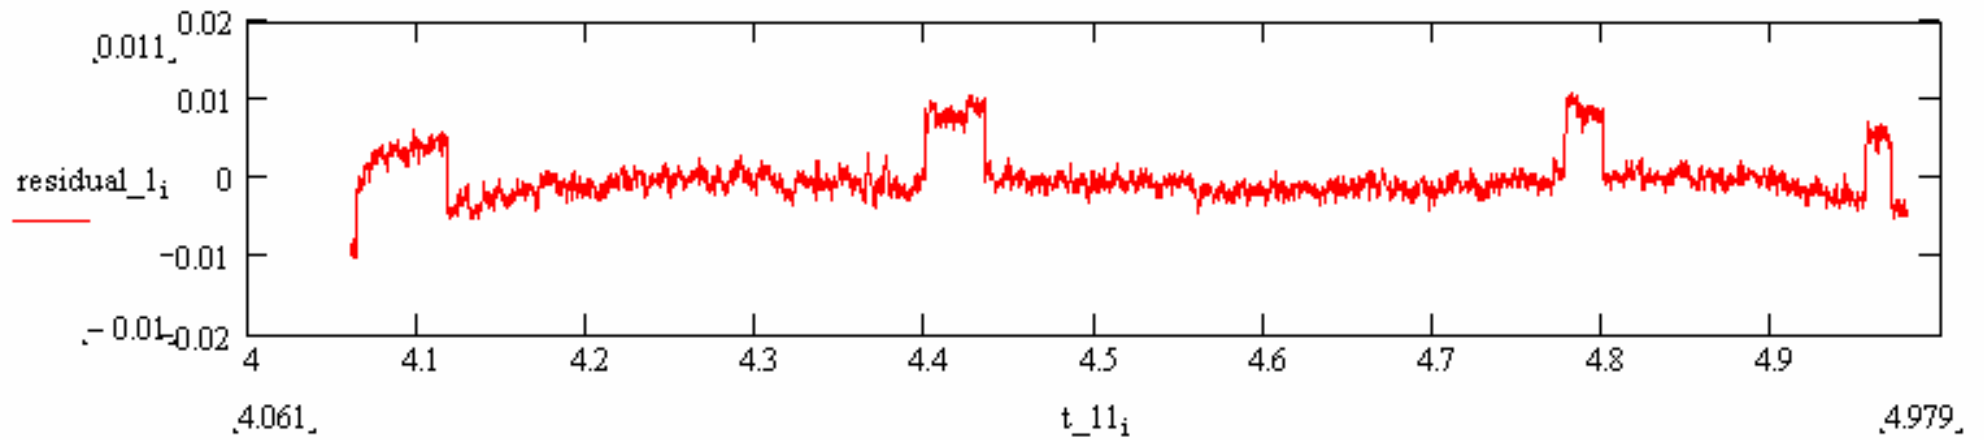
X-band residuals between 089.043:01 and 089.05:01 UT after subtracting a polynomial fit. Note the 10 mHz jumps which last several minutes.

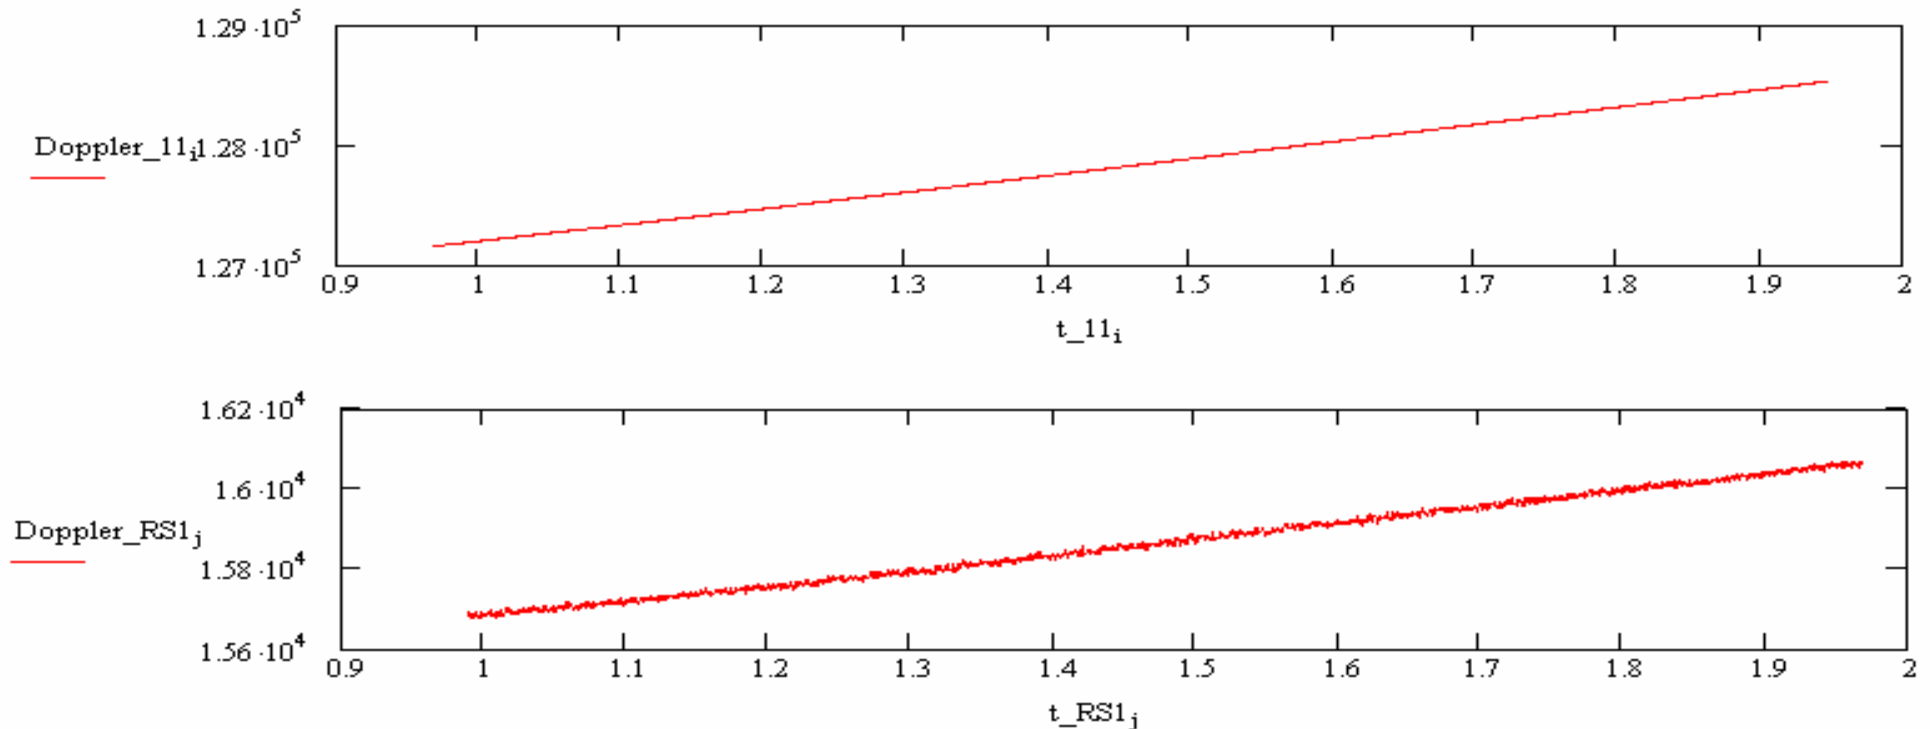
X-band (upper panel) and S-band (lower panel, unit is Hertz) one-way, USO, from 090.00:52 to 090.01:52 UT. Note the visible noise on the S-band Doppler, a feature never seen in two-way or in MEX one-way data.

Note also that the ratio X-band/S-band is NOT 11/3 but wrong by a factor of two! The reason may be that the coherency flag in the IFMS active table is set "TRUE" although the radio link is non-coherent. The IFMS is internally dividing the received Doppler by a factor of two if the coherency flag is set "TRUE" in order to output downlink Doppler only.

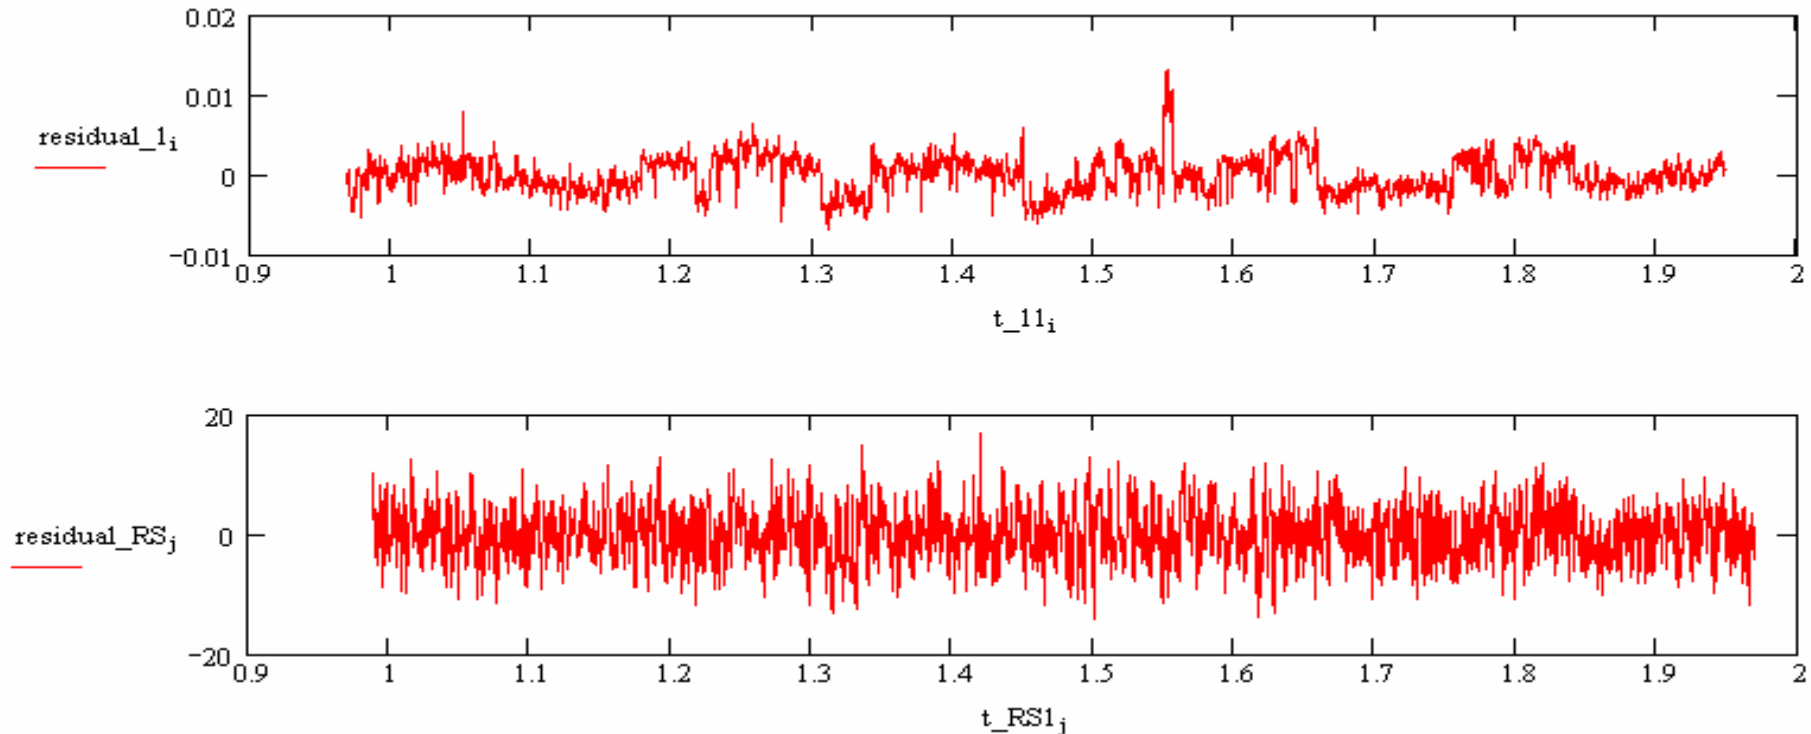
Note the jumps and spikes in the X-band by 5 mHz to 10 mHz.

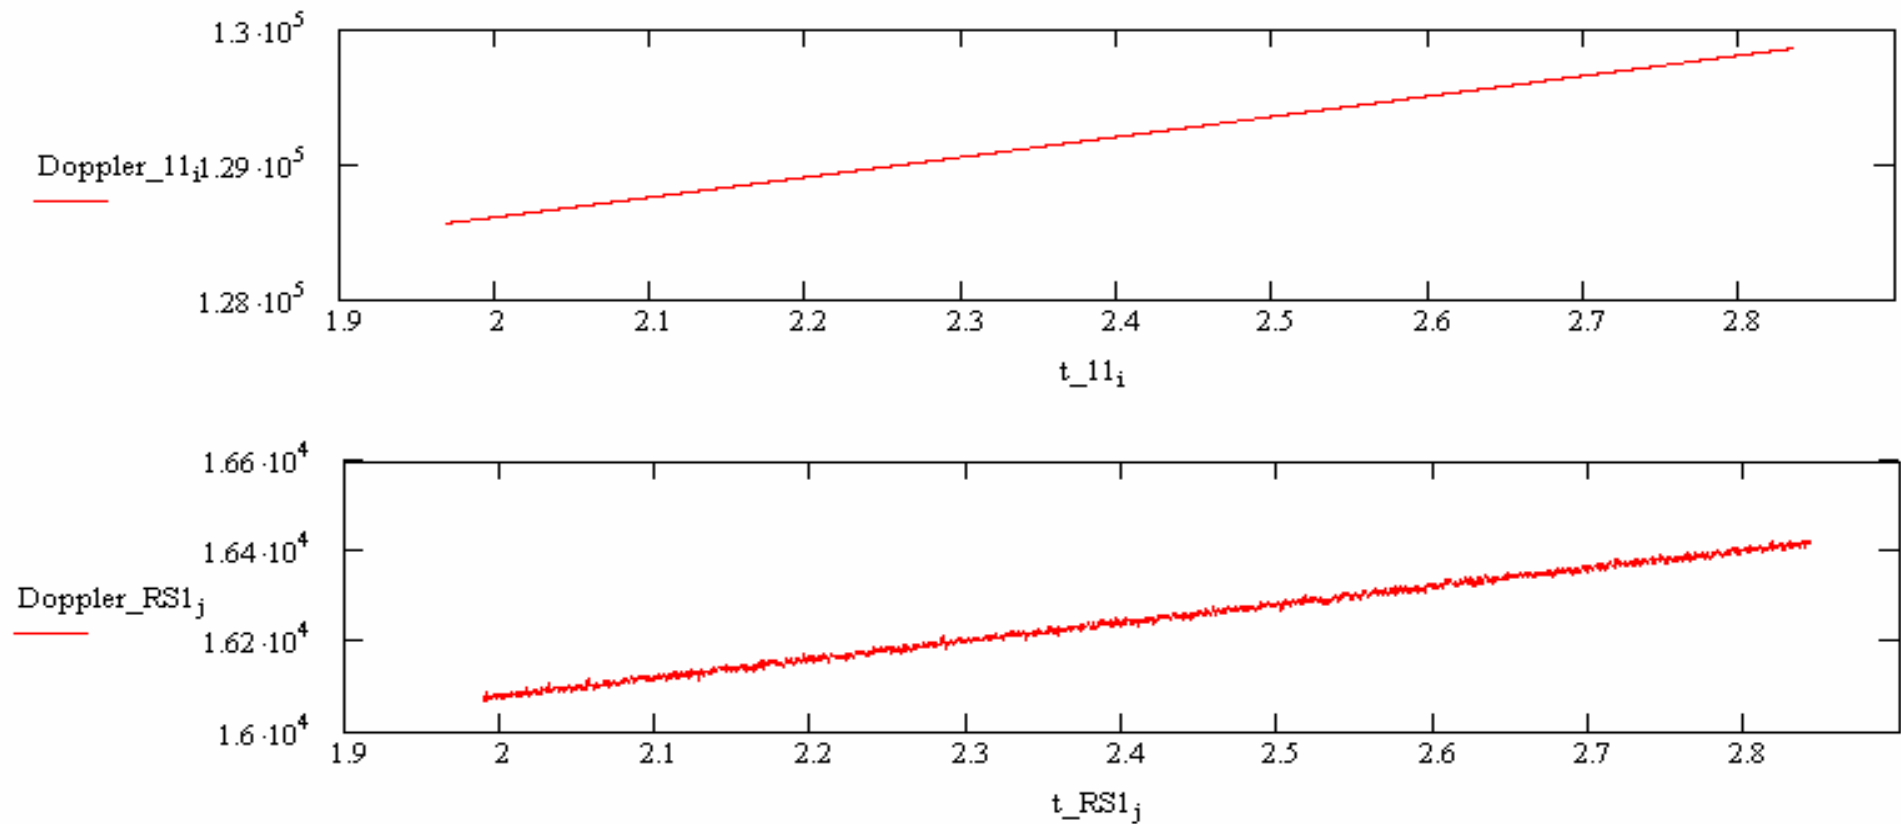
X-band (upper panel) and S-band (lower panel, unit is Hertz) one-way, USO, from 090.01:52 to 090.02:52 UT (second file). Note the visible noise on the S-band Doppler, as seen in the first file.

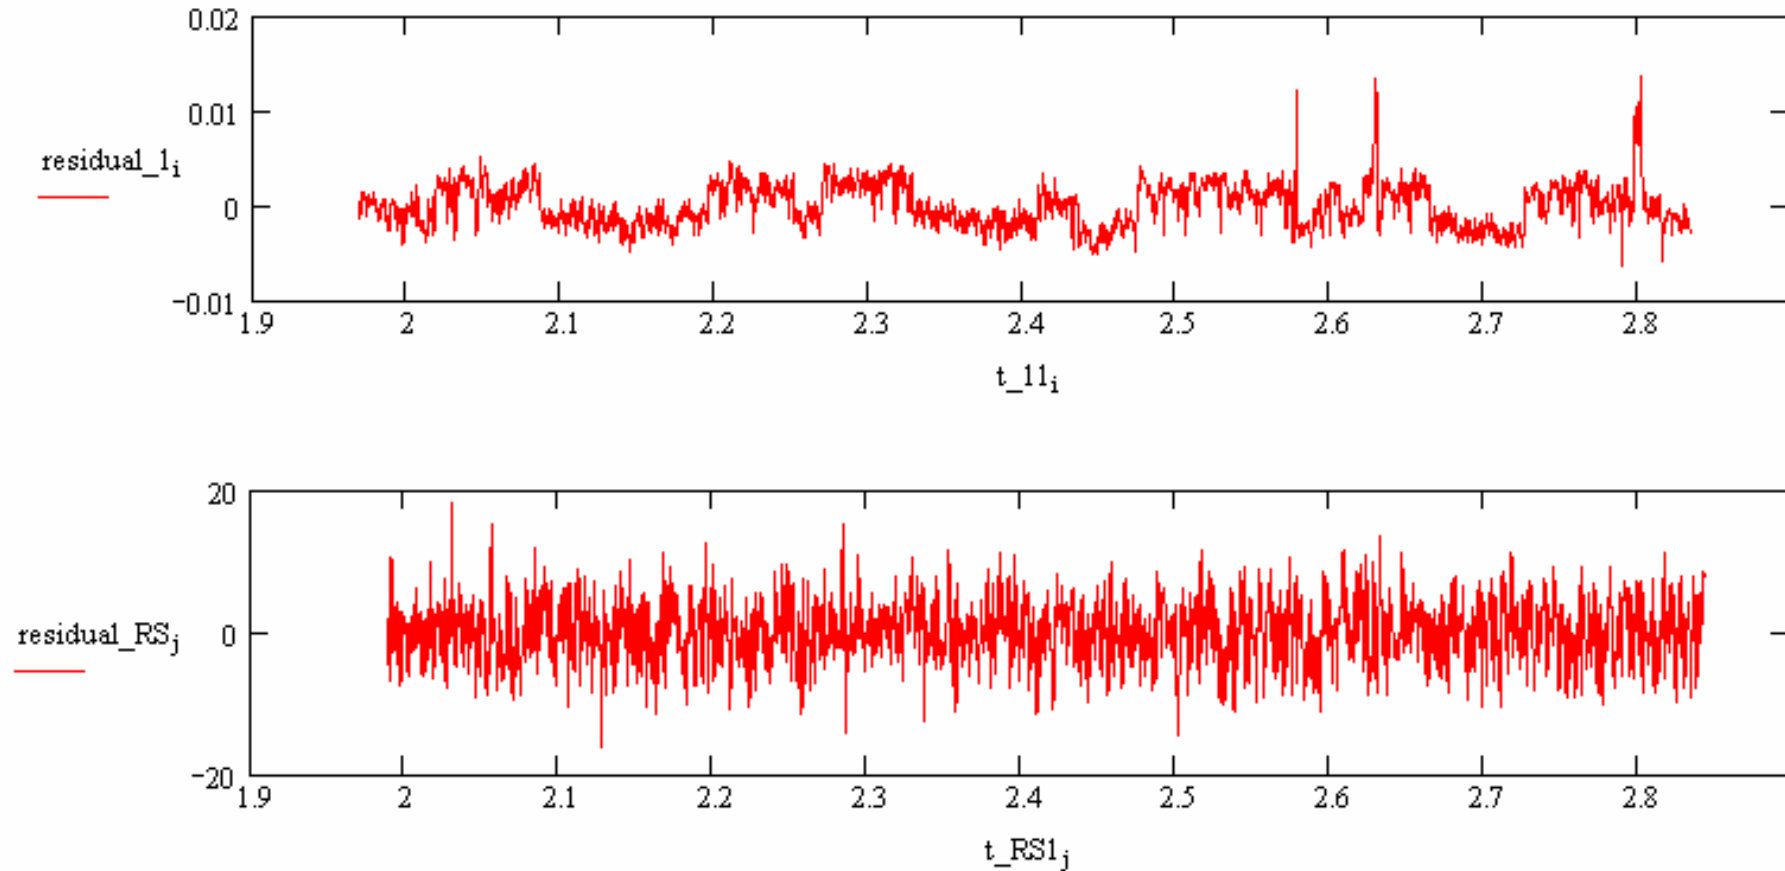
Note the jumps and spikes in the X-band by 5 mHz to 10 mHz.

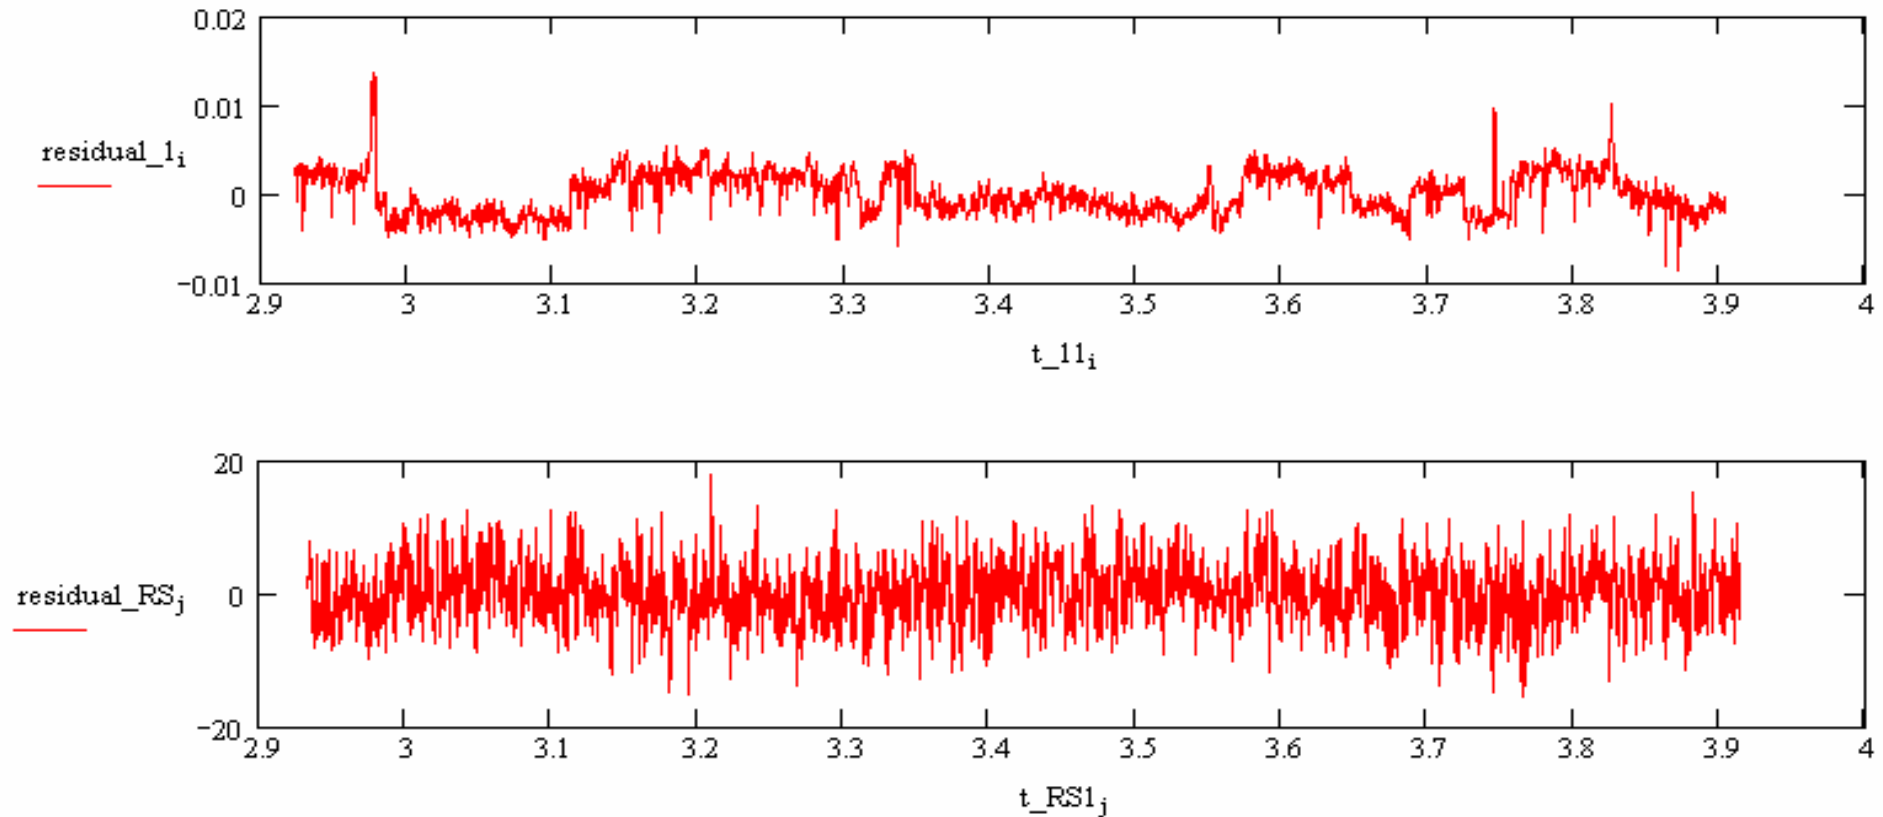
Note the jumps and spikes in the X-band by 5 mHz to 10 mHz.

The differential Doppler is not computed because there is obviously no correlation and coherency between X-band and S-band.

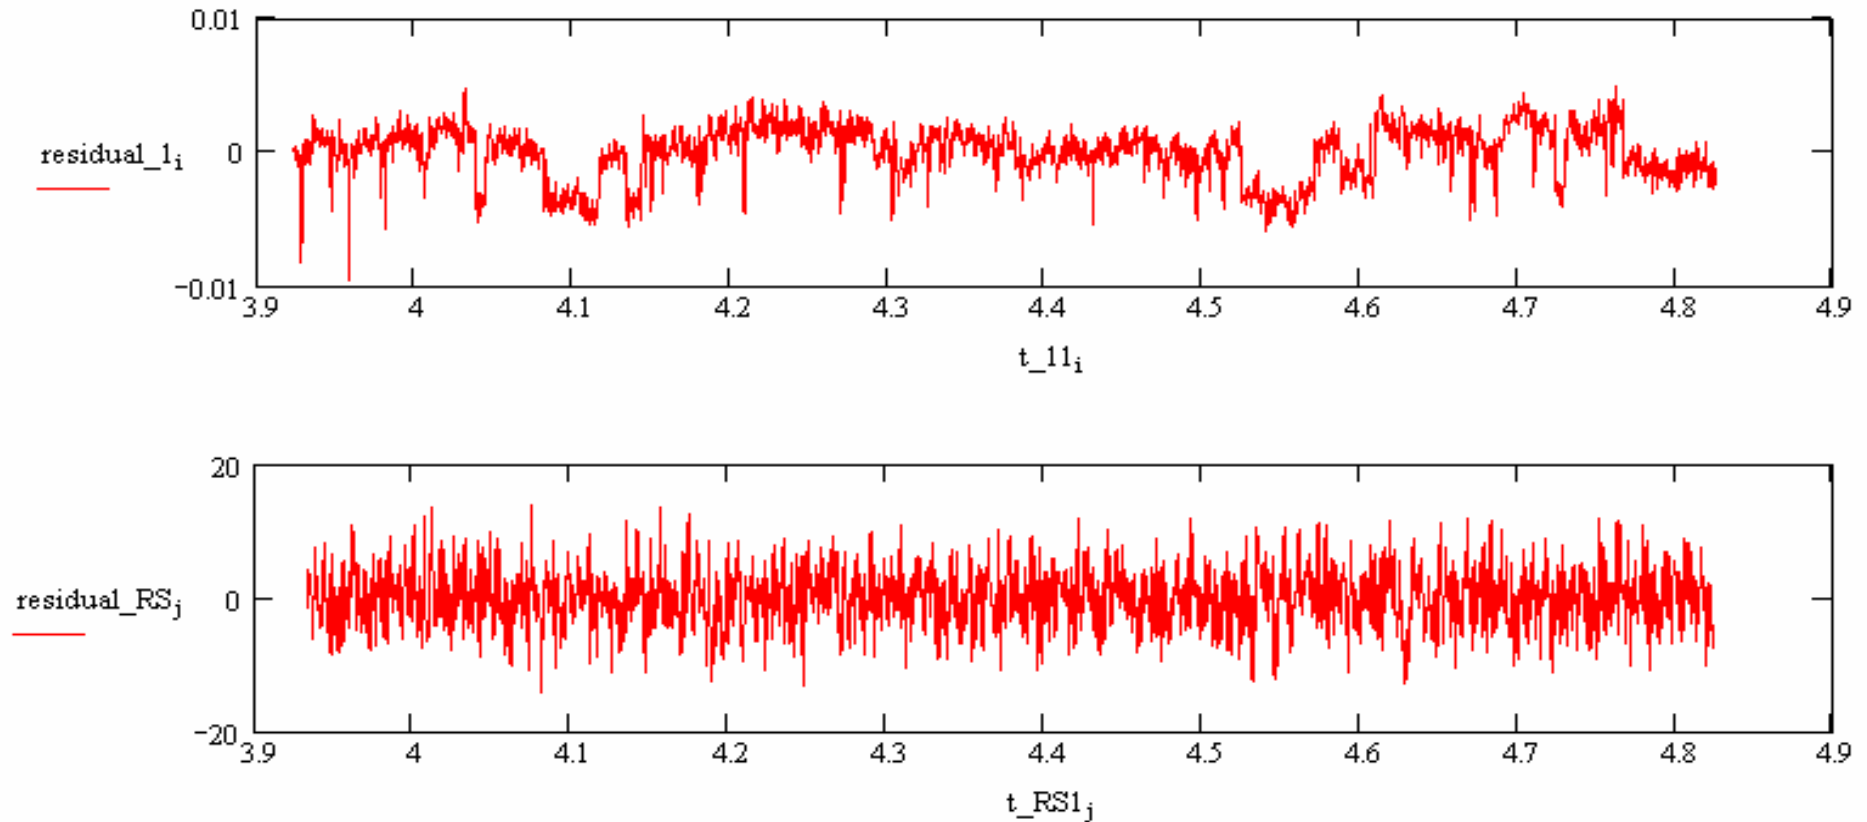
X-band (upper panel) and S-band (lower panel) Doppler residuals after subtracting a polynomial fit. The unit is Hertz.  
Note the jumps and spikes in the X-band by 5 mHz to 10 mHz.  
Note the large S-band noise amplitude.  
The differential Doppler is not computed because there is obviously no correlation and coherency between X-band and S-band.

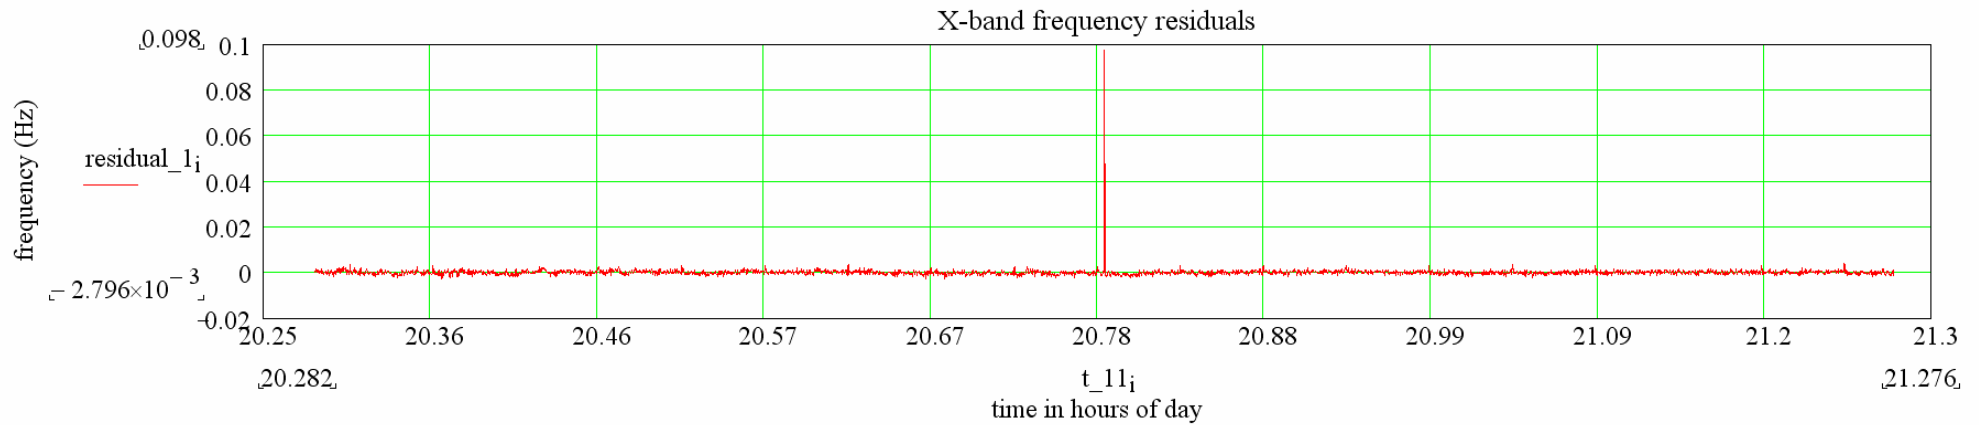
Frequency residuals at X-band from 20:18 to 21:16 UT two-way. The spike occurred at the time when the S-band was switched on at 20:45 UT.

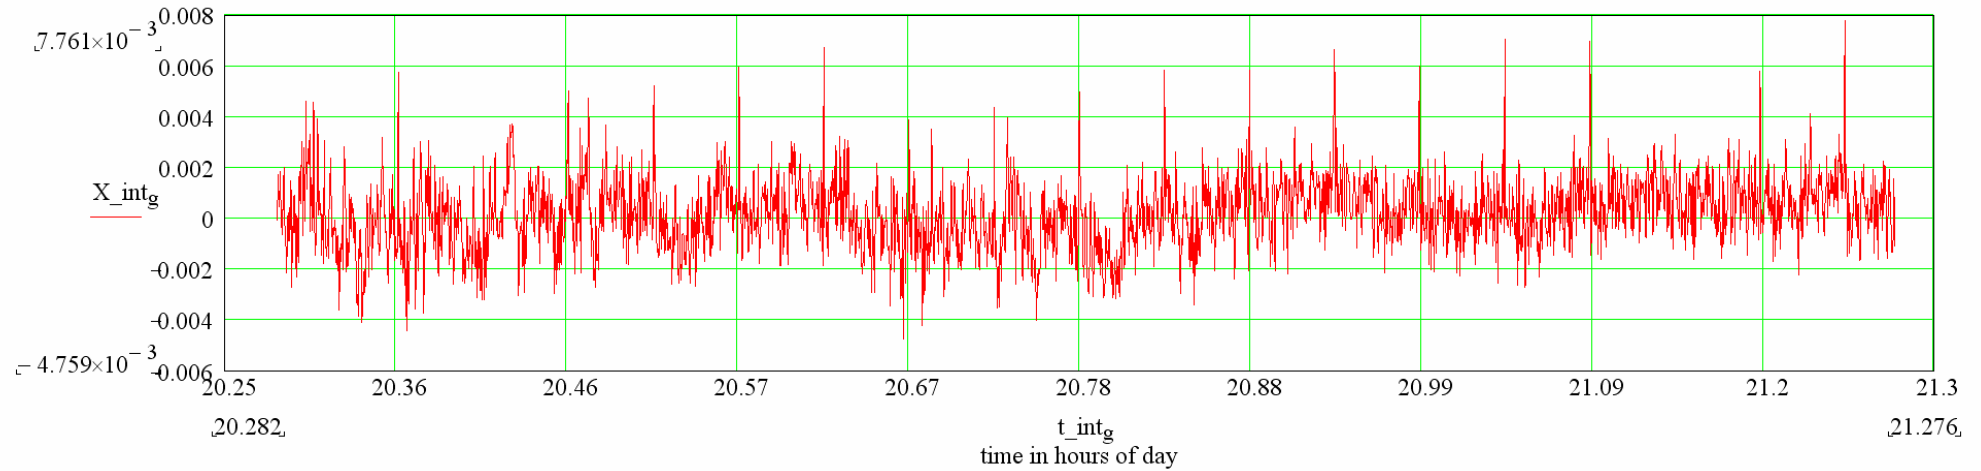
Same data as above (X-band two-way residuals) but spike removed. There is a periodical spike every 3 minutes. The 1-sigma noise is  $50 \mu\text{m/s}$ .

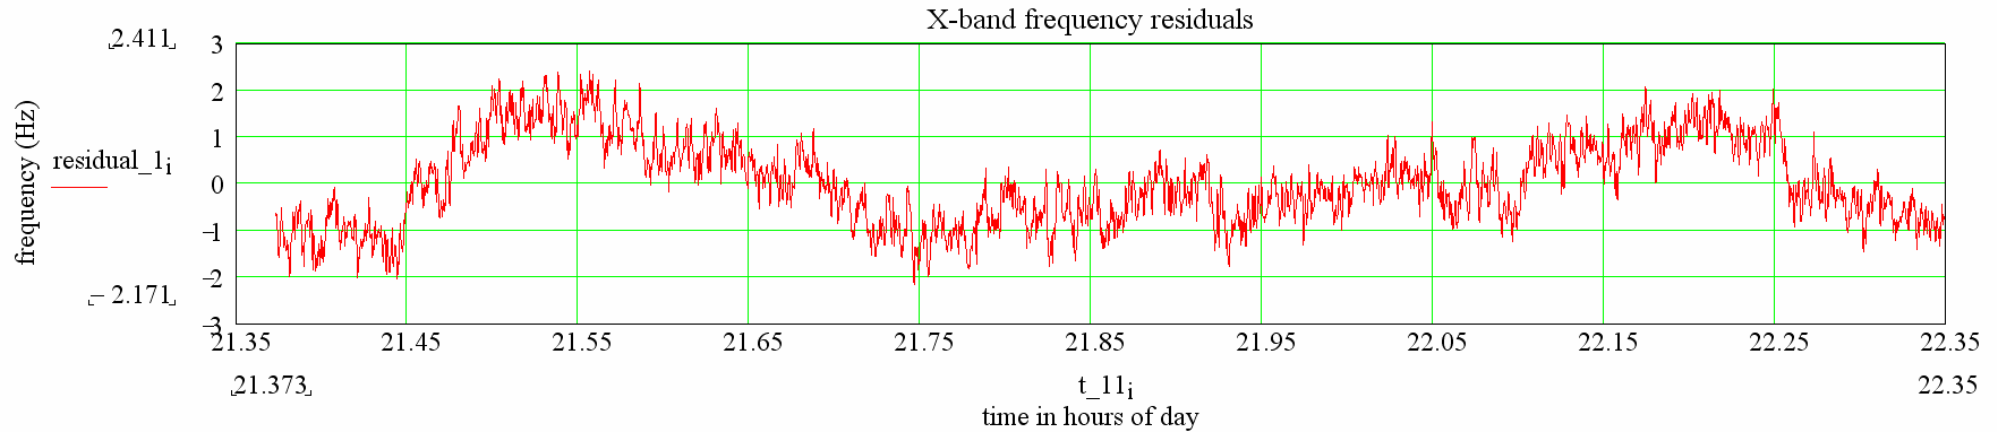
X-band frequency residuals one-way after coherency was switched off. The frequency stability is driven by the TCXO. Note the change in scale. The 1-sigma noise is 6.7 cm/s, a change by three orders of magnitude. Note also the large amplitude variations.

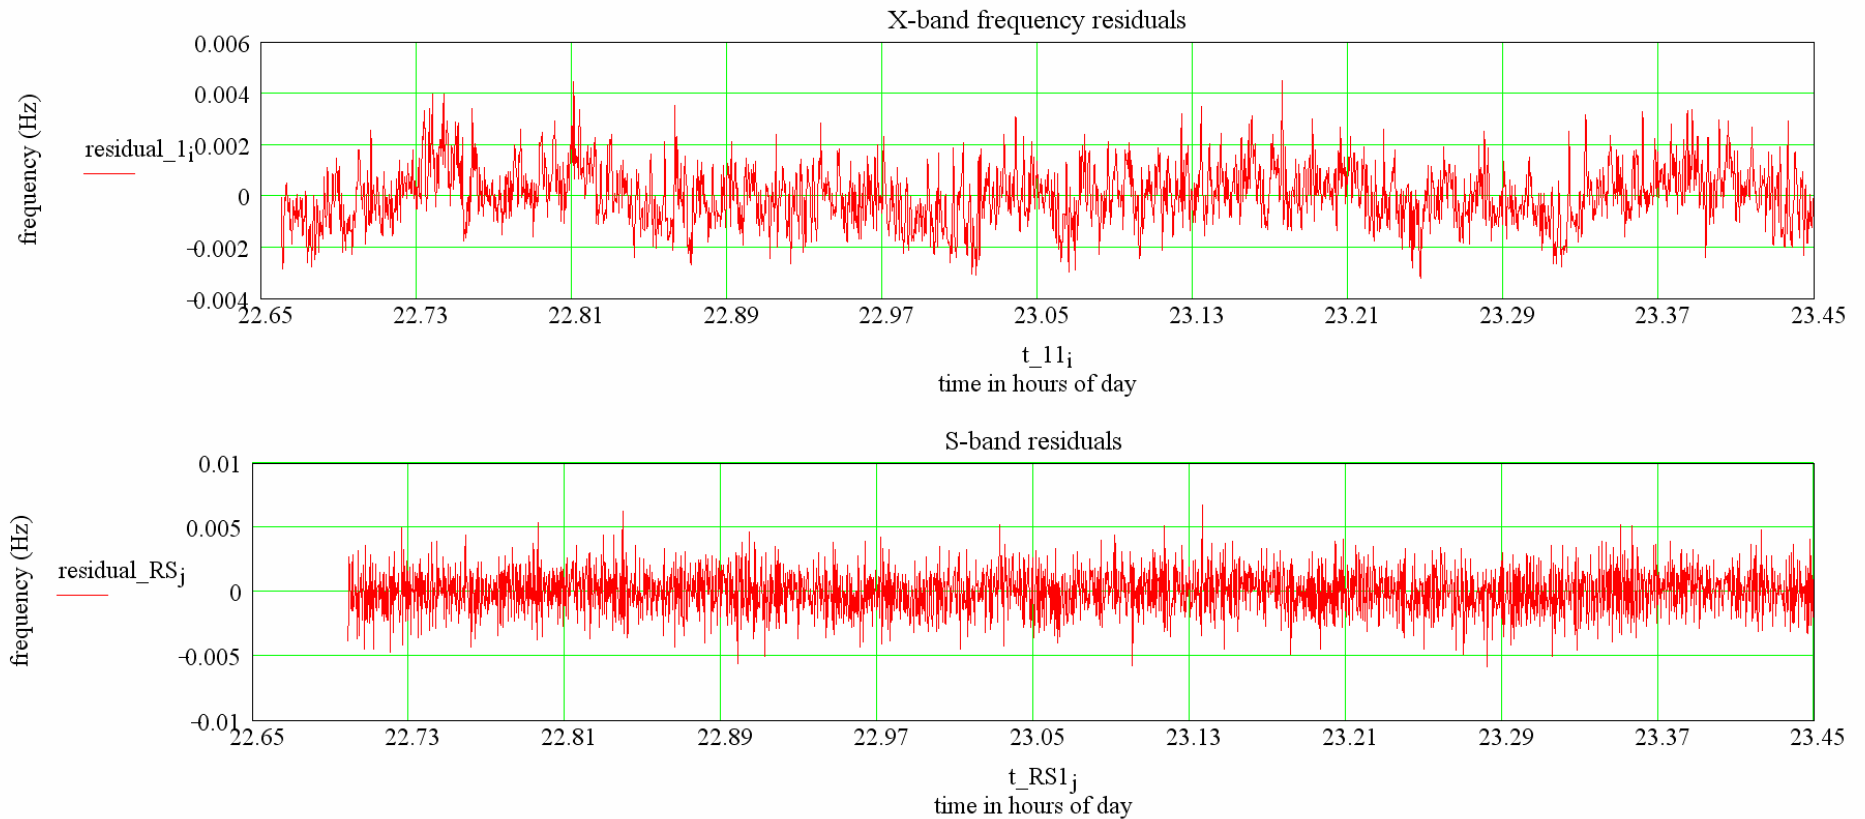
### 8.5.3 IFMS Doppler from 123.22:27 to 123.23:27 UT ONED USO

X-band (upper panel) and S-band (lower panel) frequency residuals driven by the USO. The 1-sigma noise uncorrected for plasma contributions is  $46 \mu\text{m/s}$  and  $425 \mu\text{m/sec}$  at X-band and S-band, respectively.

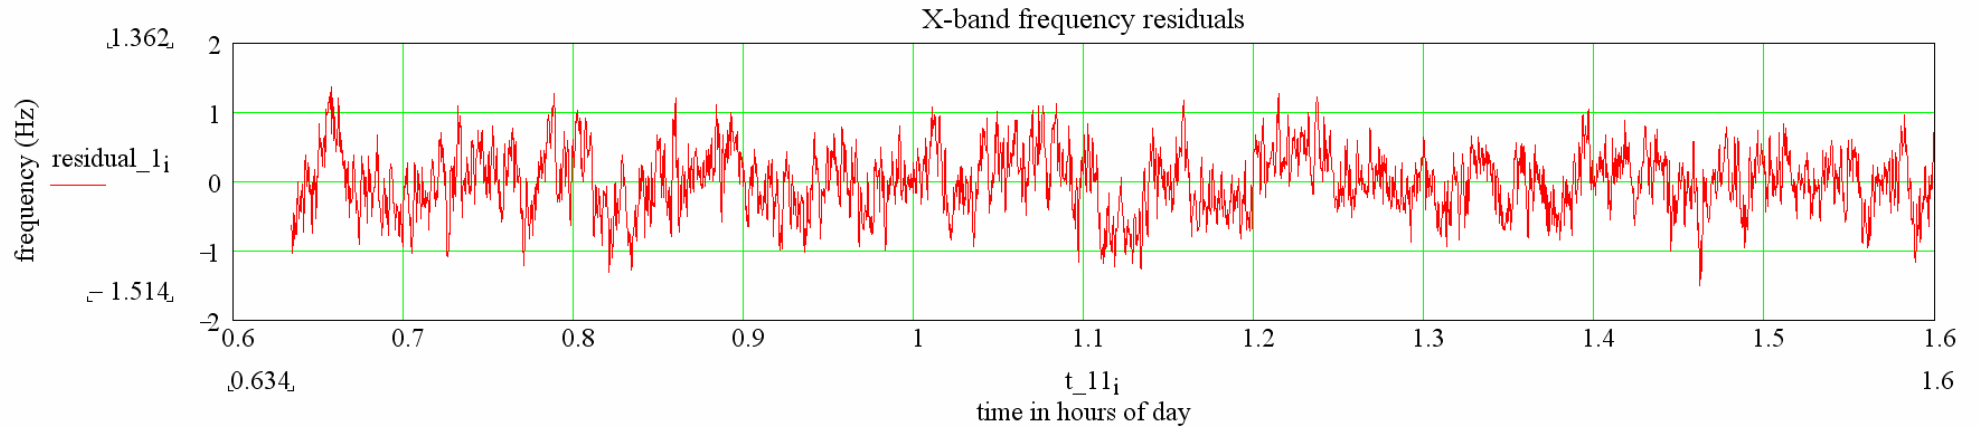
### 8.5.5 IFMS Doppler from 124.00:35 to 124.01:40 UT ONES TCXO

X-band residuals driven by the TCXO (USO muted). TM was OFF until 00:47 and TM ON for the rest of the pass. The 1-sigma noise is 3.1 cm/sec.

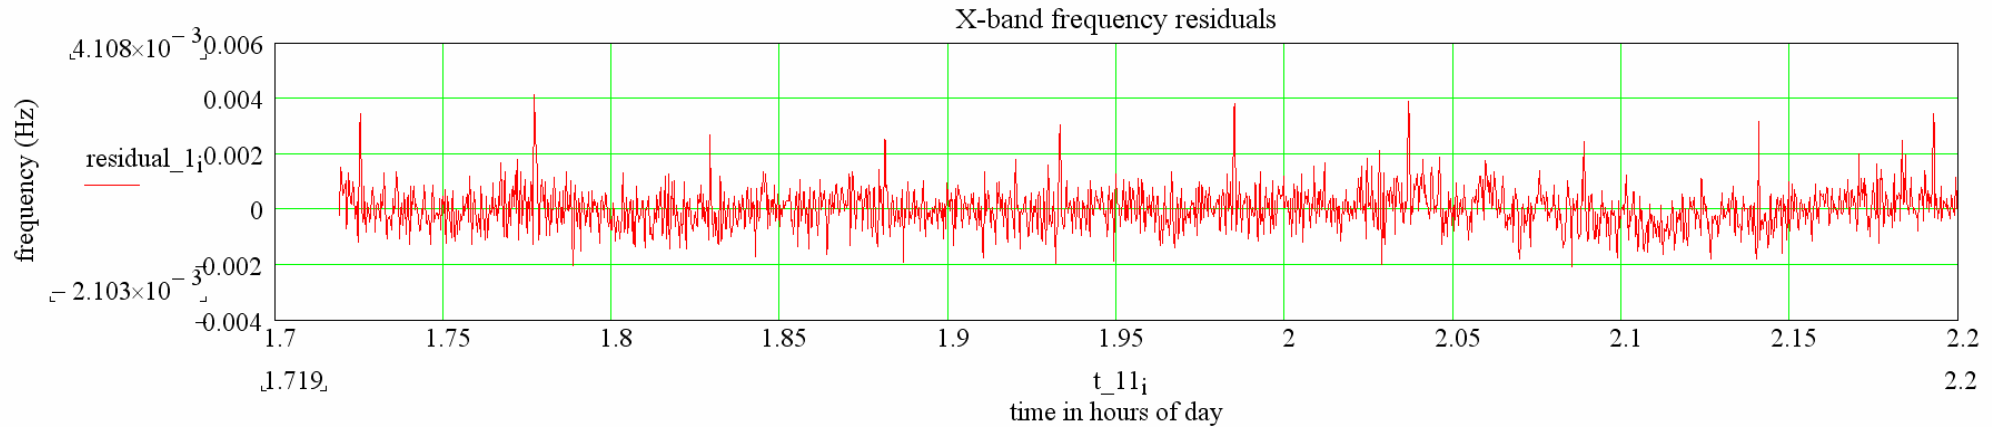
### 8.5.6 IFMS Doppler from 124.01:45 to 124.02:12 UT TWOS

X-band residuals two-way TWOS-X at the end of the pass. TM was ON. Note the spikes in the data every 3 minutes. The 1-sigma noise is 41  $\mu\text{m}/\text{sec}$ .

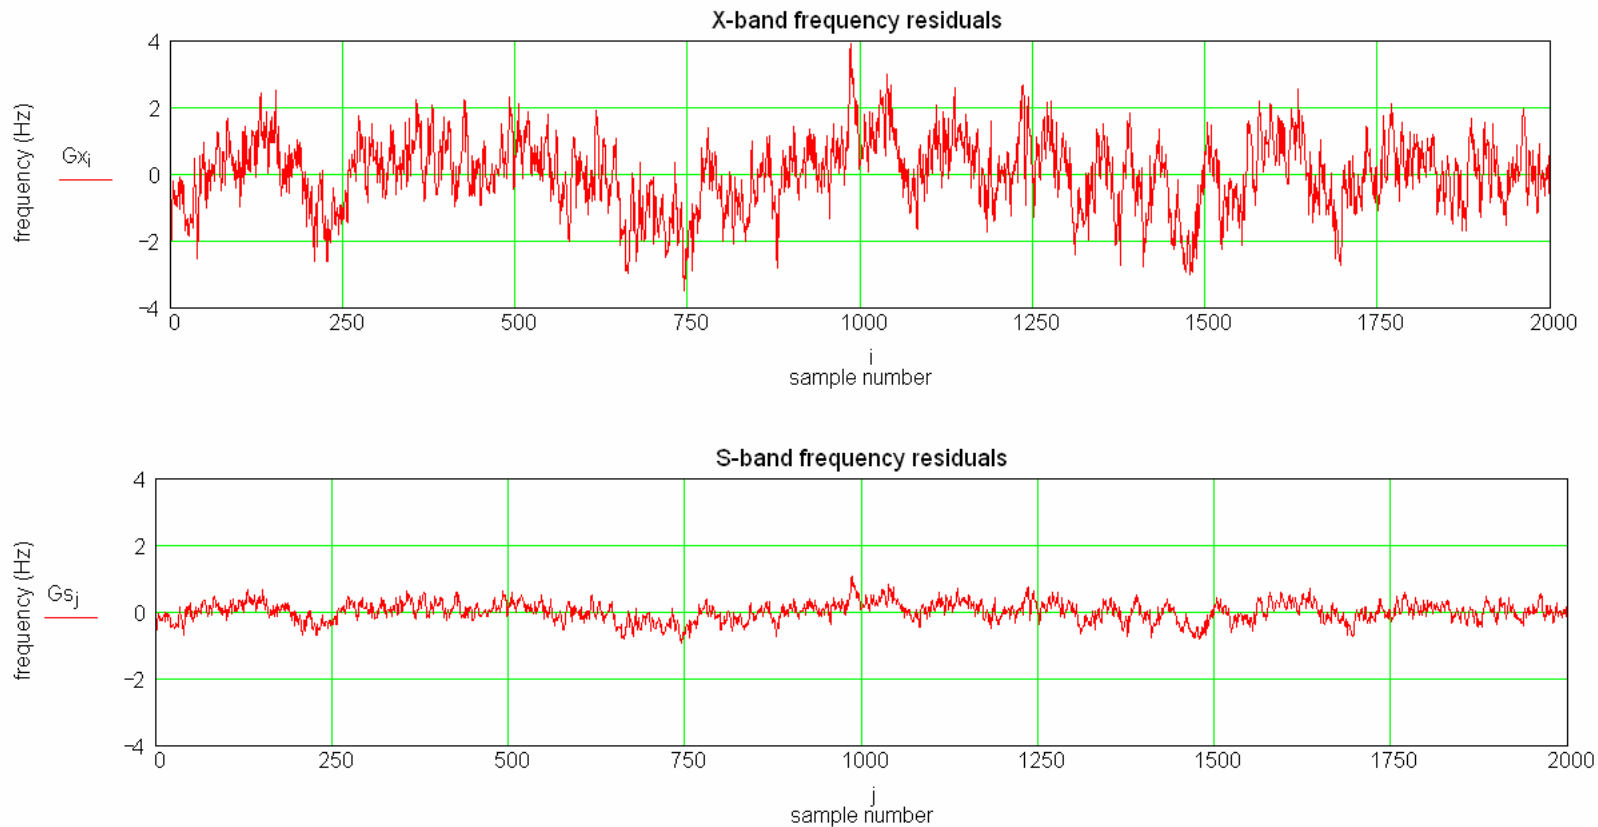
### IFMS Doppler from 124.21:42 to 124.22:21 UT ONED TCXO

X-band (upper panel) and S-band (lower panel) frequency residuals, one-way driven by the TCXO; TM is ON. The average noise is 3.8 cm/s.

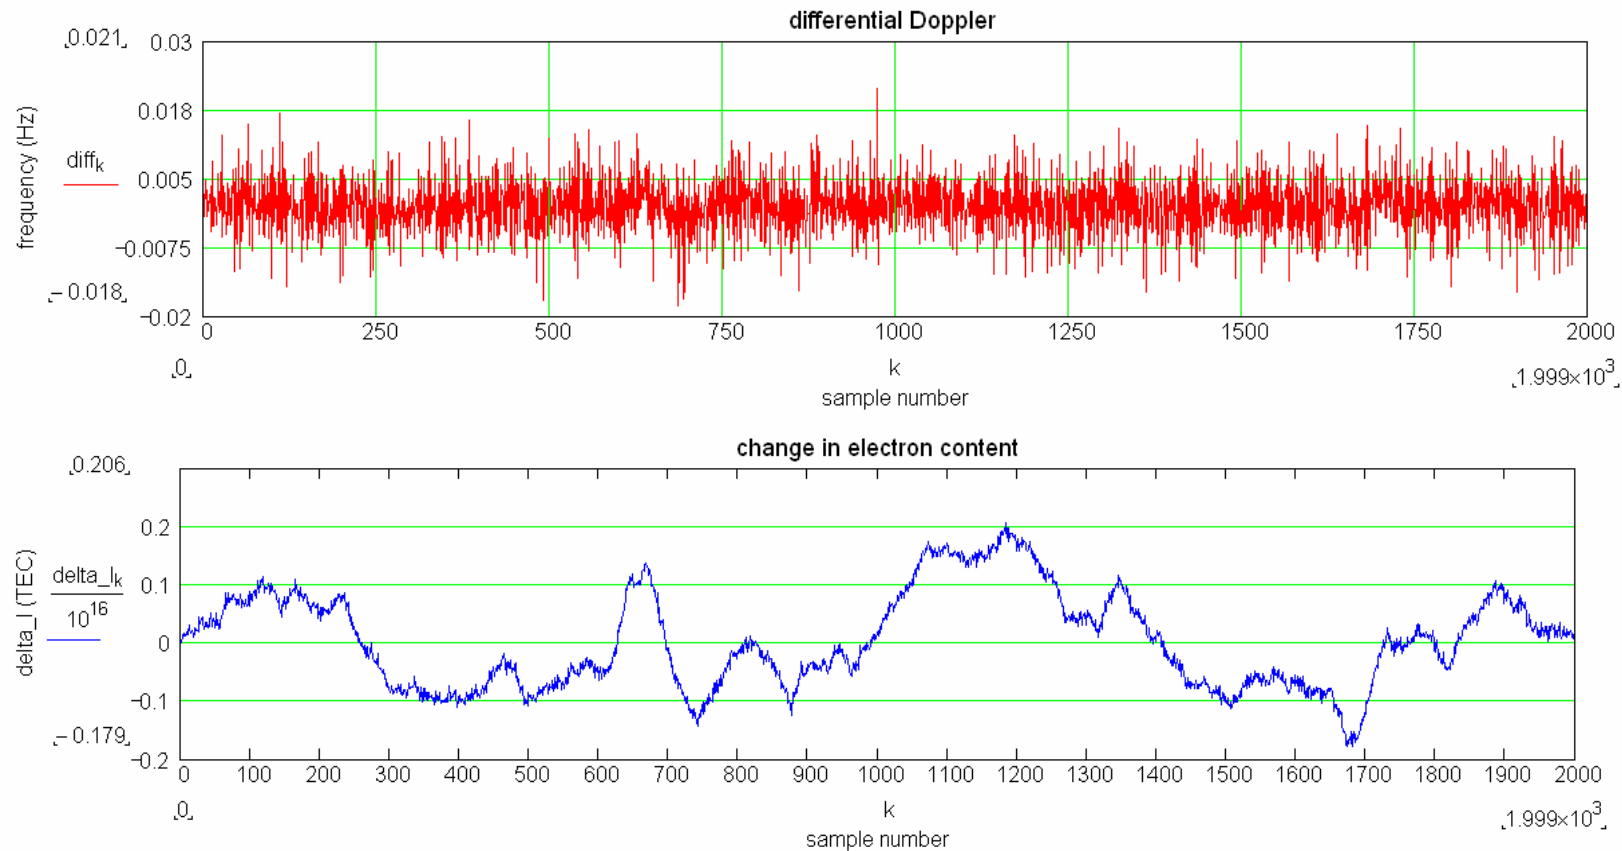
Differential Doppler (upper panel) and computed change in electron content for 2000 seconds of TCXO one-way data. It turns out that the differential Doppler is as stable as the two-way data due to the common noise source. The sensitivity in electron content is in the order of 0.01 TEC units.

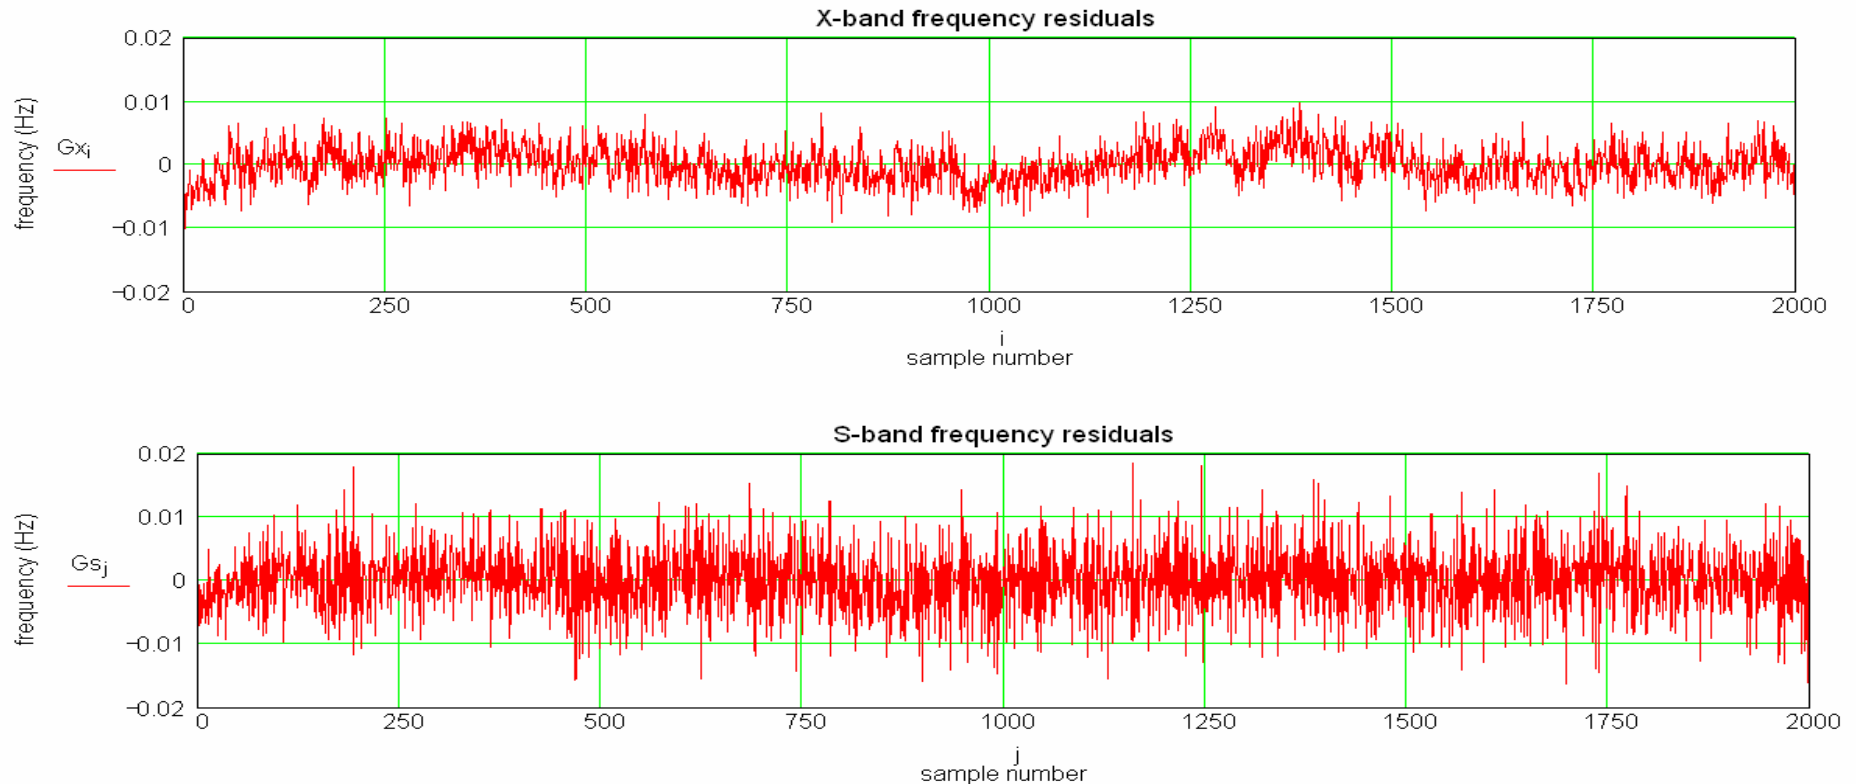
#### 9.4.2 IFMS Doppler from 124.22:36 to 124.23:24 UT ONED USO

X-band (upper panel) and S-band (lower panel) frequency residuals, one-way driven by the USO; TM is ON. Note the change in scale concerning the noise levels with TCXO.
