***ROSETTA***

Consolidated Rosetta payload report for the MCRR

RO-EST-RP-3293

17 Nov 2004

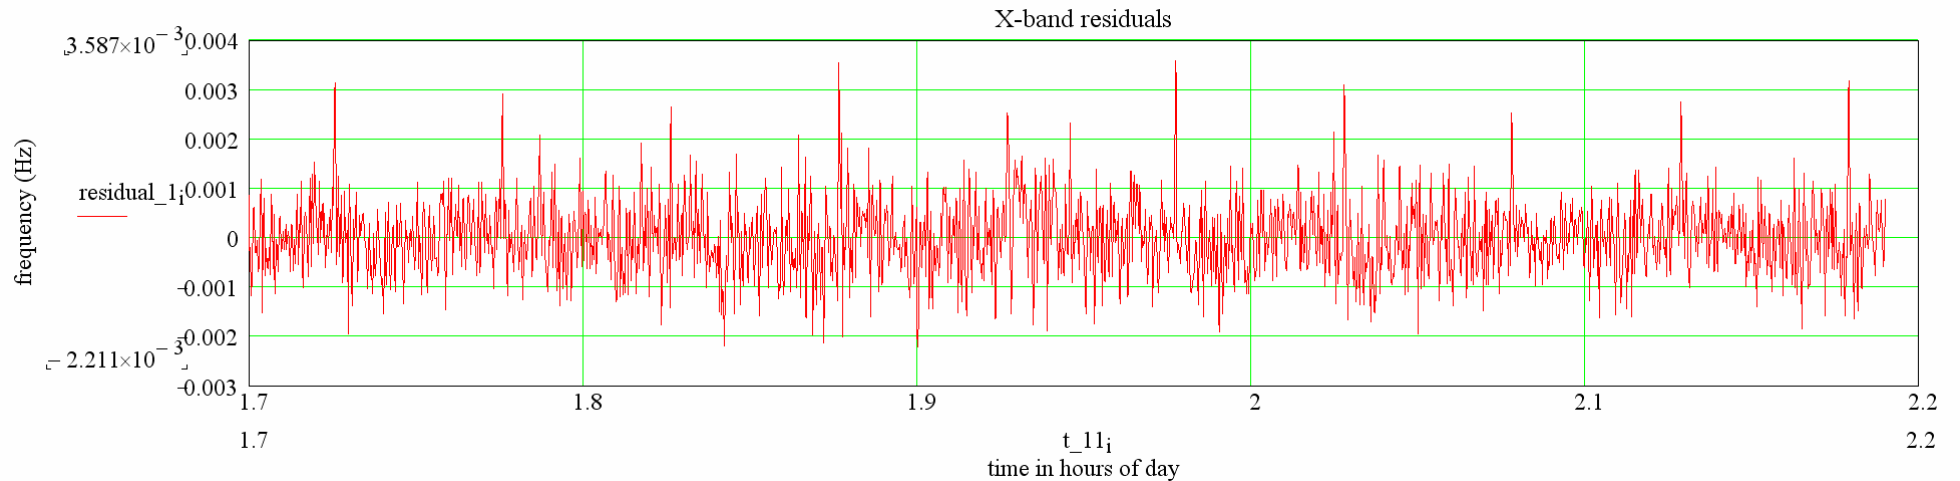
#### 9.4.4 IFMS Doppler from 125.01:42 to 125.02:12 UT TWOS-X

X-band residuals after establishing the two-way link X-band up/X-band down from 01:42 to 02:12 UT. Note the change in scale compared to the one-way TCXO data. The USO data are comparable to the two-way link. There are spikes every three minutes in the data.

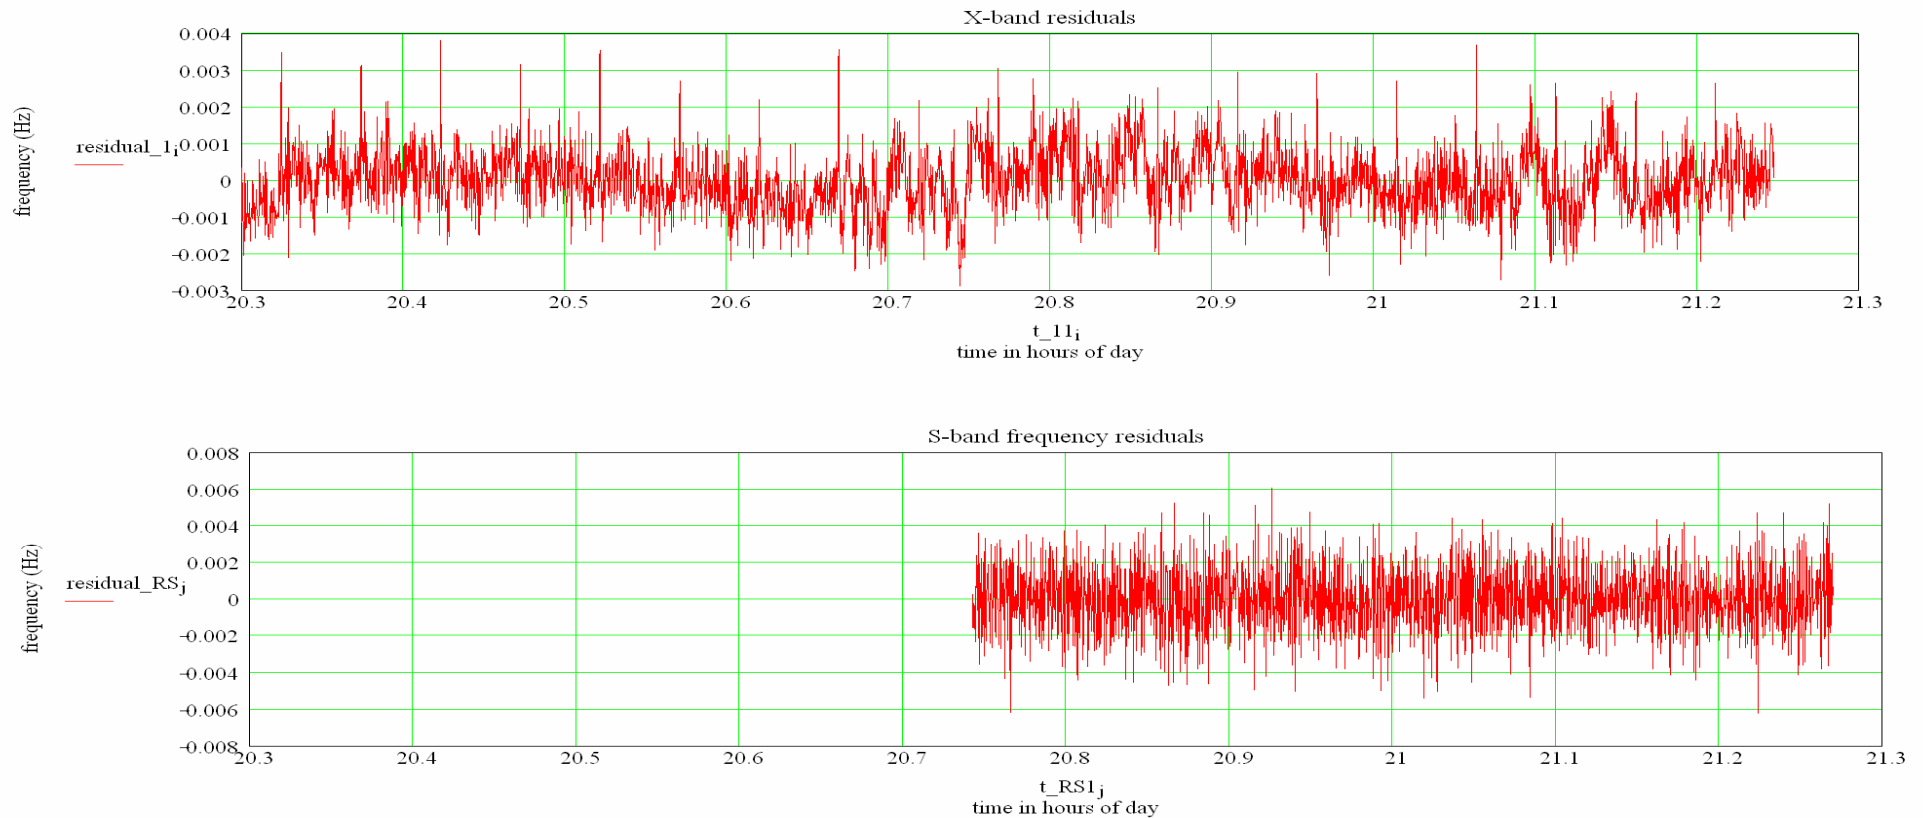
### 10.4.1 IFMS Doppler from 125.20:18 to 125.21:16 UT (TWOS -> TWOD)

X-band residuals and S-band residuals (starting at 20:41 UT) from 20:18 TO 21.16 ut: Note the spikes in the X-band data every 3 minutes. TM is ON at X-band. There was a spike of 0.15 Hz at the time of the S-band downlink switch-on (here removed).

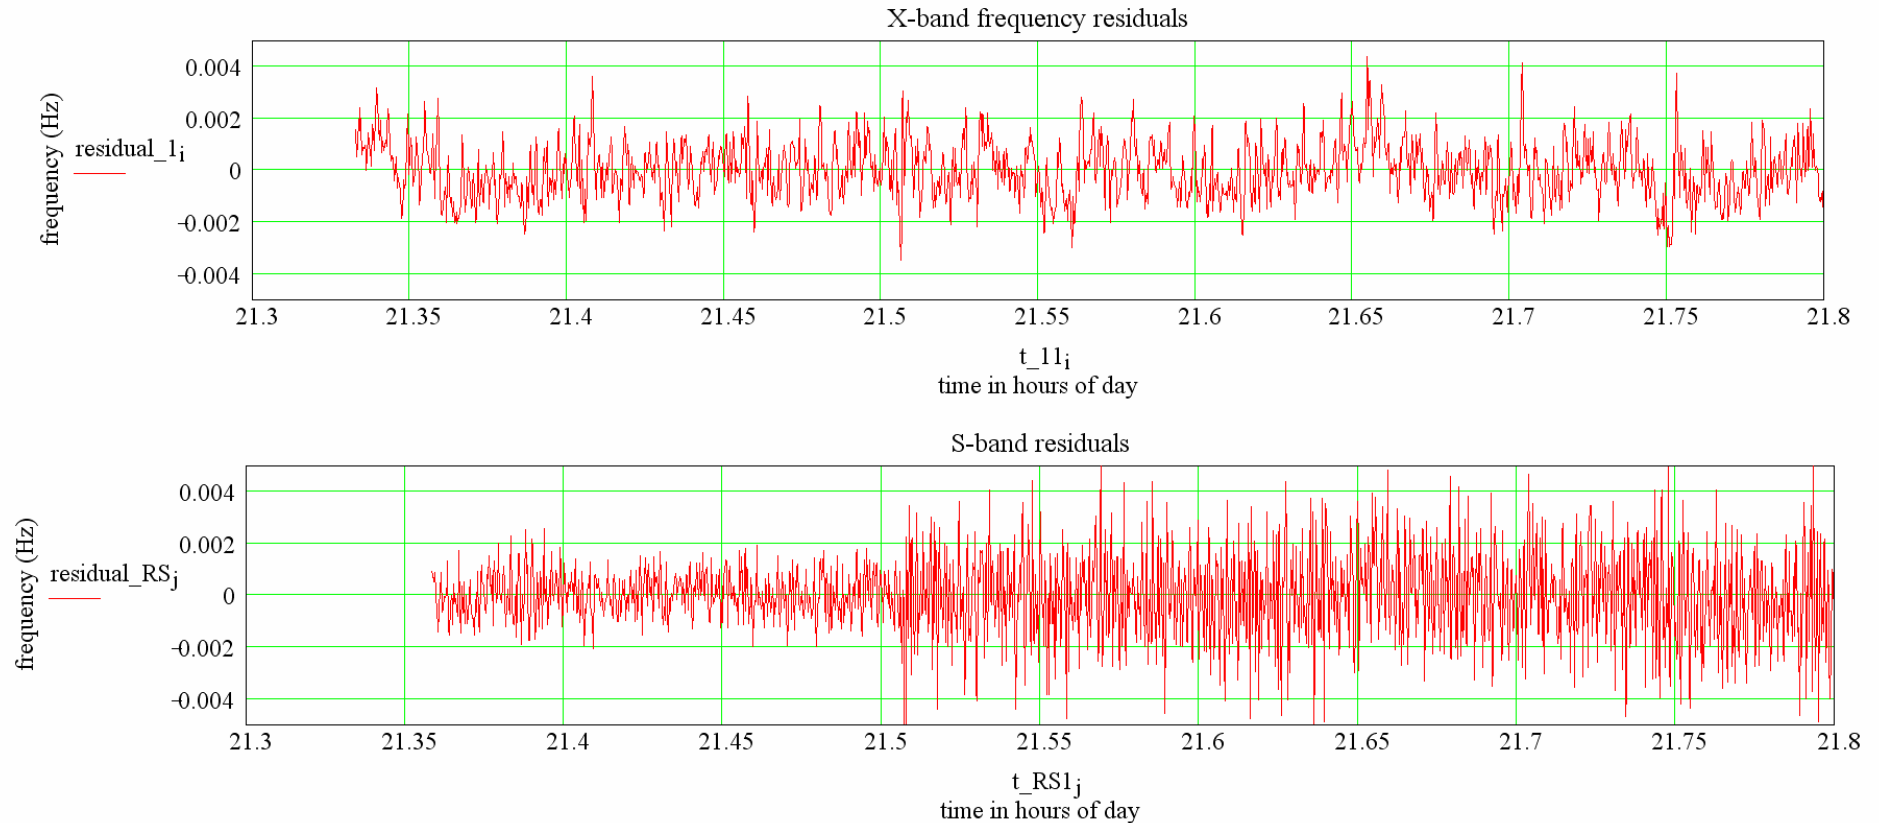
#### 10.4.2 IFMS Doppler from 125.21:18 to 125.23:31 UT ONED USO

One-way X-band residuals and S-band residuals from 21:18 to 23:31 UT driven by the USO. The TM was OFF and was switched ON at 21:28 UT which is clearly visible in the S-band data by an increased noise level of a factor of 2.5. Note the spikes in the X-band every three minutes. Apparently, these spikes are present at TM ON as well as for TM OFF.

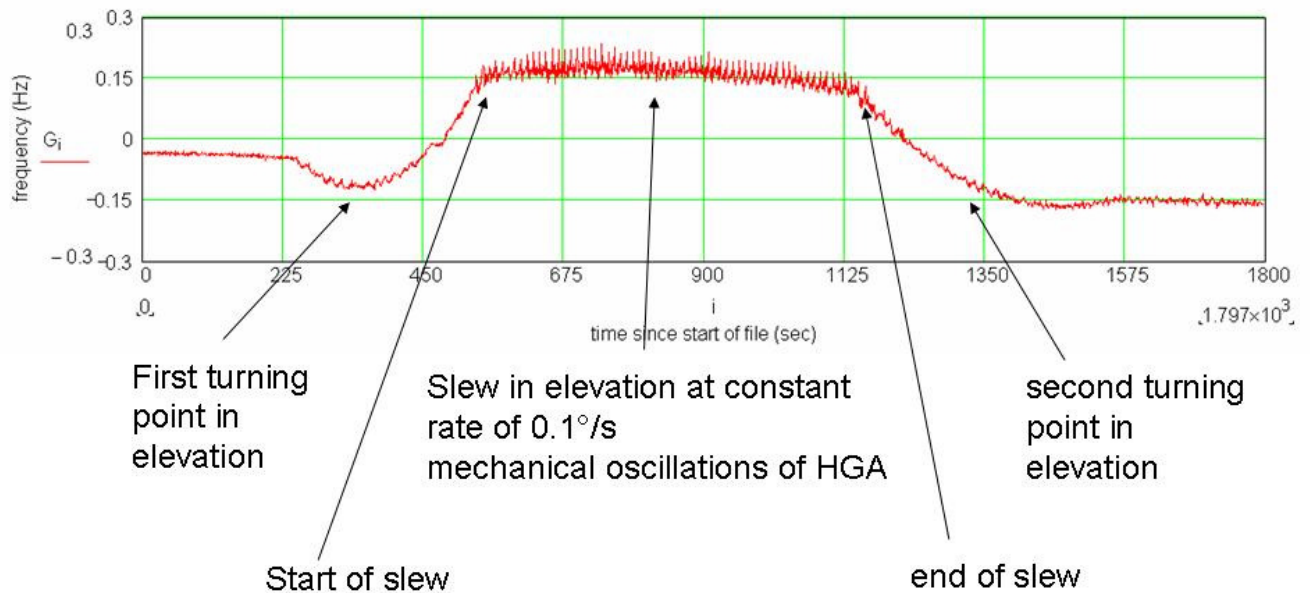
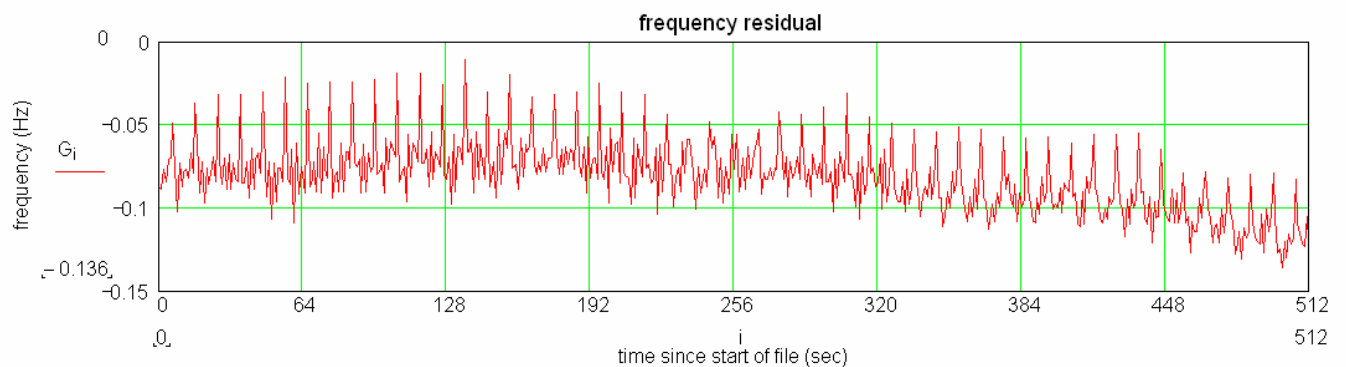
### 11.3.1 IFMS Doppler from 255.20:00 – 255.20:30, TWOD, two-way coherent

The mechanical oscillations of the HGA during the slew show a peak-to-peak amplitude of up to 70 mHz or 2.5 mm/s.

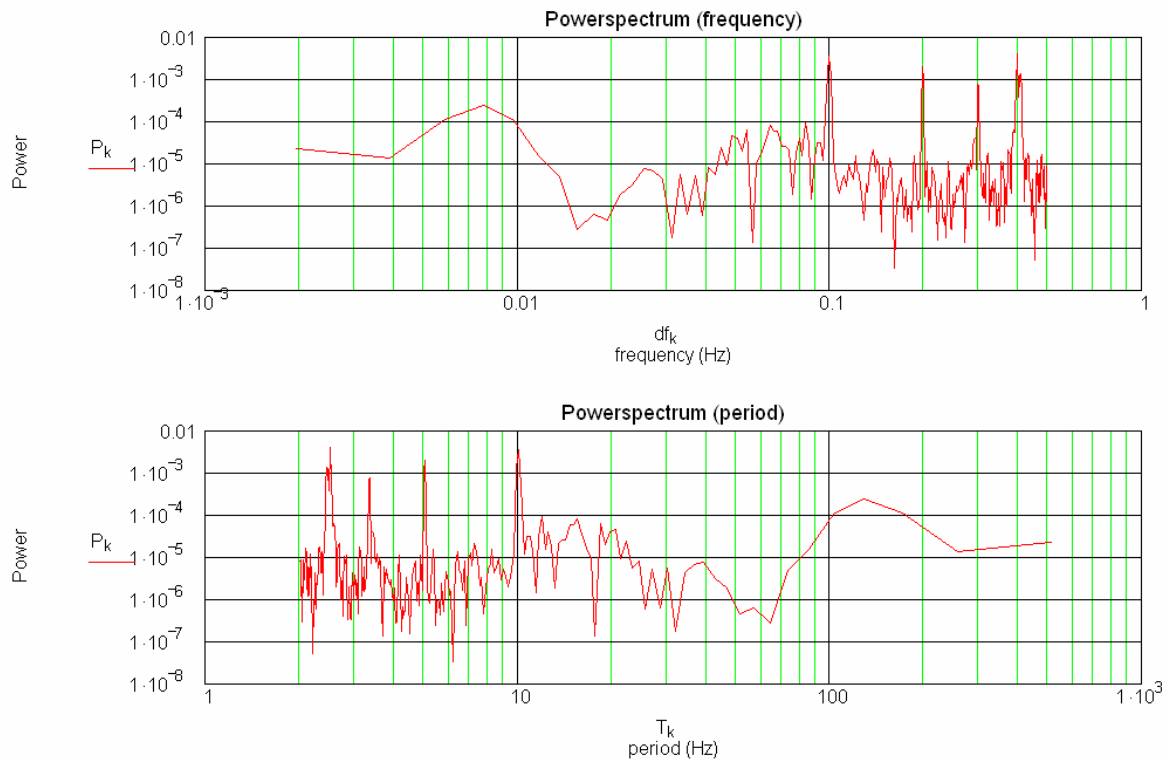
The power spectrum of the oscillations show strong peaks at 2.5 sec, 3.3 sec, 5 sec and 10 seconds.

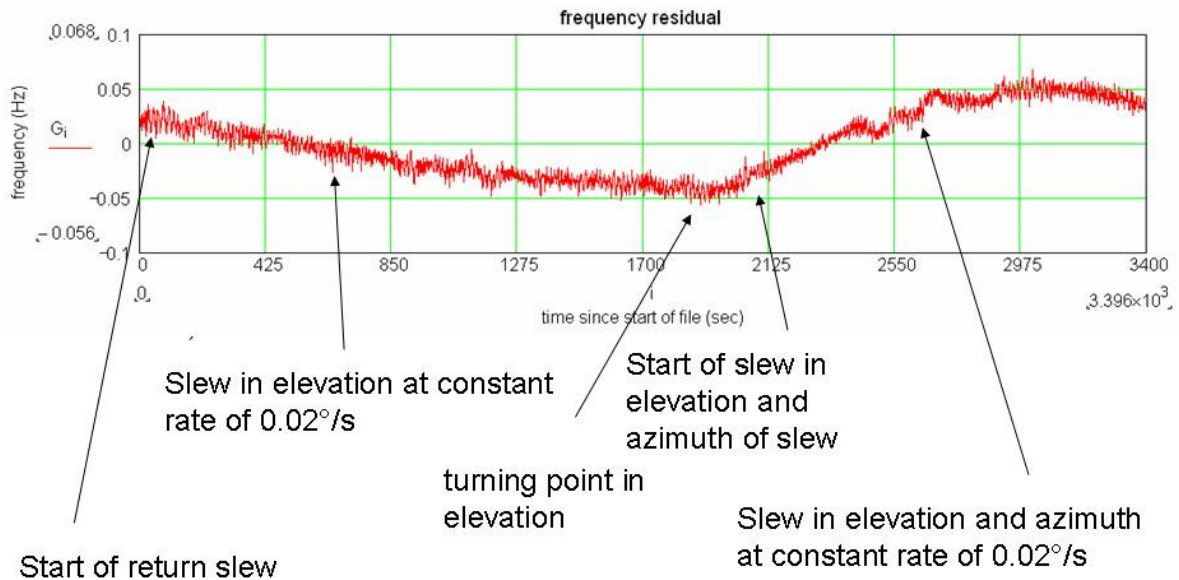
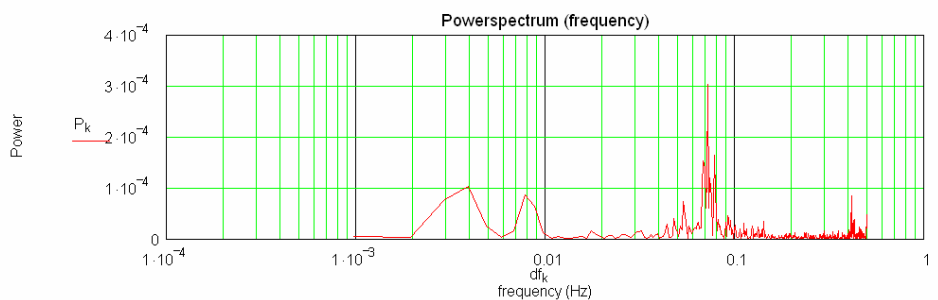
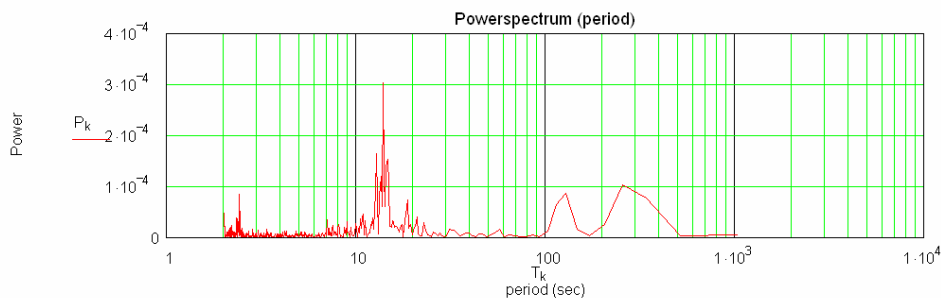
### 11.3.2 FMS Doppler from 255.20:30 – 255.21:30, TWOD, two-way coherent

X-band residuals after detrending. Return slew in elevation at slower rate of 0.02°/s and followed by a slew in elevation and azimuth at 0.02°/s. The power spectra show a 15 seconds oscillation.

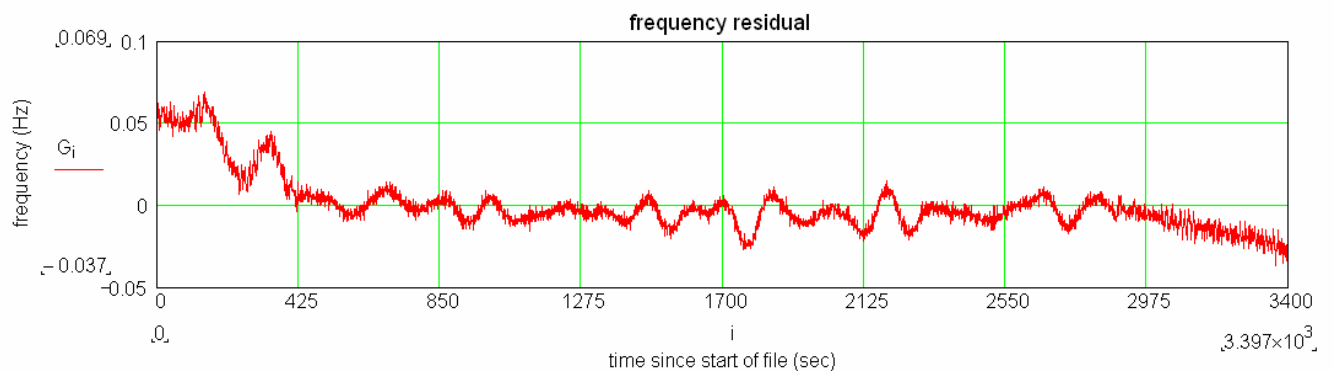
### 11.3.3 FMS Doppler from 255.21:30 – 255.22:30, TWOD, two-way coherent

X-band residuals after detrending. Constant slew in azimuth with slew rate 0.02%/sec. Prominent are 200 seconds oscillations of up to 25 mHz peak-to-peak.

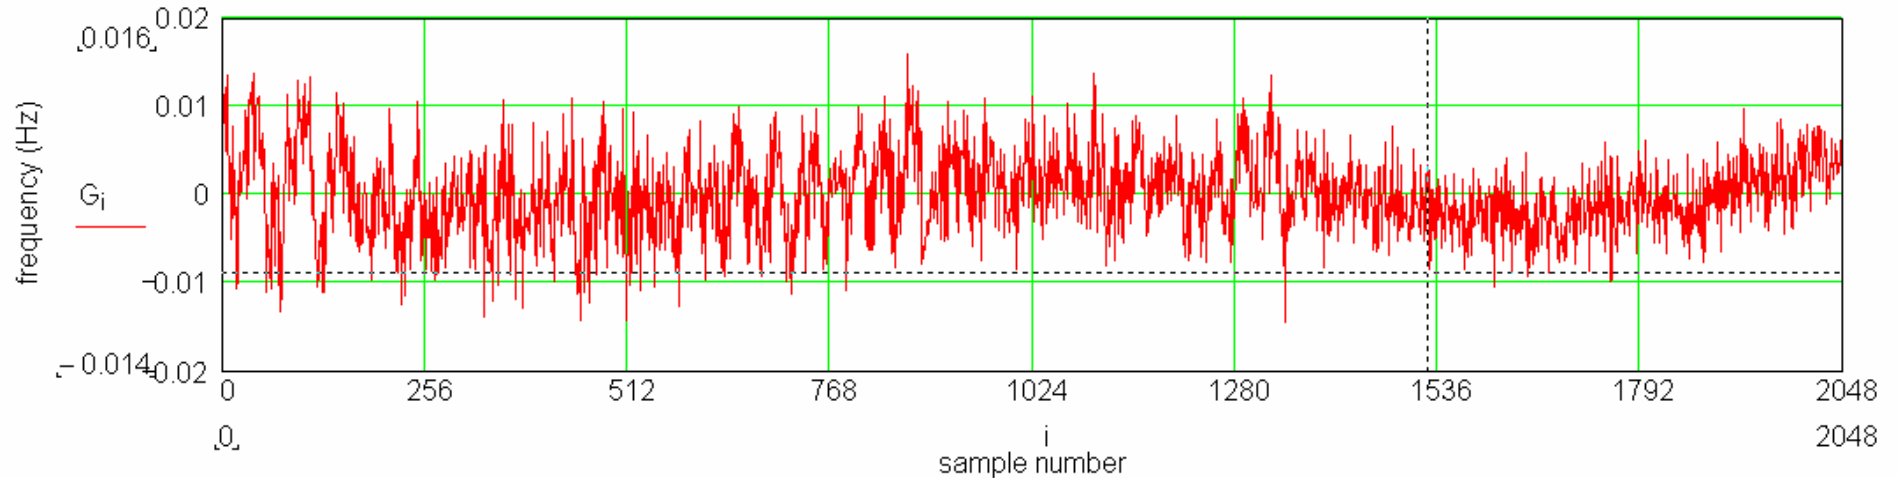
Last 2048 X-band samples from the first TWOD time series starting at 283.18:38 UT. Note the change in noise fluctuation at sample 1360 or 283.19:00 UT. This may mark a change in TM or range modulation.

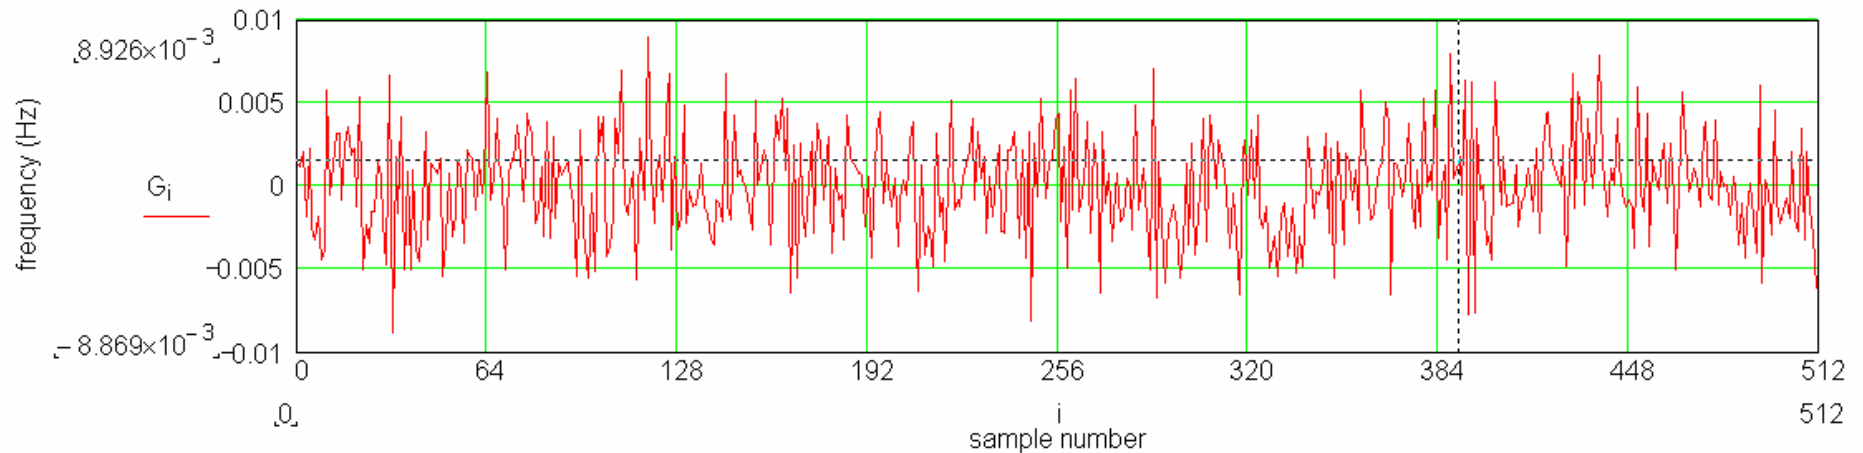
Last 690 X-band samples starting at 283.19:00 UT, switch OFF or change of TM OR ranging modulation? Power of oscillations are two orders of magnitude less.

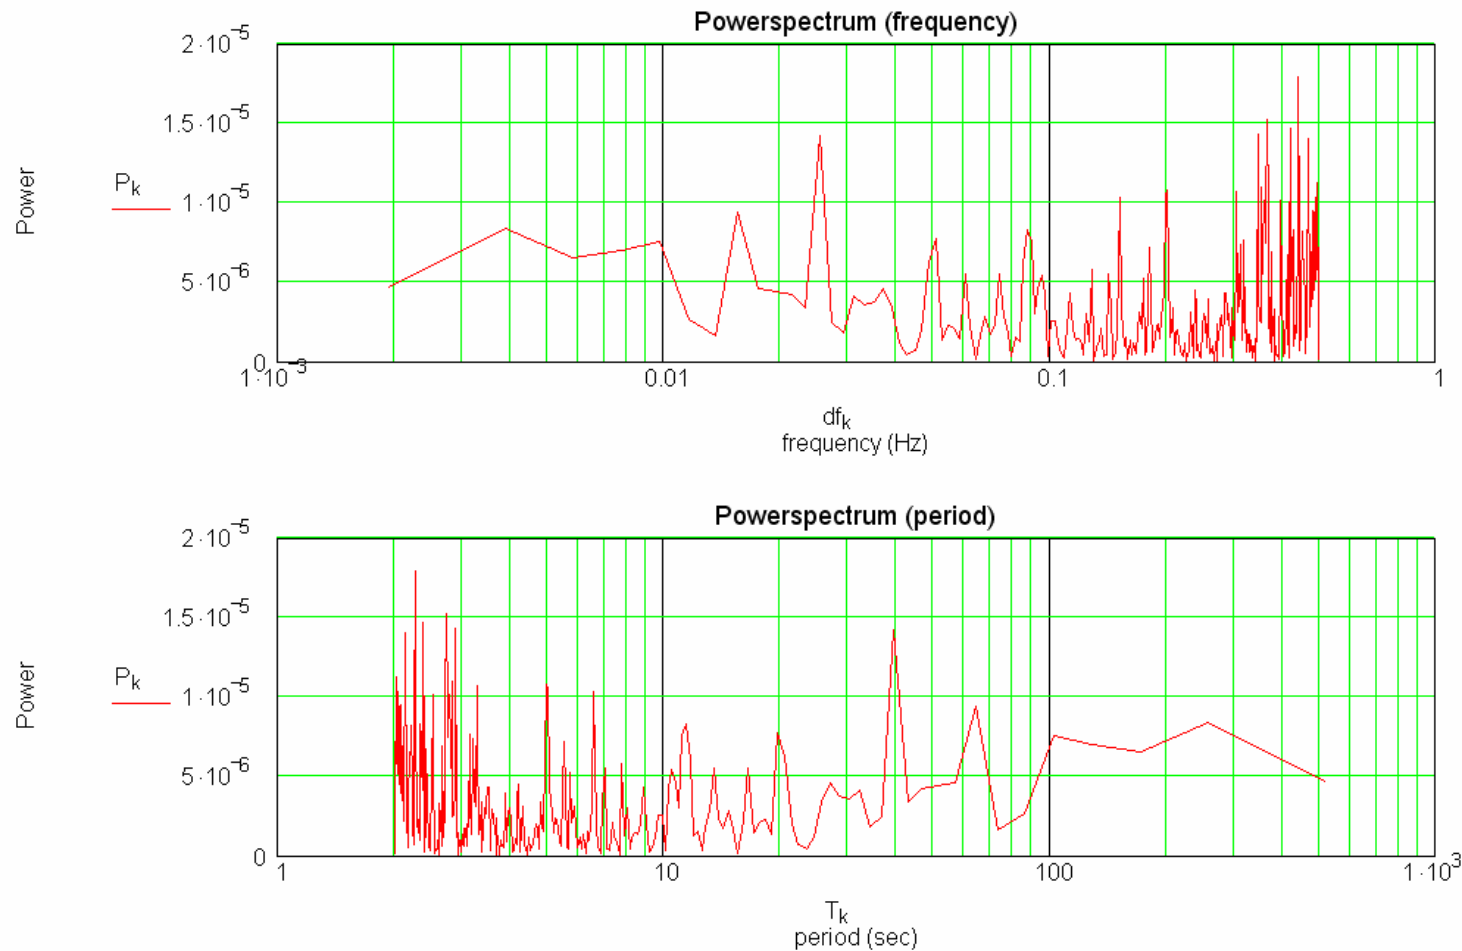
Power spectra of last 690 X- band samples starting at 283.19:00 UT, Dominant period of 40 seconds is two orders of magnitude weaker than periods before 283.19:00 UT.

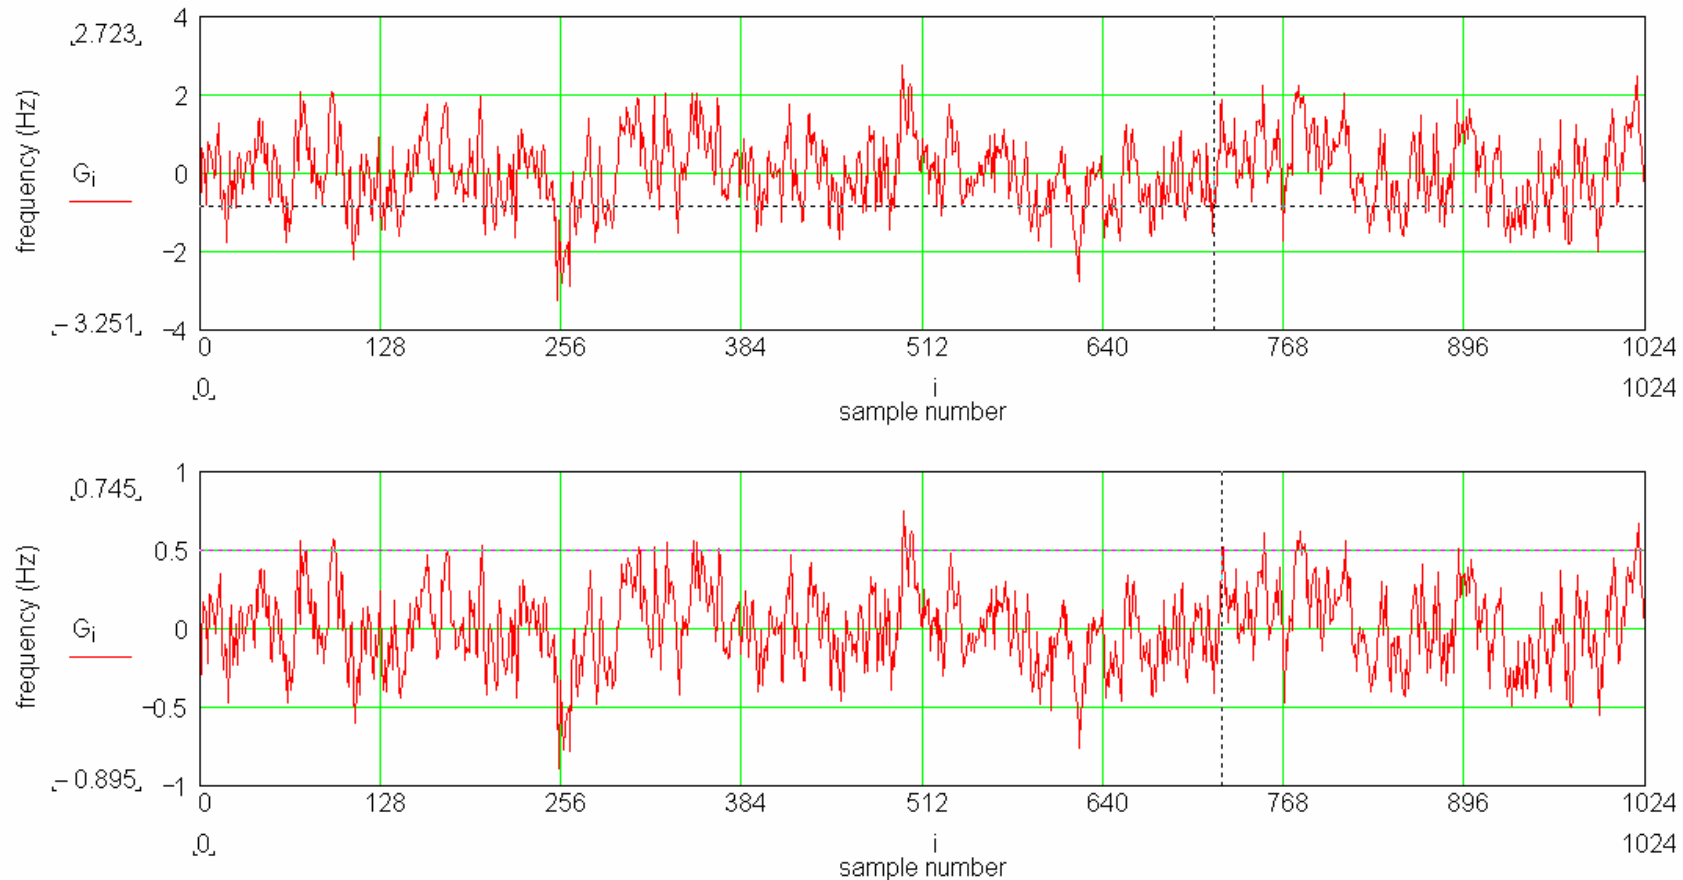
### 12.4.2 IFMS Doppler from 283.19:19 UT – 19:49 UT, ONED-TCXO

X-band (upper panel) and S-band (lower panel) frequency residuals after detrending the received antenna frequencies. The large amplitude fluctuations of the TCXO make it unusable for radio science purposes.

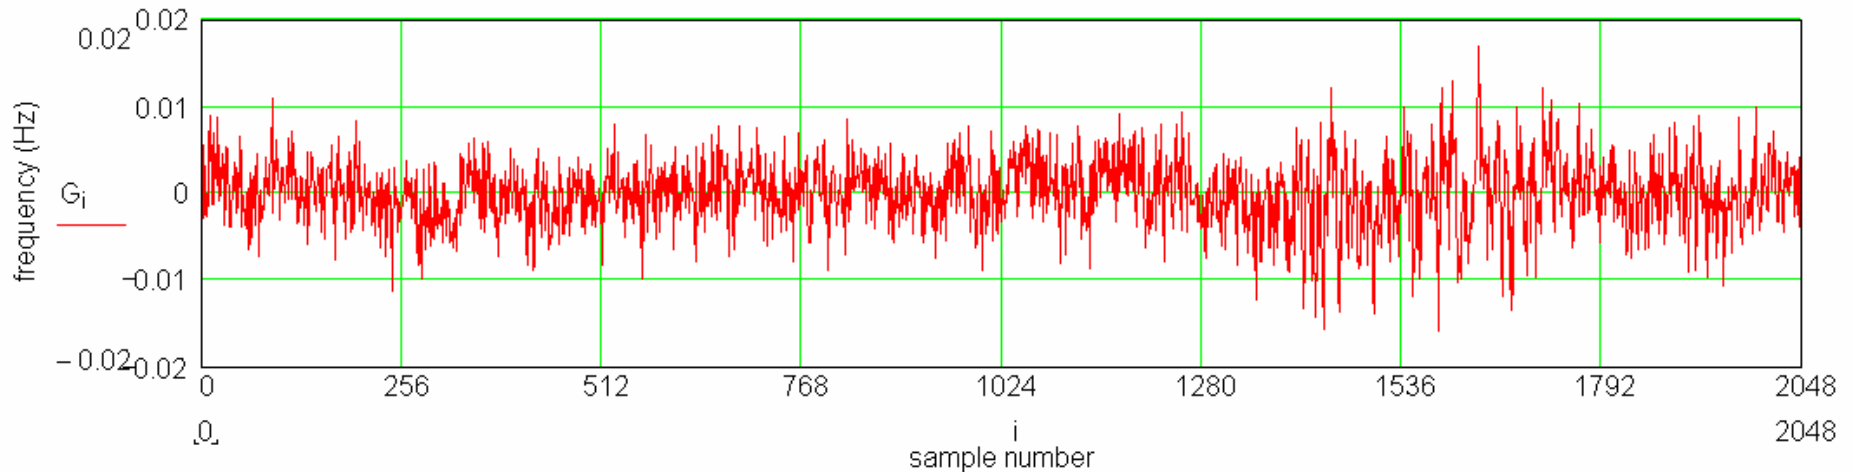
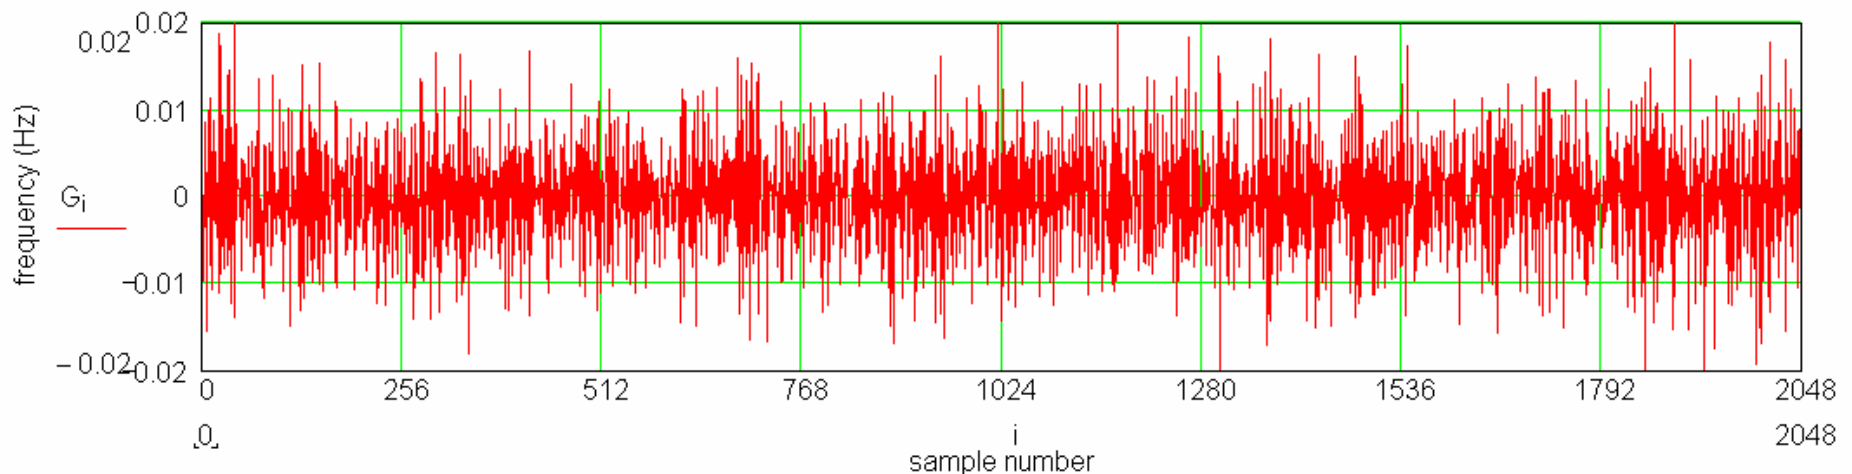
One-way X-band (upper panel) and S-band (lower panel) frequency residuals driven by the USO after detrending between 20:49 UT and 21:49 UT. TM is ON at X-band. TM was switched OFF at 21:45 (sample 1700), but no immediate transition can be seen.

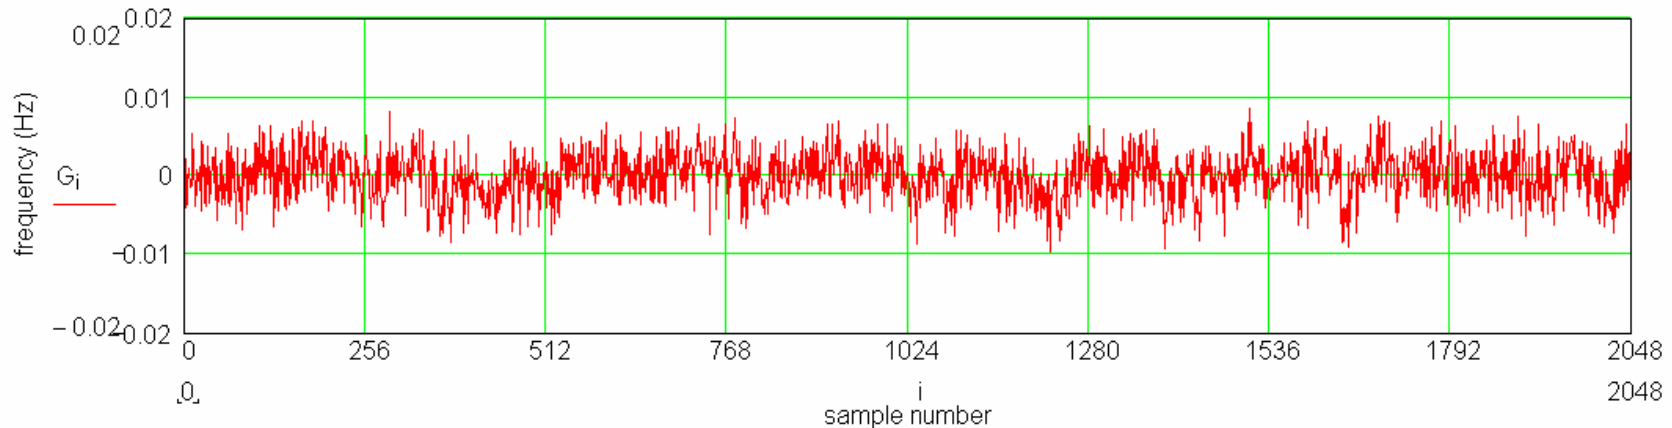
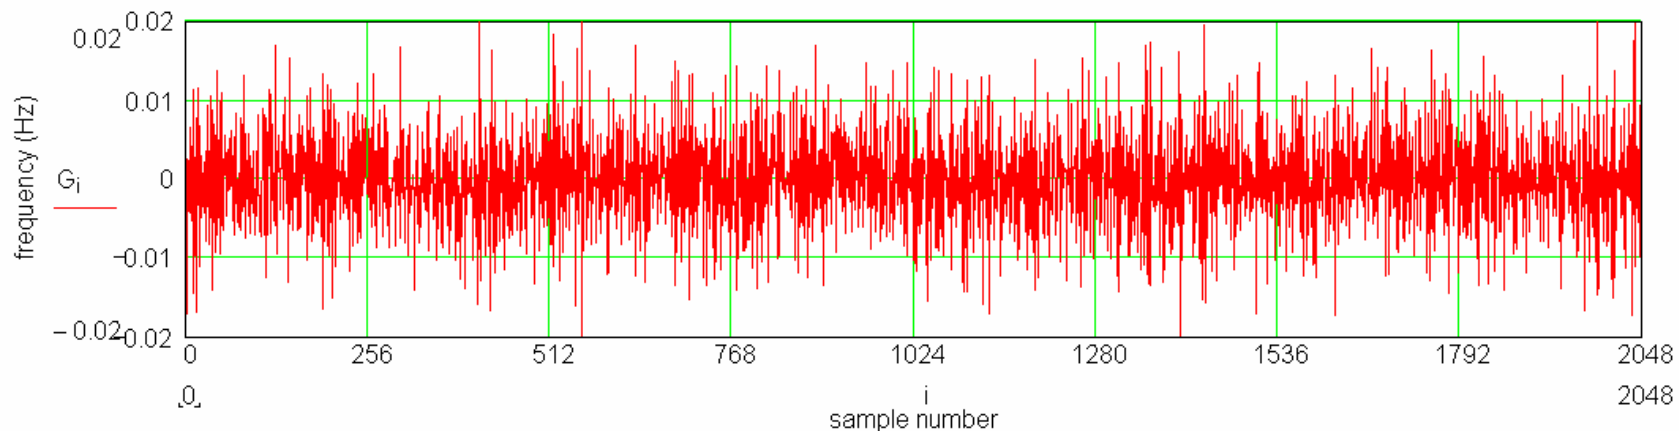
#### 12.4.4 IFMS Doppler from 283.21:49 – 22:49 UT, ONED-USO, TM OFF

One-way X-band (upper panel) and S-band (lower panel) frequency residuals driven by the USO after detrending between 21:49 UT and 22:49 UT. TM is OFF at X-band. TM was switched ON at 22:45 (sample 1700), but again no immediate transition can be seen. X-band noise level is 20% lower than with TM ON, S-band noise level is unchanged.

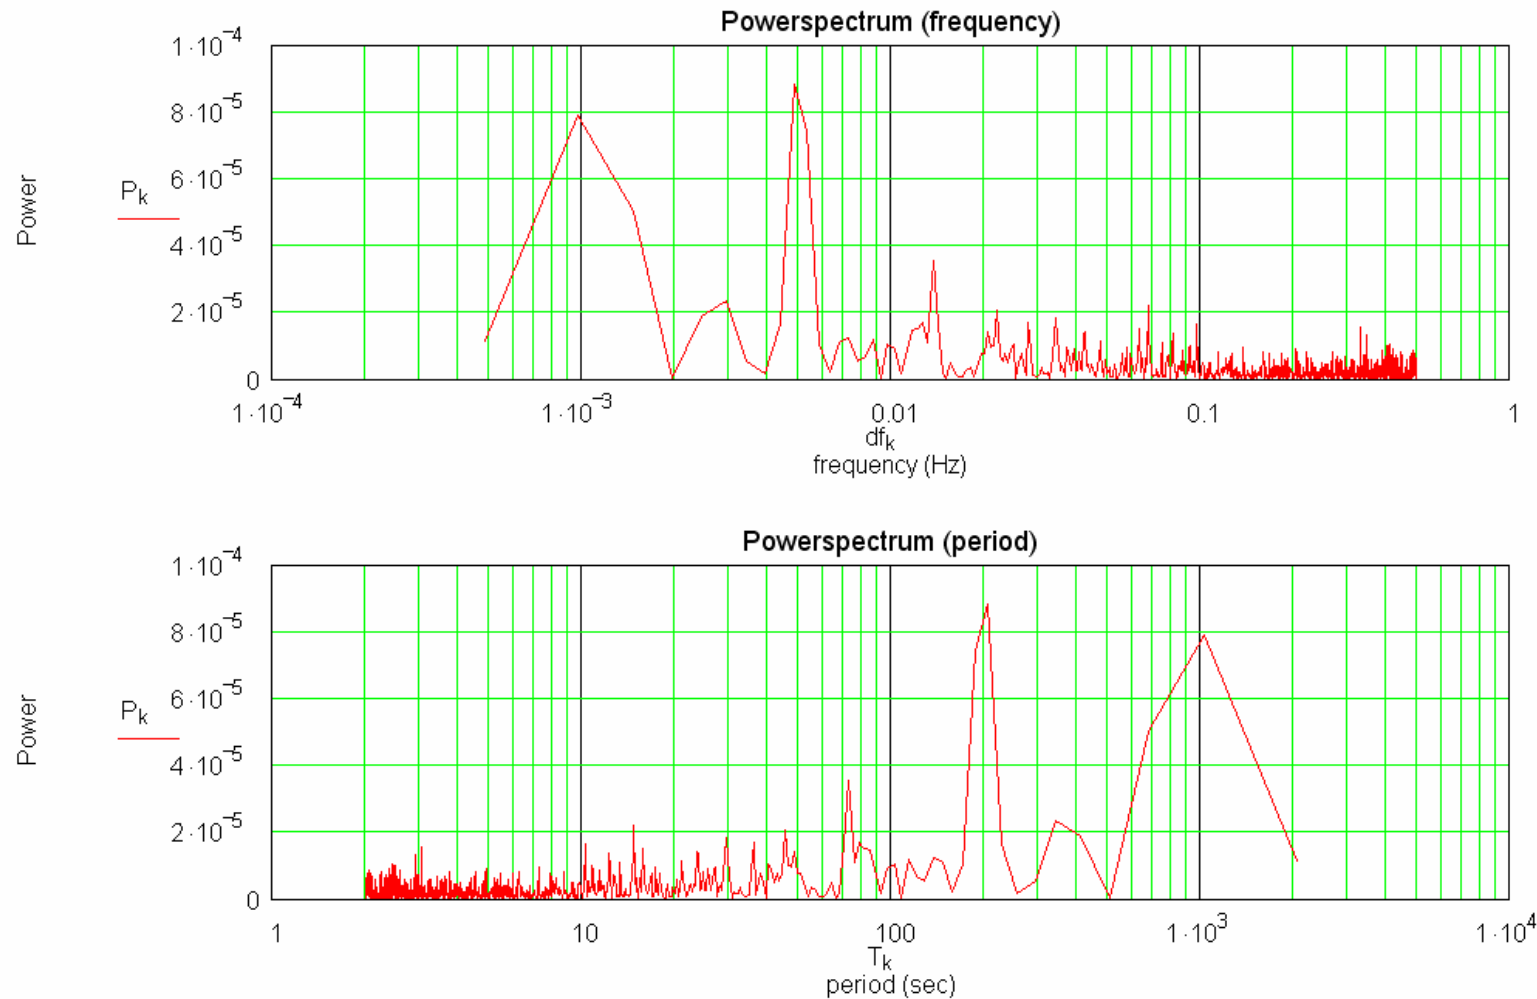
Power spectrum of the X-band frequency residual time series shown above between 21:49 to 22:49 UT, TM is OFF. the 50 seconds period disappeared. The S-band power spectrum is unchanged.

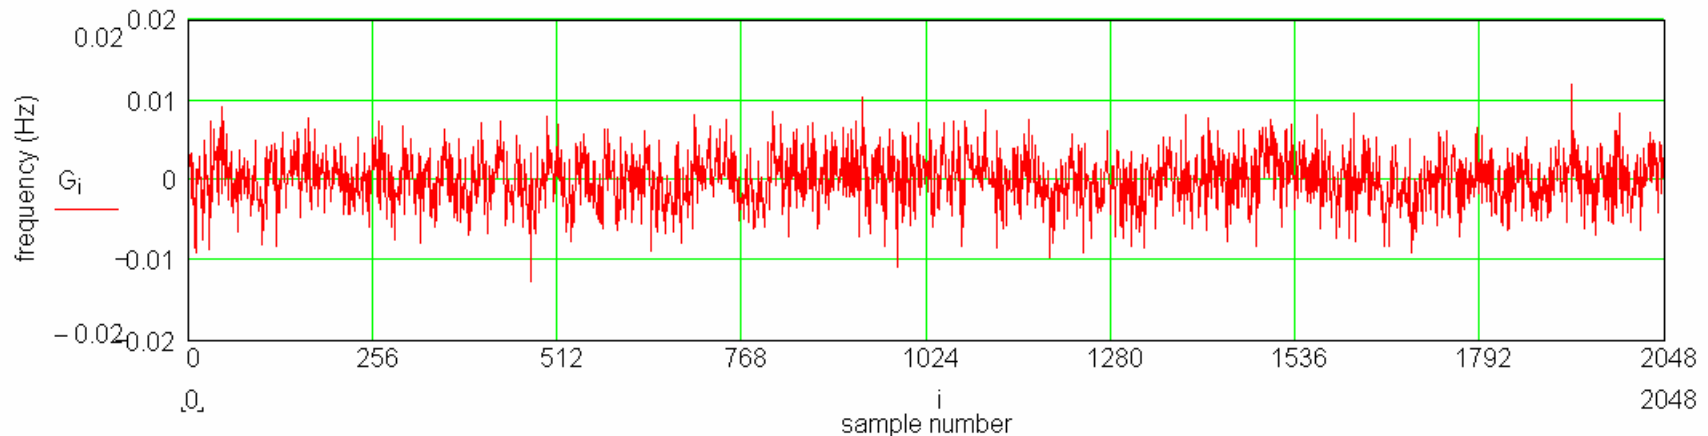
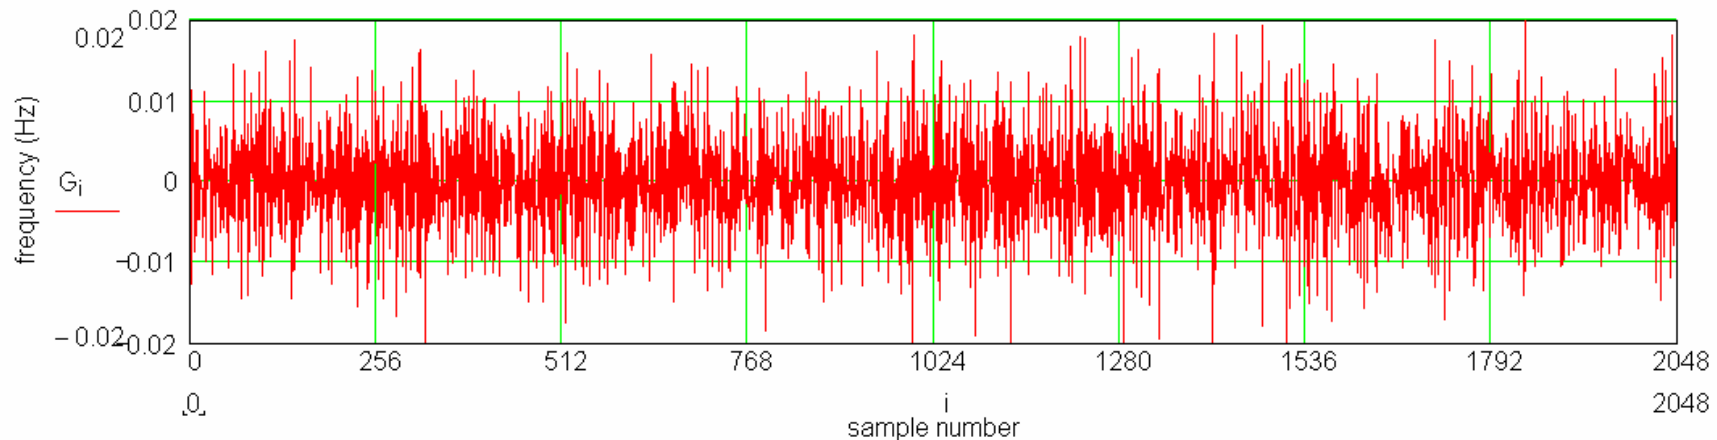
**12.4.5 Doppler from 283.22:49 – 284.00:49 UT, ONED-USO, TM ON**

One-way X-band (upper panel) and S-band (lower panel) frequency residuals driven by the USO after detrending between 22:49 UT and 23:49 UT. TM is ON again at X-band. X-band noise level is 20% higher again than with TM OFF, S-band noise level is unchanged.

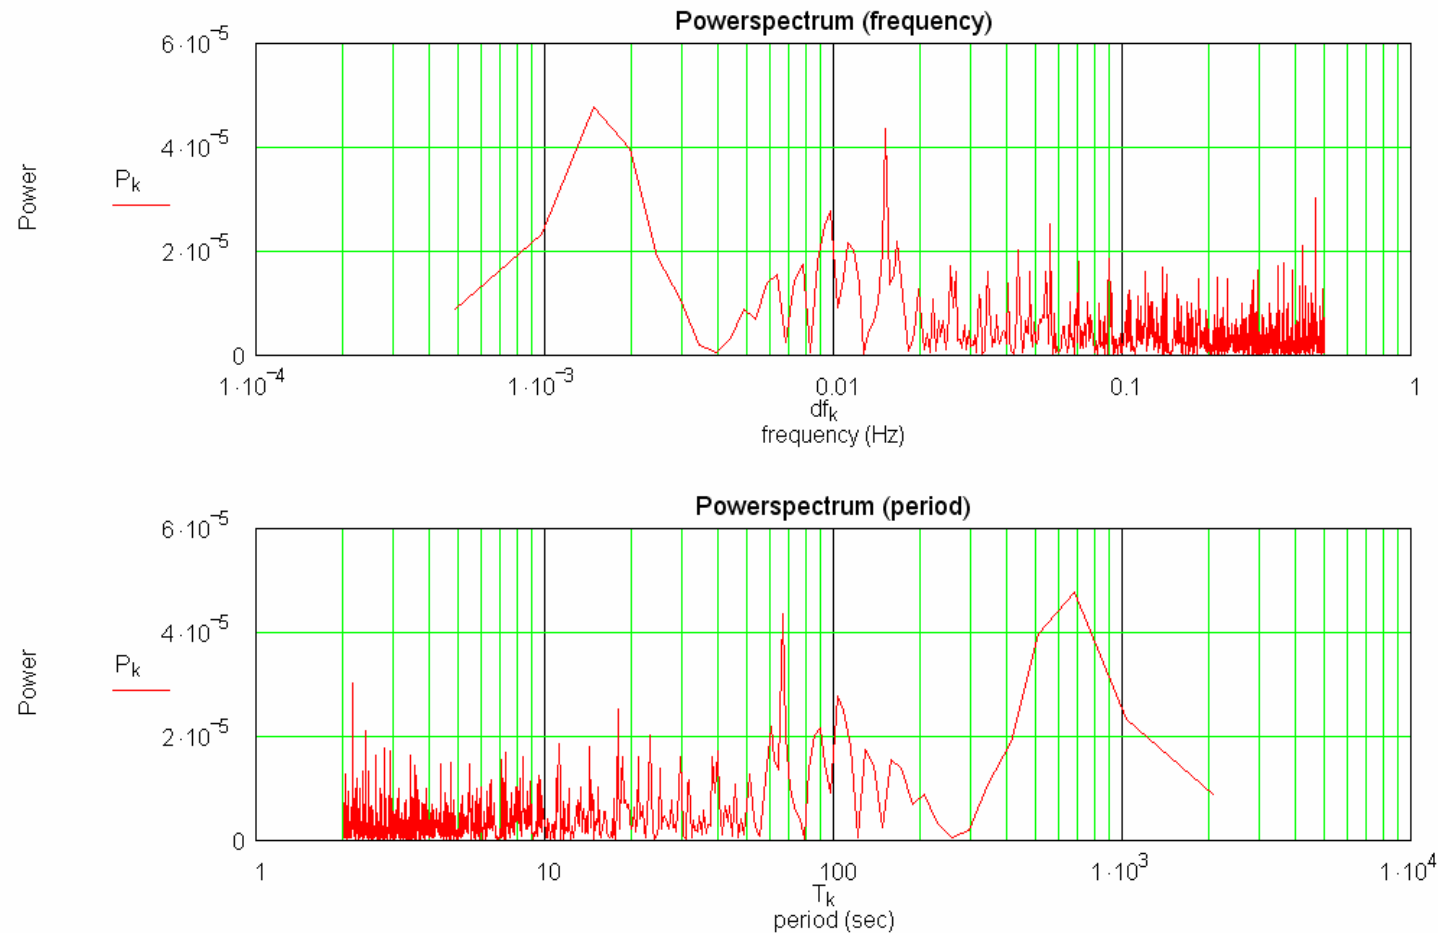
Power spectrum of the X-band frequency residual time series shown above between 22:49 to 23:49 UT, TM is ON again. The 50 seconds period appears again, although weaker than before the TM switch. The S-band power spectrum is unchanged.

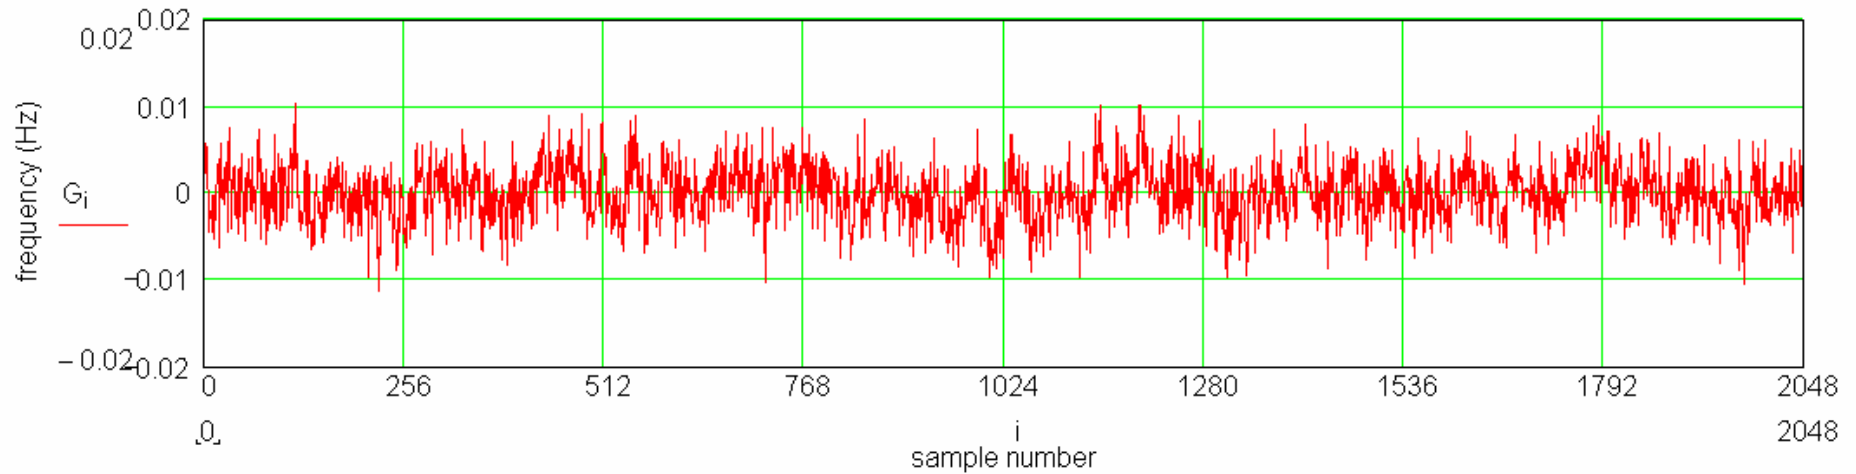
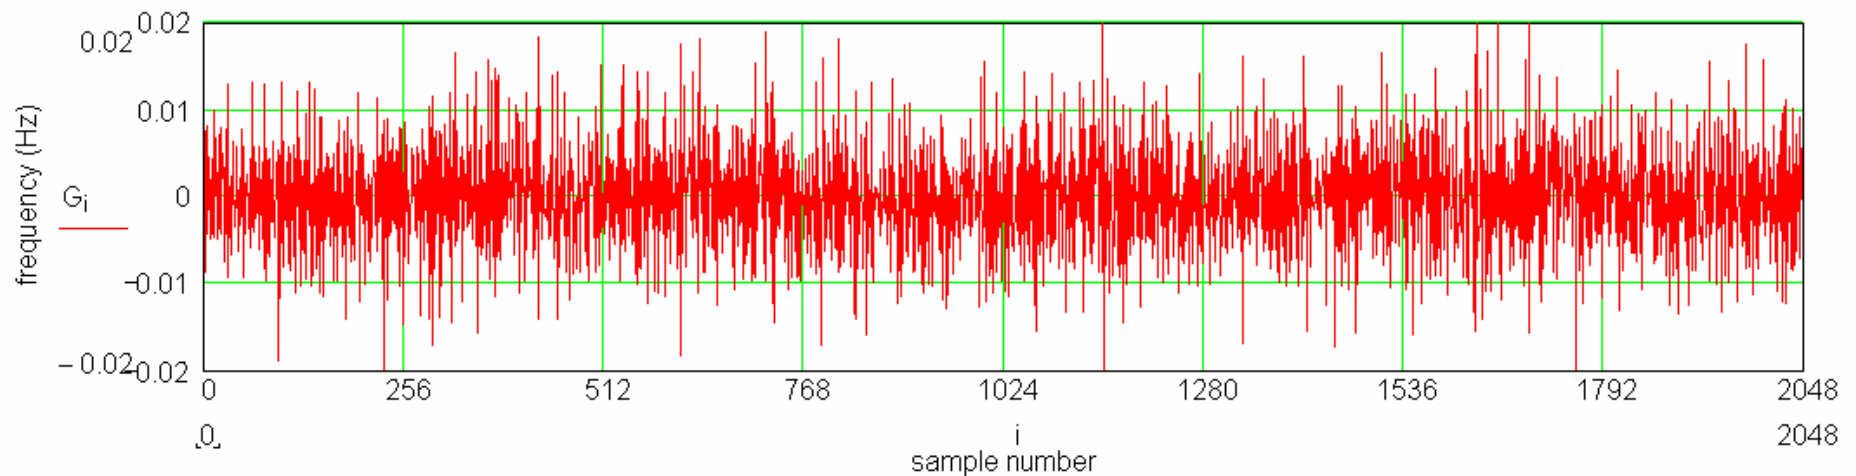
One-way X-band (upper panel) and S-band (lower panel) frequency residuals driven by the USO after detrending between 23:49 UT and 00:49 UT on DOY 284. TM is ON at X-band.
