***ROSETTA***

Consolidated Rosetta payload report for the MCRR

RO-EST-RP-3293

17 Nov 2004

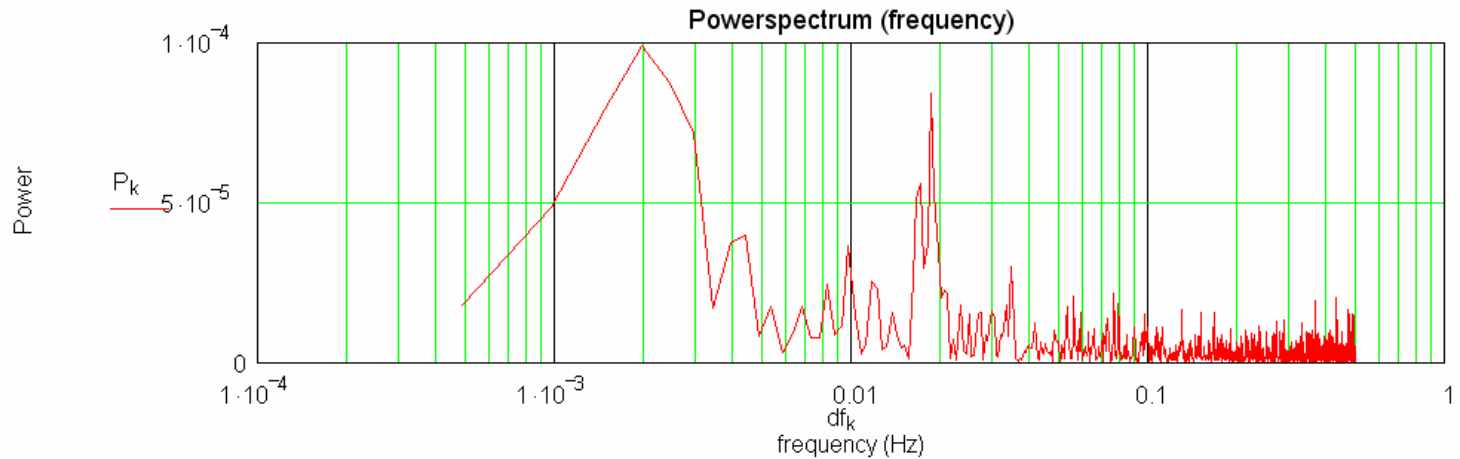
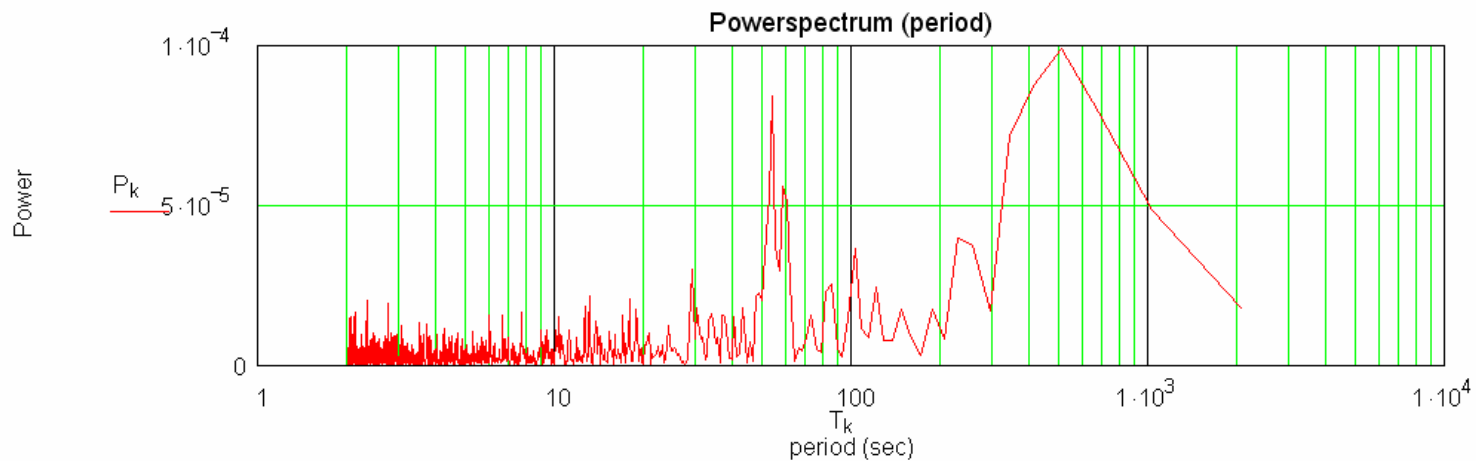
Power spectrum of the X-band frequency residual time series shown above between 23:49 to 00:49 UT, TM is ON. The 50 seconds period is getting stronger. The S-band power spectrum is unchanged.

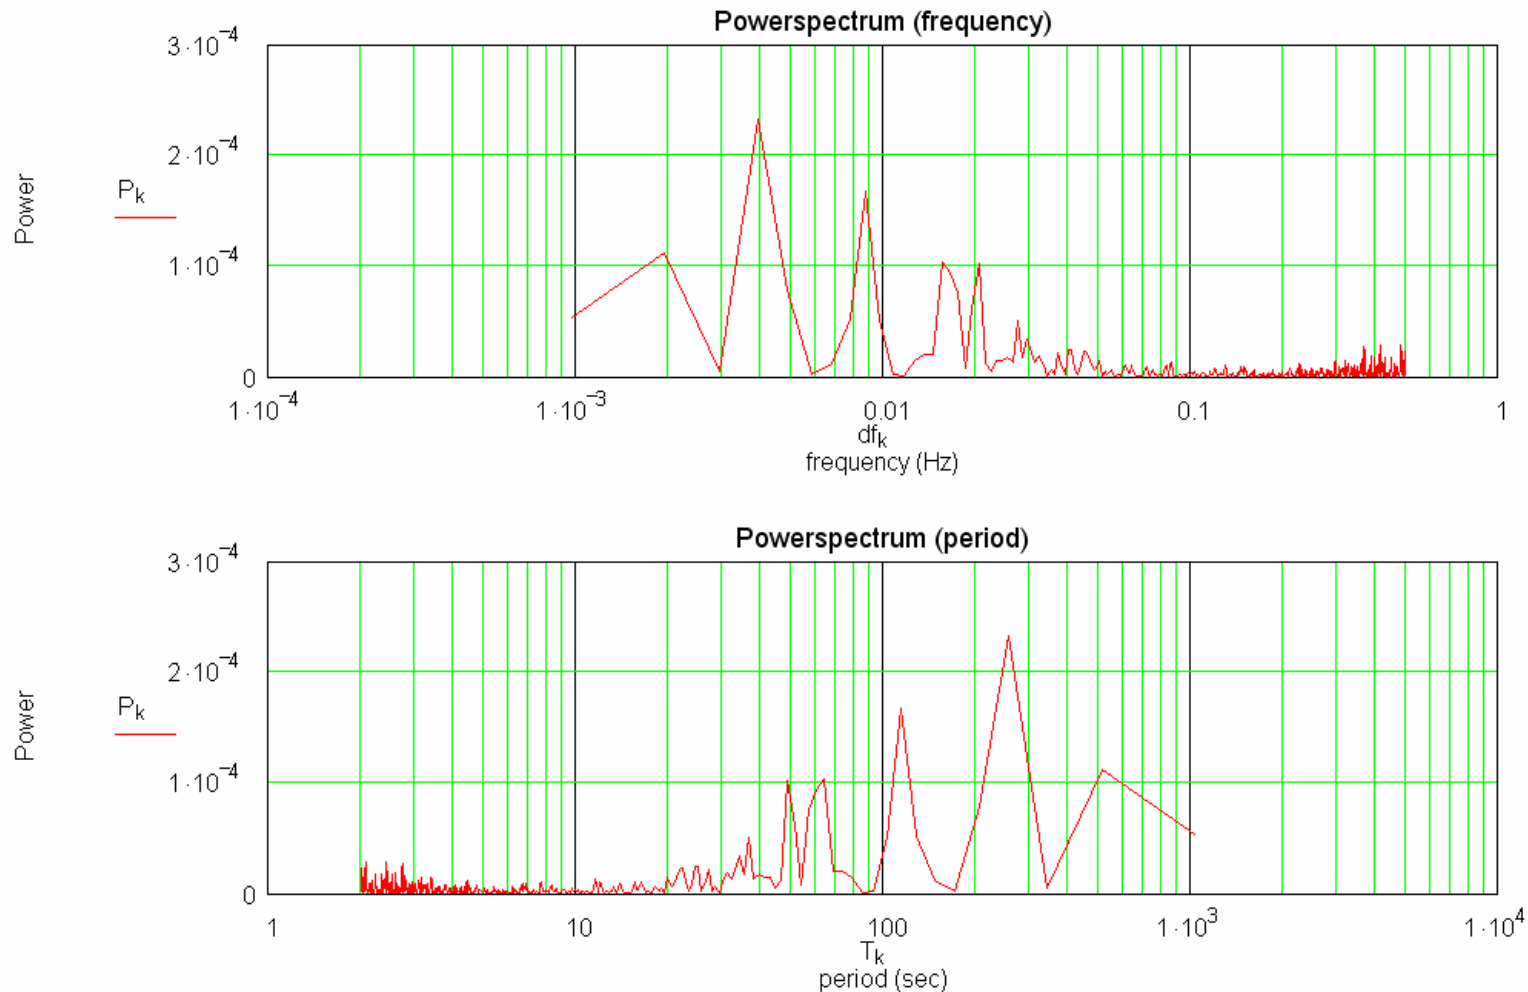
Power spectrum of the X-band frequency residual time series shown above between 01:12 to 01:49 UT, TM is ON. The 50 seconds period is strong. The S-band power spectrum is unchanged.

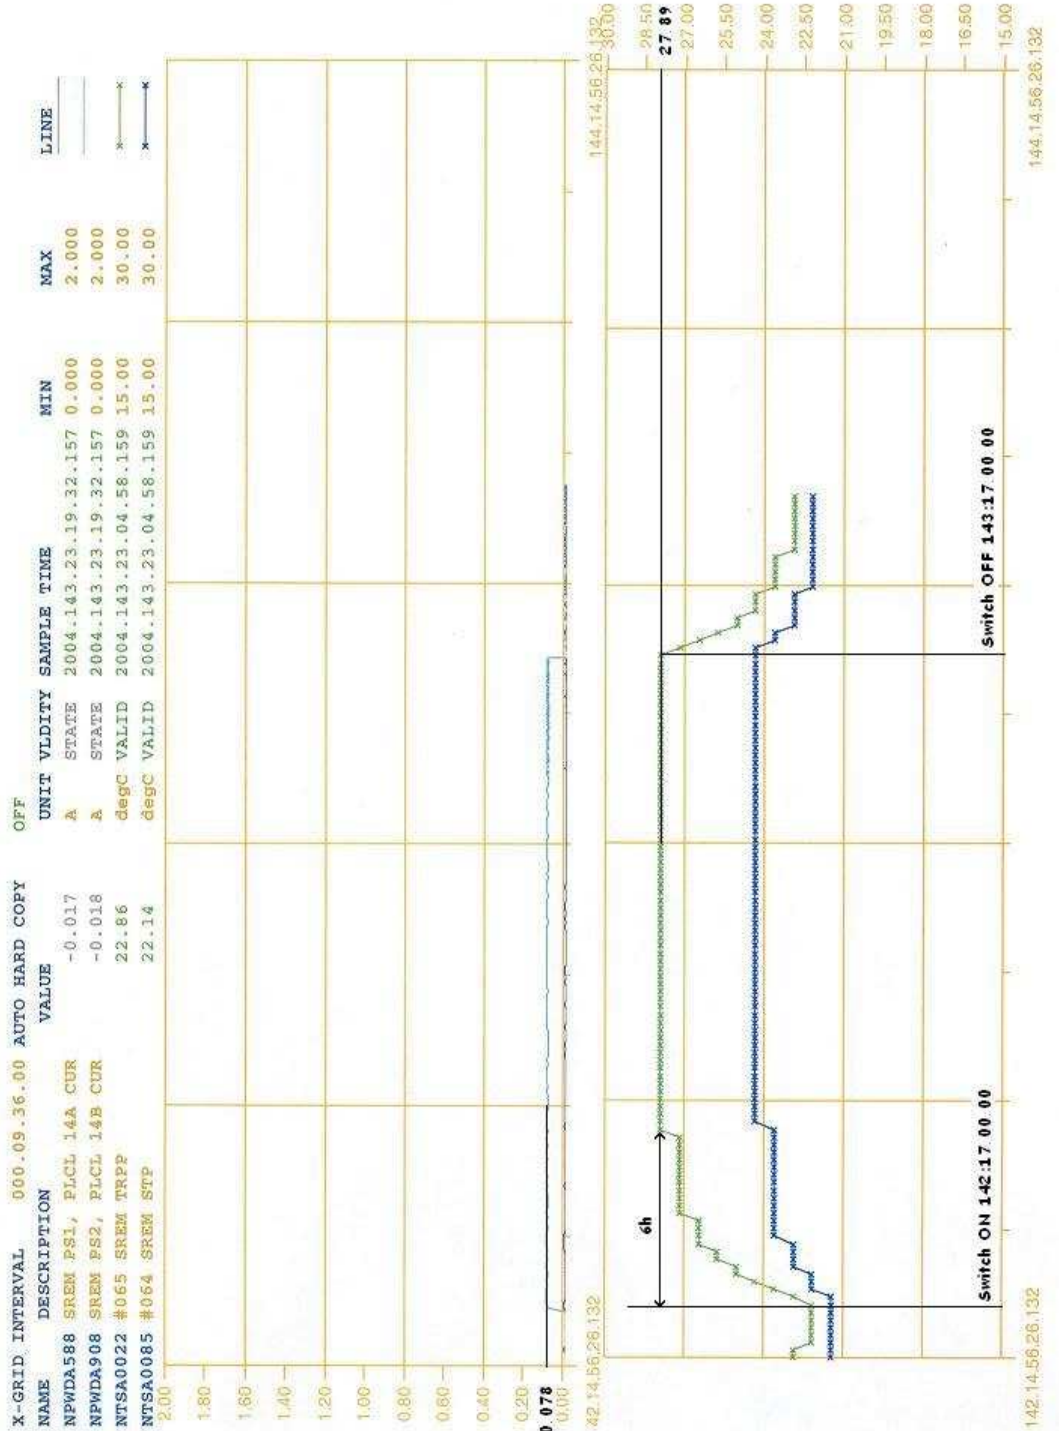
1. The time gaps are introduced in the TC procedure SE-FCP-003. The observed durations of these gaps are consistent with the software code. Actually it is further investigated whether these time gaps can be reduced.
2. In an out-of-pass action SREM was switched on for 24 hours and the temperature sensors NTSA0022 and NTSA0085 were monitored. The result of this test is shown in figure 5. The lower panel shows, that approximately 6 hours after switch-on a stable temperature is reached. The maximum temperature of 28° is well below the maximum acceptable temperature of 55°.

Figure 5: Out-of-pass test of SREM. The external temperature sensors NTSA0022 and NTSA0085 show that a stable temperature is reached after 6 hours of operation.

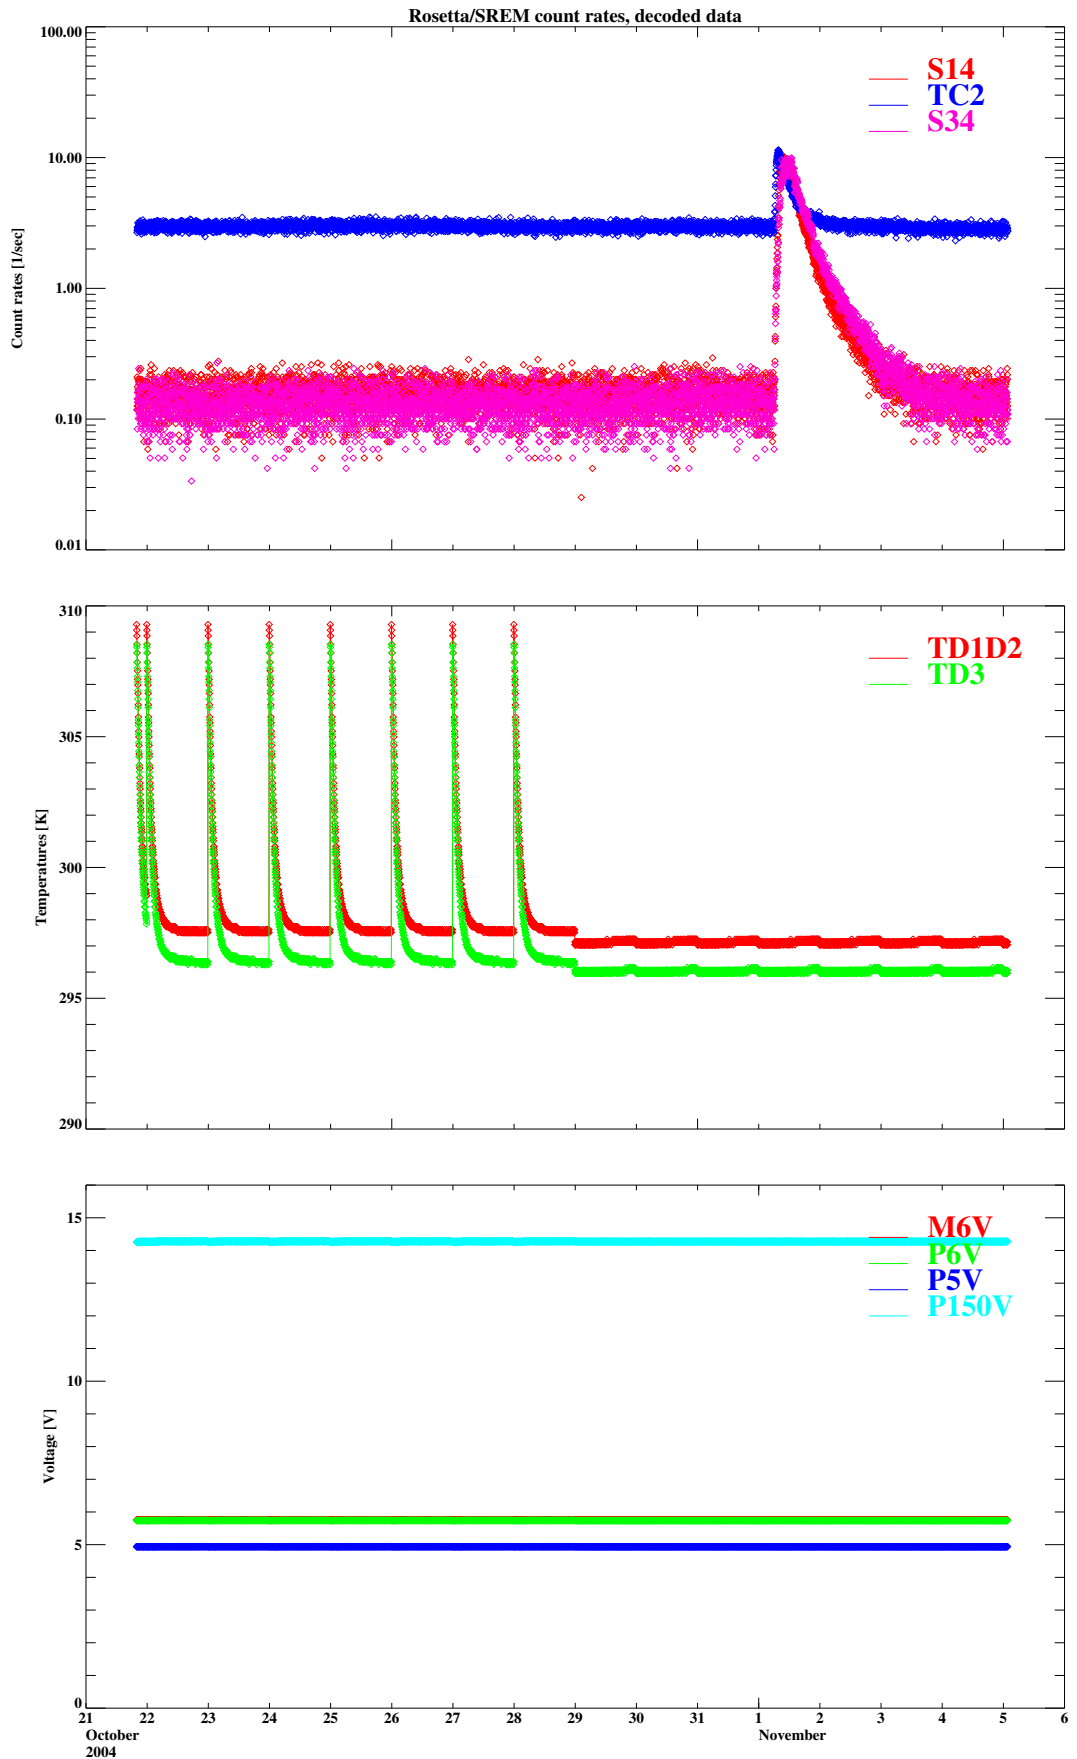
- Until October 15 further test were performed which confirmed the timing problem. The OBCP was modified and successfully tested. with the EQM
- In the following the modified OBCP was uploaded to the spacecraft and in the night of October 21, SREM was switched on again with the new OBCP.

- The data received since then looks good!

**Figure 6:** SREM/Rosetta summary plot from October 21 to November 6. The upper panel shows count rates of three SREM counters. The enhancement on November 1 is due to solar protons. The middle panel shows the two detector head temperatures. In the lower panel the SREM voltages are plotted, which are very stable and at nominal level.

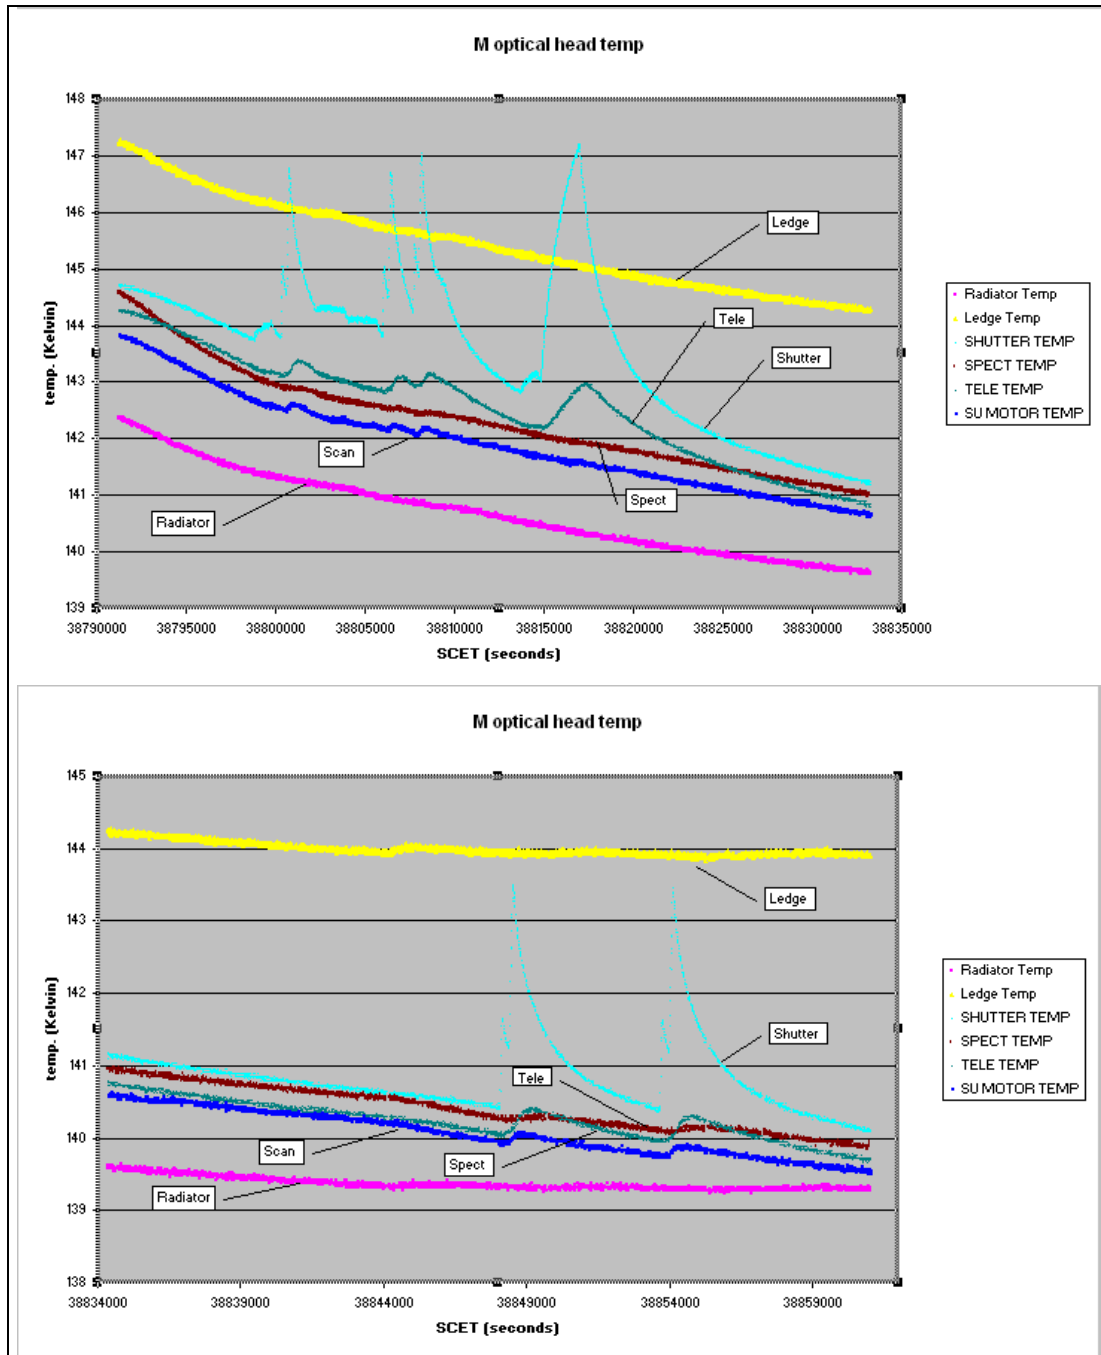
Figure 1. M Channel Optical Head Temperature during the first day of commissioning (Main Channel).

Also for M the preliminary evaluation has pointed out a substantial agreement with the on-ground calibration runs. However, minimal differences exist which have been interpreted in terms of the anomalously high temperature of the optical heads (see previous chapter).

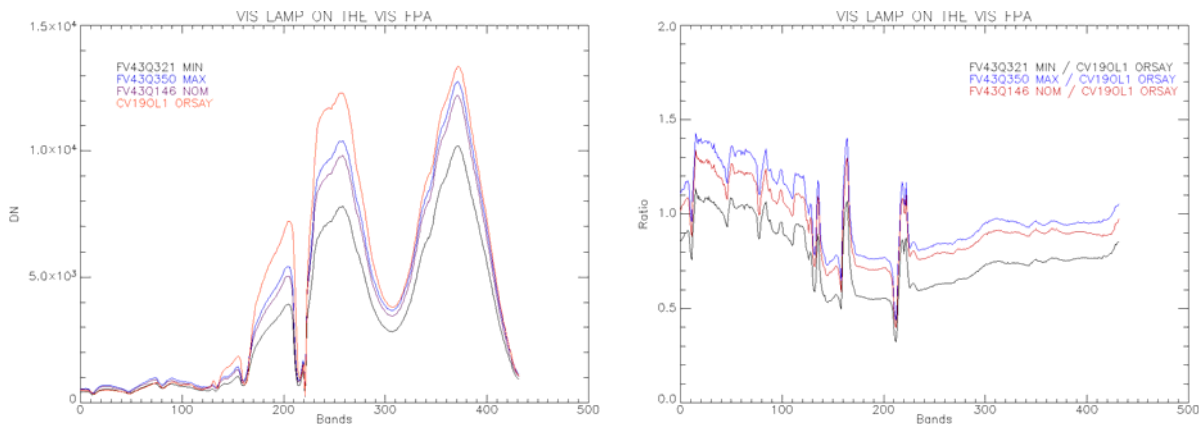
Figure 7. Calibration of VIRTIS-M Visible channel. On the left the spectral curves are compared with ground data (ORSAY), and on the right their ratio.

For the visible (figure 7) the signal for nominal current value is higher for On-Ground calibration (named Orsay on the plot) respect to in flight data of about 1000 DN at b=370 peak and 2500 DN at b=250 and b=200 peaks. The spectral shifts is observed near the filter position (b=222) and for peak at b=200.

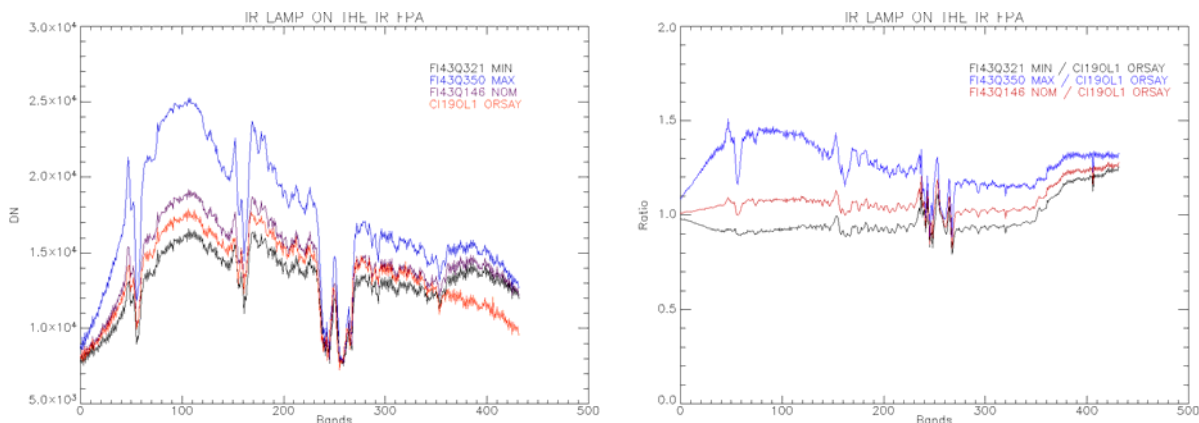
Figure 8. Calibration of VIRTIS-M Infrared channel. On the left the spectral curves are compared with ground data (ORSAY), and on the right their ratio.

For the infrared (figure 8) both nominal acquisitions are similar in intensity (on ground DN max about 1700 at band 110 vs. in flight DN max about 1900 ) and in shape; the signal at bands > 350 is higher for in flight acquisition: this effect is introduced by the higher temperatures of the telescope-spectrometer assembly during commissioning (142-143 K) respect to the ground calibrations (128-129 K). Many lab-measurements made on the polystyrene filter confirm the shifts (of about one channel) observed in the main absorption features around bands 230-260, varying the temperature of the calibration unit.

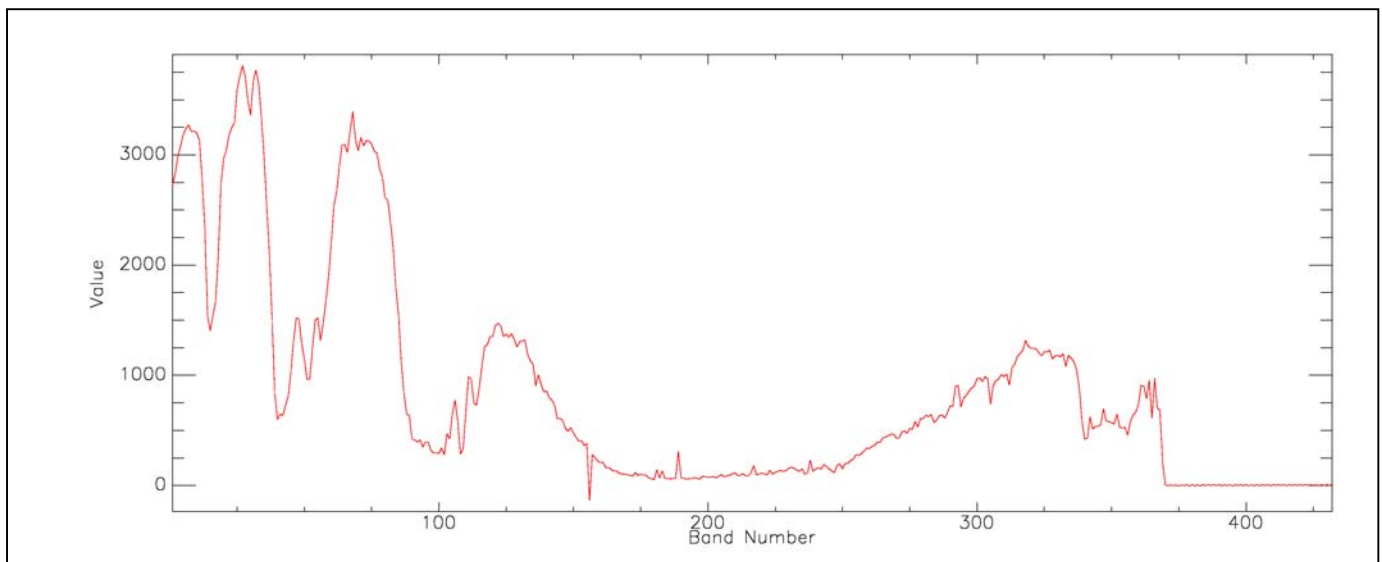
VIRTIS was commanded to take three scan images around Earth location (Earth was a point source), however one of the scans has failed due to a wrong instrument programming. The failure has been due to an incorrect instrument programming which has been understood. A reminder has been added in the VIRTIS user manual.

The raw spectrum shown in the figure is essentially very similar to the one shown in paragraph 3.2 except for the region above 4.45 micron (band larger than 375) where saturation of the dark current occur due to the long integration time used (we have adopted a 10s integration against the 0.1 seconds used during the observation reported in paragraph 3.2).

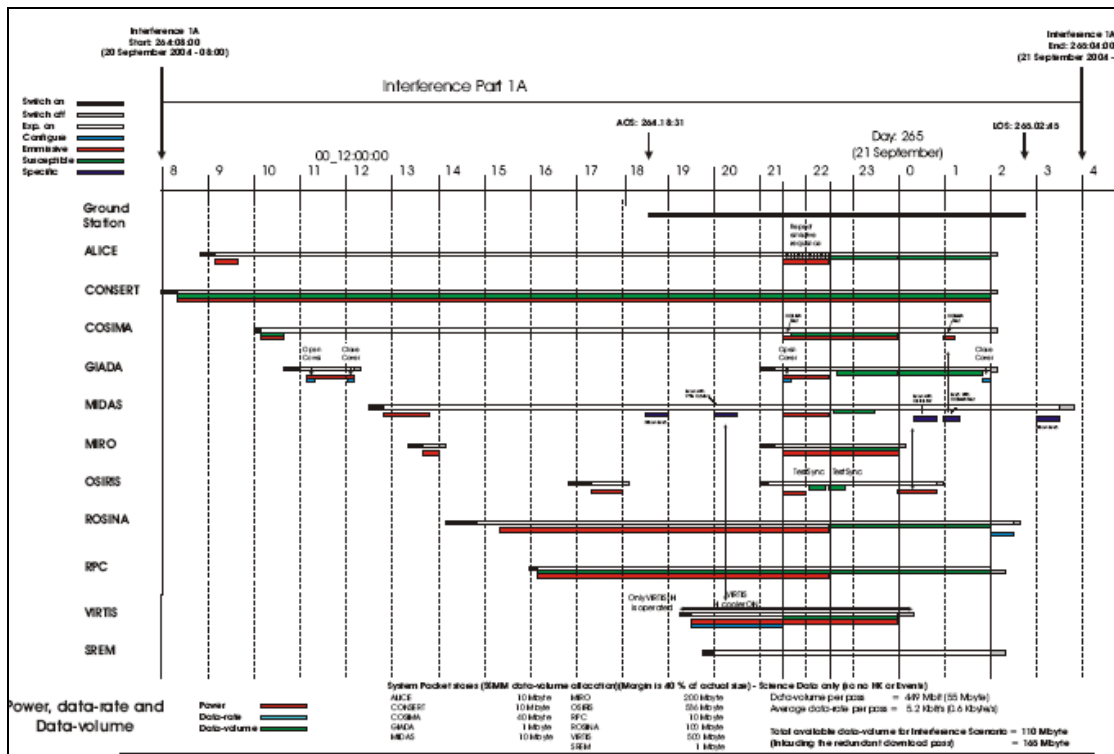
The interference test was performed in the period 20-21/09 ,during that VIRTIS was switched ON for about five hours in emissive mode with only H-channel On.

The post processing of the data has shown NO problem of interference nor on the Housekeeping values nor on the science data.
